Lead Glass and Photomultiplier Evaluation A Progress Report*

Jonathan Dickey, Eric Scott, Paul Smith and Scott Teige
Department of Physics
Indiana University, Bloomington, IN 47405

The GlueX collaboration intends to reuse the Lead Glass Detector previously used for Brookhaven National Laboratory Experiment 852. Since lead glass is subject to radiation damage and photomultiplier tubes subject to various aging mechanisms evaluation of the suitability for use of these components is essential. This document describes methods developed and the progress of the evaluation.

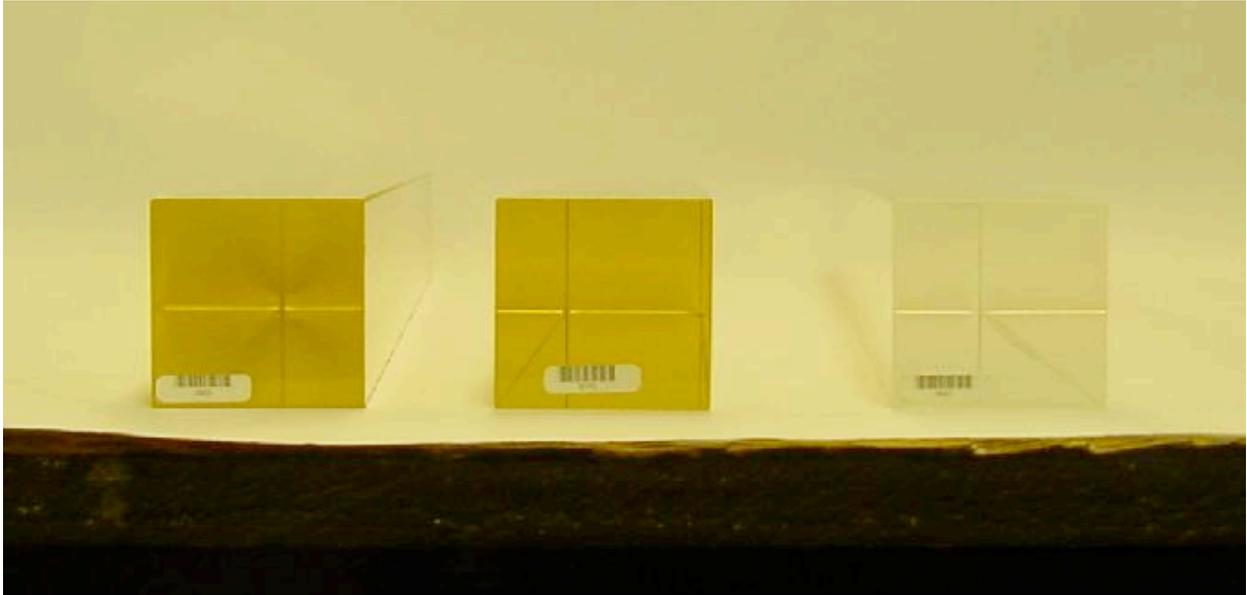
Radiation exposure causes lead glass to darken, reducing the amount of Cerenkov light produced by electromagnetic showers detected by the phototubes of the calorimeter. Figures 1 and 2 are photographs of damaged and undamaged lead glass blocks.

Figure 1: An end view of three blocks. The two at the left were used in RadPhi, the other is from E852. The blocks are $4 \times 4 \text{ cm}^2$, the white stickers are bar code labels.

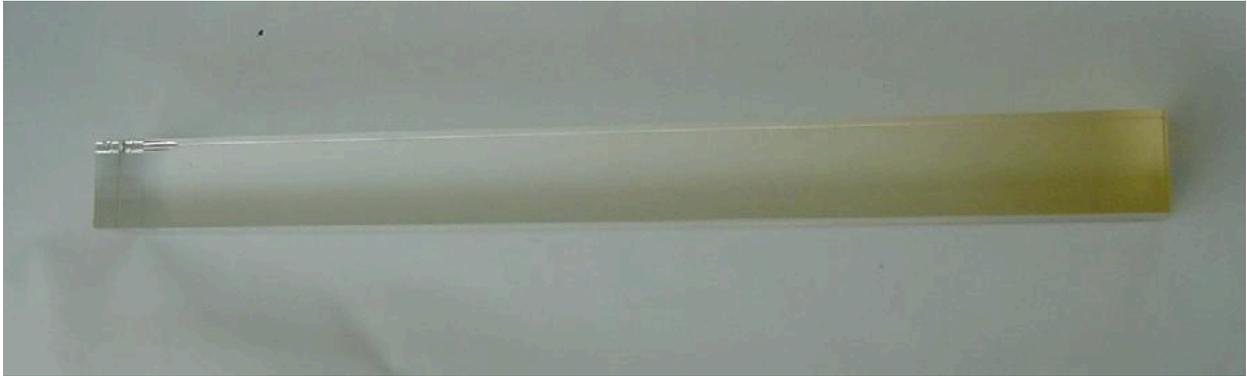
This radiation damage leads to degradation of the resolution of the detector and is, to some extent, temporary. The damage can also be reversed, at least partially, by exposure to ultraviolet light or heat.

Figure 2: A full length view of one of the damaged blocks. Note the chipped corner on the upper left and the dependence of the damage on the depth into the block

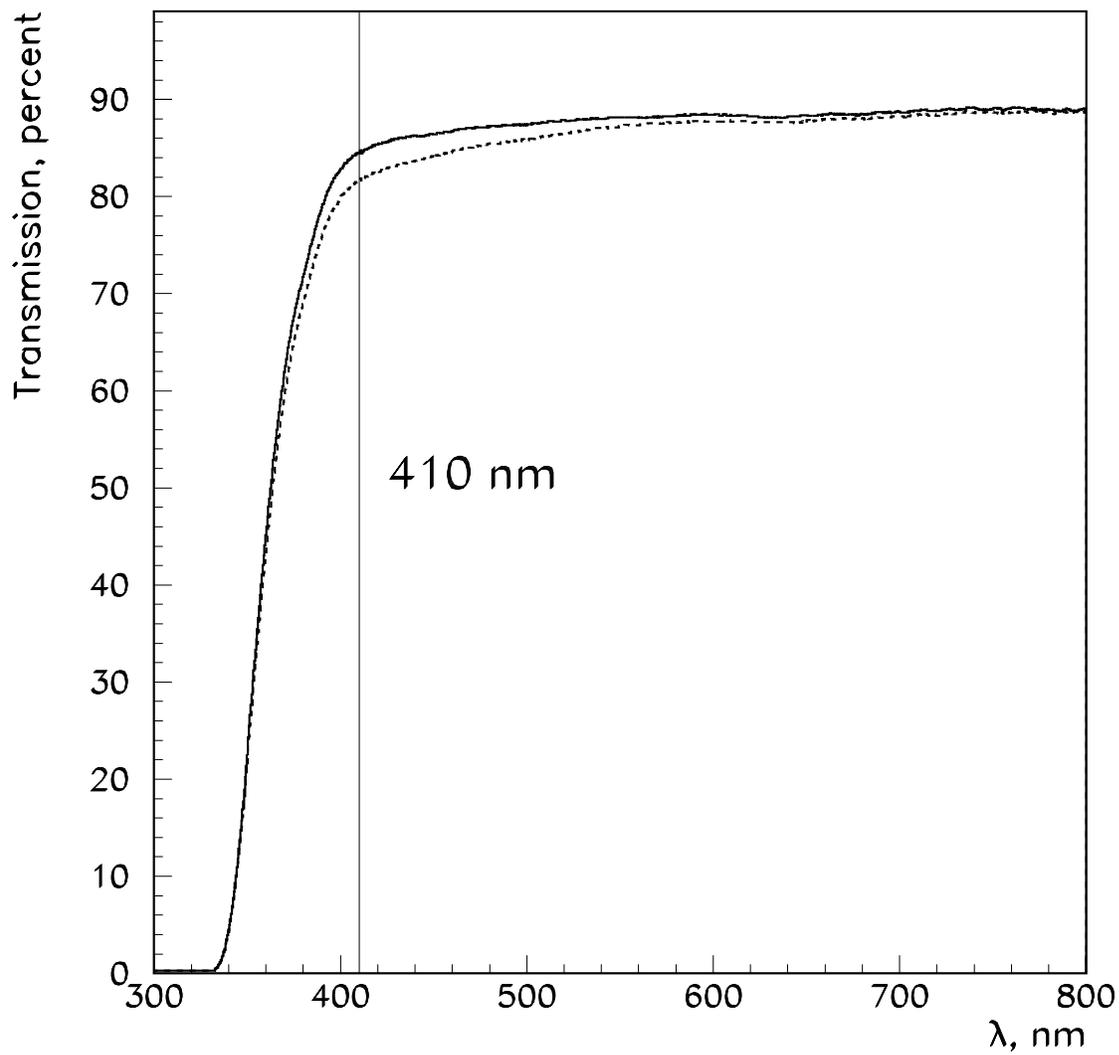
had never been used, another was a block selected as slightly radiation damaged. It can be seen that the transmission at shorter (bluer) wavelengths is degraded. Subtraction of blue light leads to a perception of "yellowing" consistent with the visual observations.

It can also be seen from figure 4 that the fractional change in transmission between damaged and undamaged glass is largest near 410 nanometers. Transmission at this wavelength was chosen as the criterion for selection of damaged/undamaged glass.

Based on the measurements presented here, the criterion for defining a block as radiation damaged is that transmission at 410 *nm*, uncorrected for reflection, is less than 84%.

Figure 4: The transmission of unused lead glass (solid curve) and radiation damaged glass (dashed curve) as a function of wavelength. The measurement for the damaged block was made midway along the length of the block, that is, where damage was not easily visually detectable. The line at 410 nm indicates the wavelength chosen to diagnose radiation damage. No corrections for reflection at the surfaces of the glass have been made.

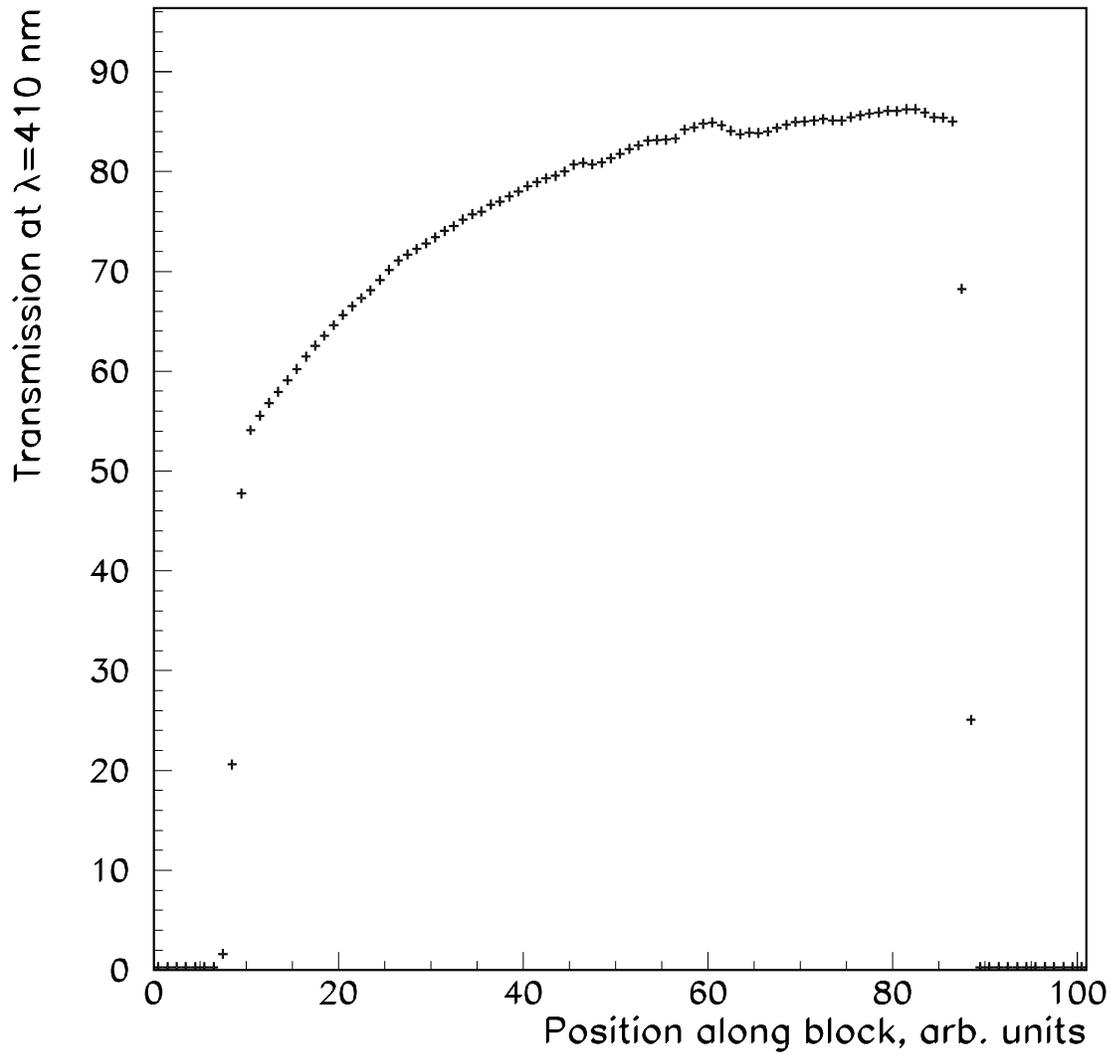
The mechanical modifications to the spectrophotometer allow the blocks to be scanned (at one wavelength) along their long dimension. Figure 5 shows the result of one such scan of a radiation damaged block. The units of length in this plot are arbitrary and correspond to a step number in the software controlling the scan.

where Z_c is the characteristic length of the damage. Z_c is found to be 11 *cm*.

Figure 5: The transmission of 410 *nm* light as a function of depth in a radiation damaged lead glass block. The characteristic length scale of this damage is 11 *cm* or about 3 radiation lengths. No corrections for reflection at the surfaces of the block have been made.

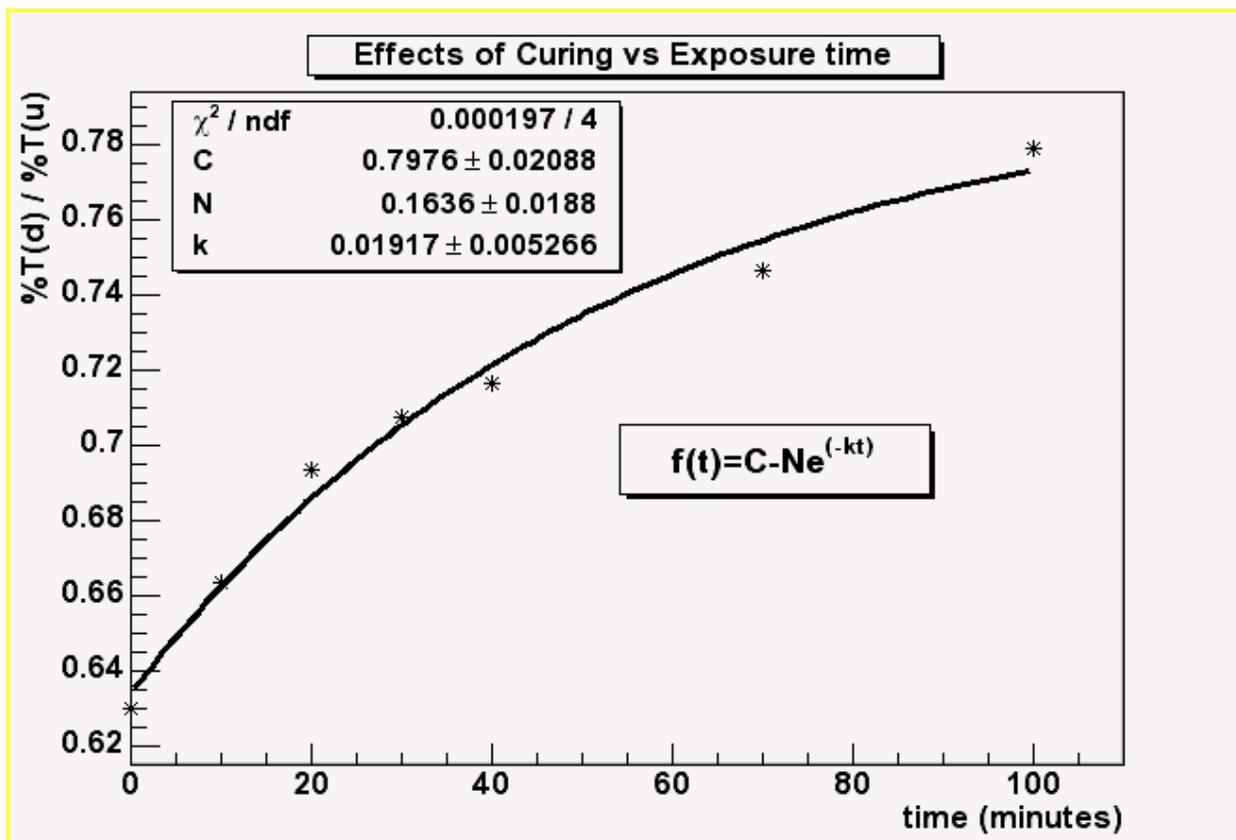
determine the length of time required to complete the cure and the final transmission that could be expected given a cure of infinite length. Figure 6 shows the result of this study for a radiation damaged block. The fit function predicts the transmission that could be achieved if the exposure was carried on forever: 79.8%. This value is substantially smaller than the 89.1% observed for undamaged glass

Figure 6: The time dependence of transmission after curing with ultraviolet light

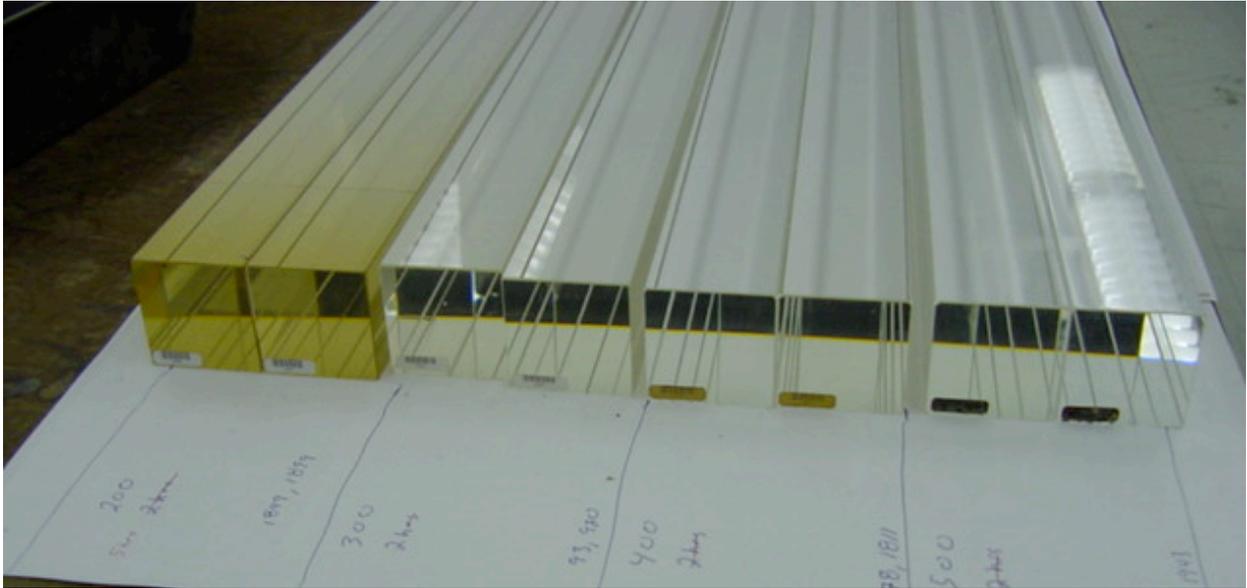
Figure 7: An end view of some representative blocks before and after heat treatment.

After treatment, the blocks are re-tested. Either visually or using spectrophotometer measurements, heat treated blocks are *indistinguishable* from new lead glass. Figure 7 shows photographs of several treated and untreated blocks. The blocks farthest to the left in this photograph were subjected to the full heat treatment, the others to various lower temperatures. Numerically, the heat treated blocks achieved an uncorrected transmission at 410 *nm* between 86-87%, identical to values achieved by unused glass.

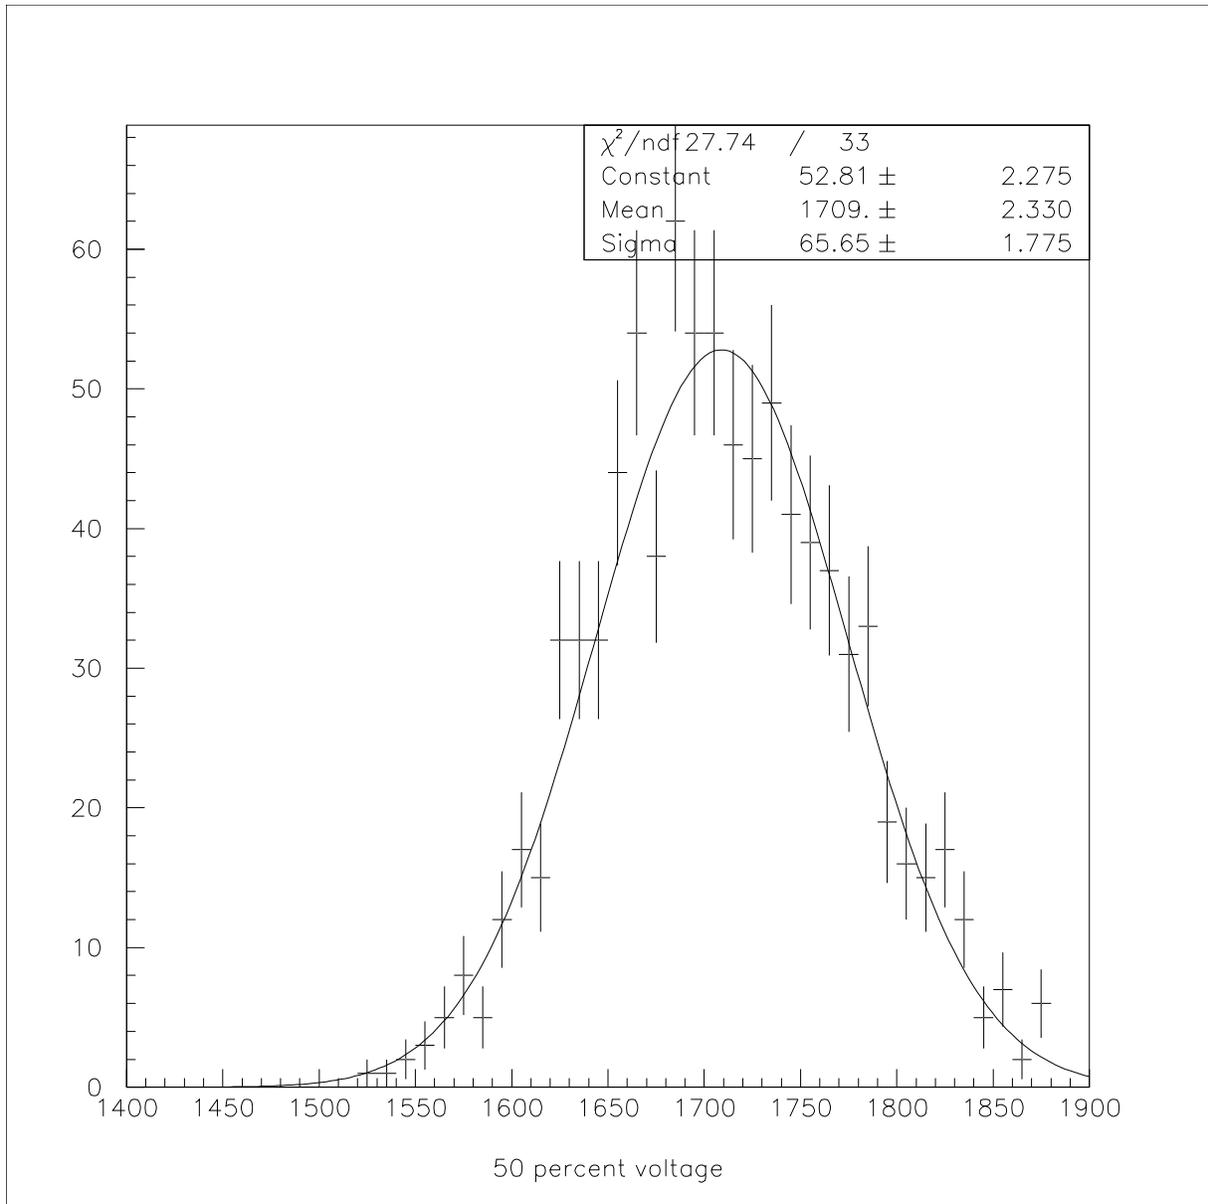
The data from the tester was analyzed offline. A tube was flagged as "suspect" if the function given by 3 failed to reach 90% efficiency over the tested range of voltages. Diagnostic output was printed to the screen identifying the tube and giving the location of further diagnostic data. The distributions shown in figure 11 for flagged tubes were examined. About 10% of all tested tubes were initially flagged by this process. The detailed examination revealed that most flagged tubes were, in fact, operational but the fit failed to converge. In nearly all cases this failure to converge was caused by a "late turn on" of the phototube response. That is, the 50% voltage was in excess of ≈ 1850 volts. The fit was initialized so that it would converge for most tubes thereby minimizing the number of distributions to be examined in detail. However, this choice of initialization resulted in the $\approx 10\%$ false positive test rate.

Determination of failure during detailed examination was unambiguous. The tubes detected as failures had *no* signals over threshold at any voltage. Of the 977 tubes tested to date, 21, or 2.2% have failed. The failed tubes were inspected visually to determine if this method would be sufficient to detect failed tubes. 9 of the failed tubes had the transparent photocathode characteristic of vacuum failure. One of these was mechanically damaged, a crack in the envelope was apparent.

Figure 12: The observed distribution of V_0 for the tubes tested to date.
