# Central Drift Chamber straw radiation test results

*Yves Van Haarlem*  
*Carnegie Mellon University*  
GlueX-doc-1379 (version 8)

March 10, 2010

This note describes a radiation test done with a prototype of the GlueX Central Drift Chamber. The goal is to determine if the aluminum anode layer inside the straw would be damaged by radiation expected in GlueX.

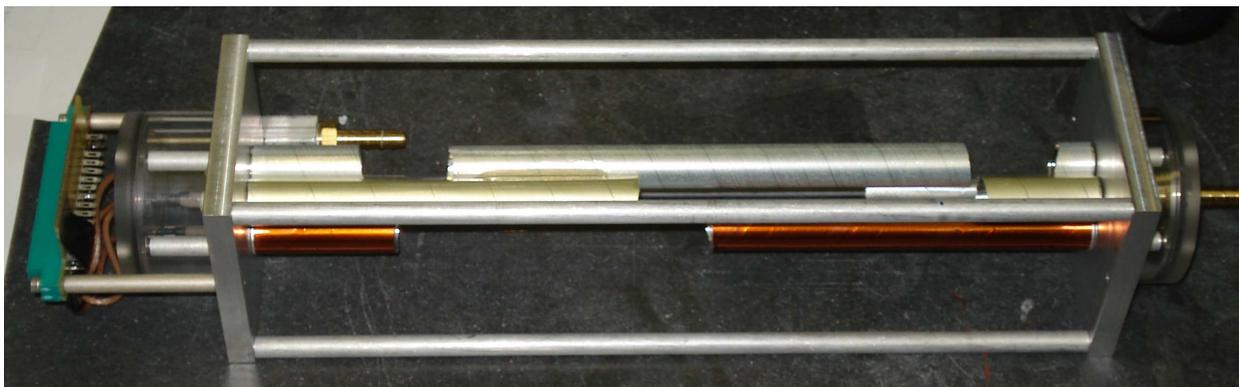
Figure 1: Picture of a four straw prototype after radiation and examining of the straws.

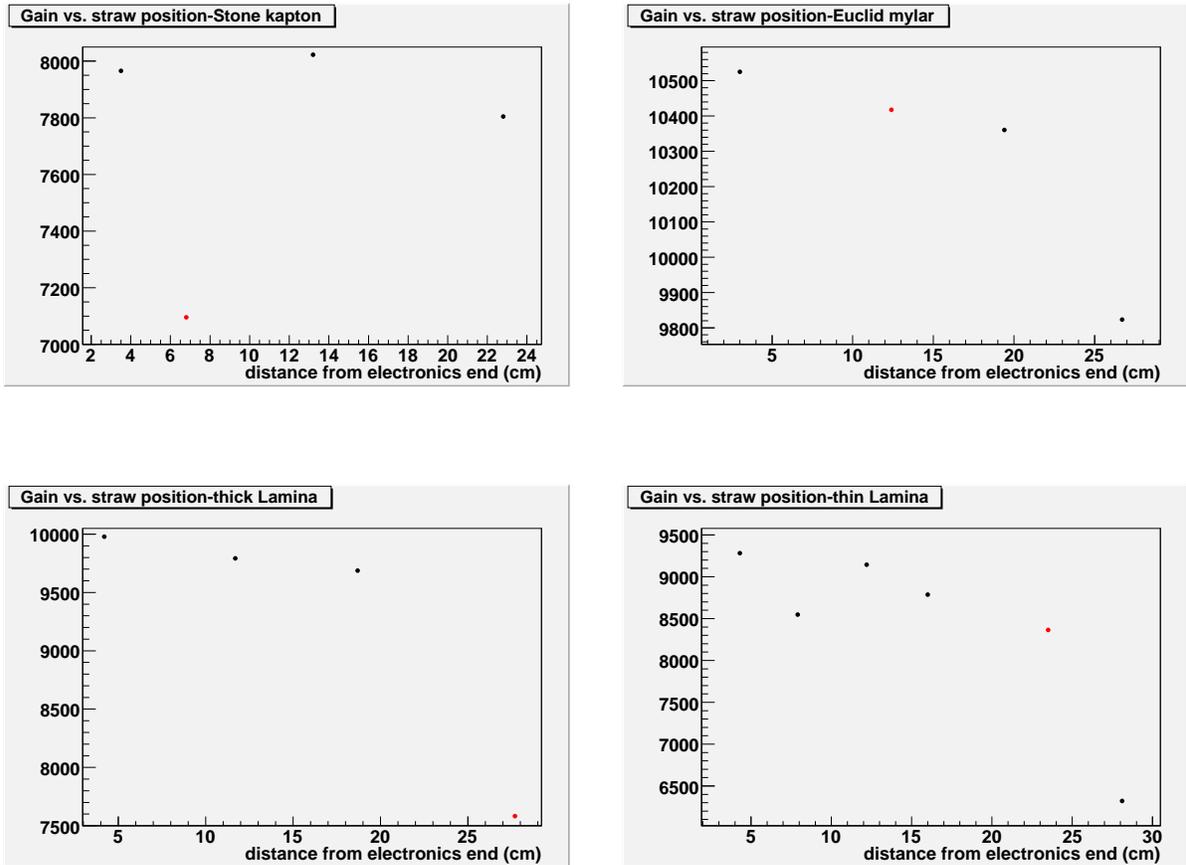
In Fig. 2 the gain of the straw is shown as a function of distance from the read out electronics. The gain is measured using an  $^{55}\text{Fe}$  source. The red point indicates the spot where the straw was irradiated. In general one expects a slowly decreasing gain as a function of distance from the read out electronics followed by a more drastic drop if one gets close to the end of the straw (the electric field lines get distorted due to the presence of material that holds the straw). This behavior is observed in all the straws except in two points: at 7 cm distance there is a dip in the Stone-kapton and the Lamina-thin straw. The dip in the Stone-kapton straw might be due to the irradiation. Although the Lamina-thin straw was located under the source as well during irradiation, it is not clear if the dip is also due to radiation because the other way around there is no dip in the gain observed for the Stone-kapton straw where the Lamina-thin straw got irradiated (at 24 cm distance). It also seems that the Lamina-thick straw got irradiated quite close to the end where you expect to see a drop in gain due to electrostatic effects.

Figure 2: Gain as a function of distance from the readout electronics for the four tested straws. The red point indicates where the straw was irradiated.

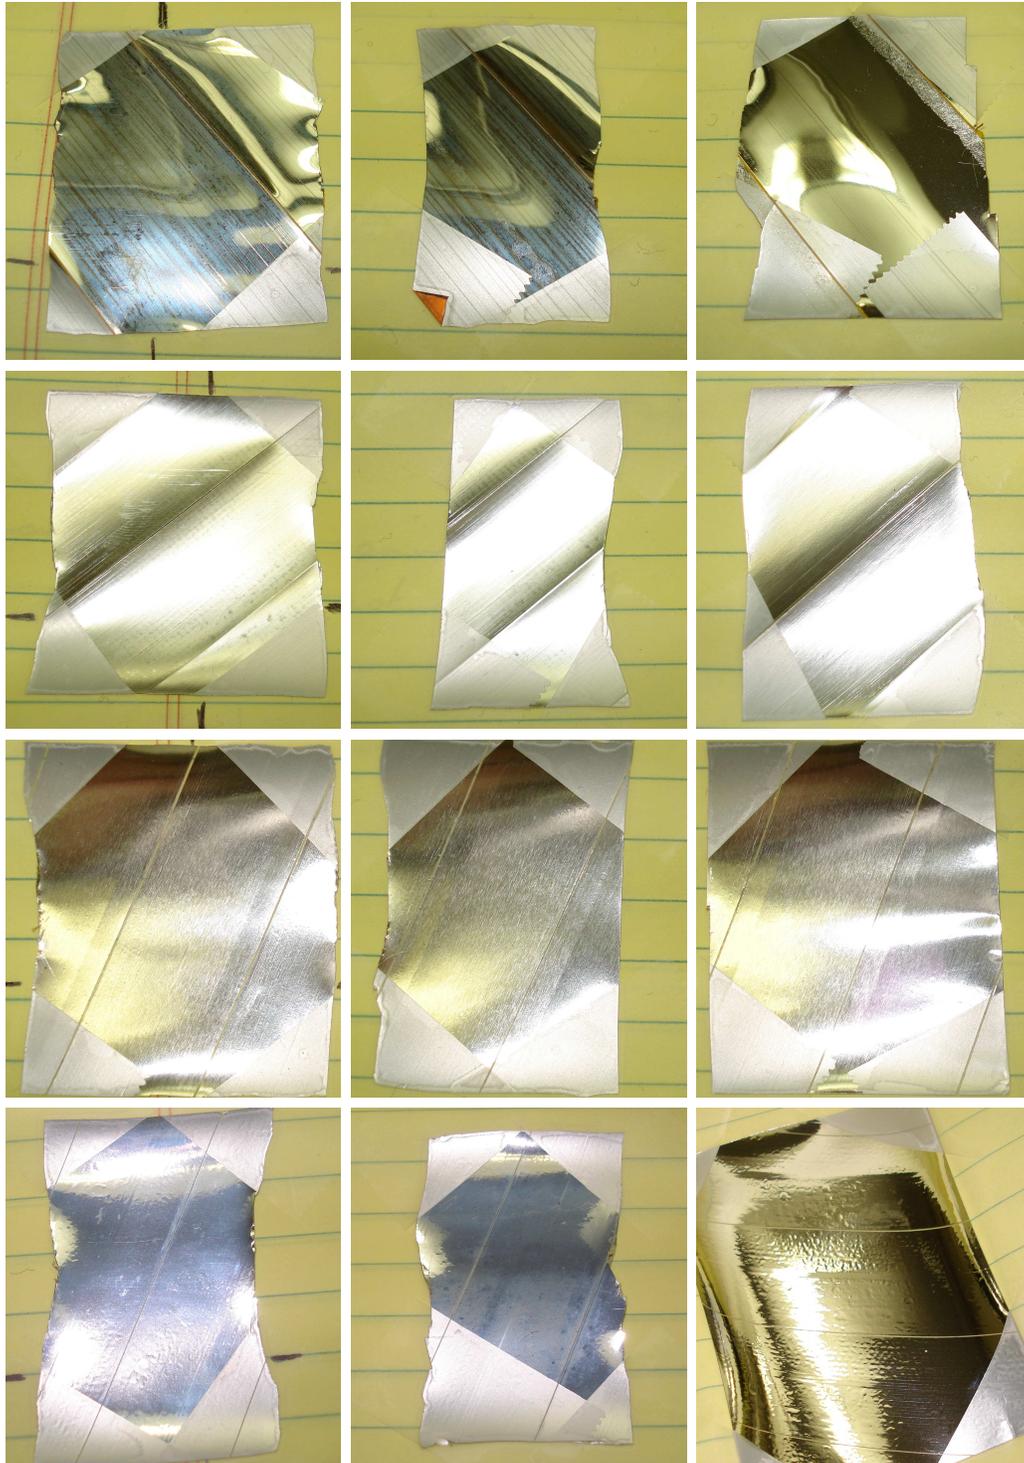
After irradiation and the  $^{55}\text{Fe}$  measurements, the straws were cut open to visually inspect them. The area that was irradiated was compared with an area that was not irradiated and a straw that was never used. The results are shown in Fig. 3. First of all, all Al layers seem to be intact and no cracks were observed. Although one cannot see differences between irradiated areas and not irradiated areas, there is a clear difference between the straw that was not used and the straw that was irradiated for the Stone-kapton and Lamina-thick type straws. It seems that something got deposited on/etched the aluminum layer, the questions is what it and what caused it. The same thing probably happened for the other two straw types but due to different finish it cannot be seen with the naked eye.

Figure 3: Pictures of the straws that were visually inspected. From left to right: area of the straw that was irradiated, area of the straw that was not irradiated, and area of the same type of straw that was never used. From top to bottom: Stone-kapton, Euclid-mylar, Lamina-thick, and Lamina-thin straw.

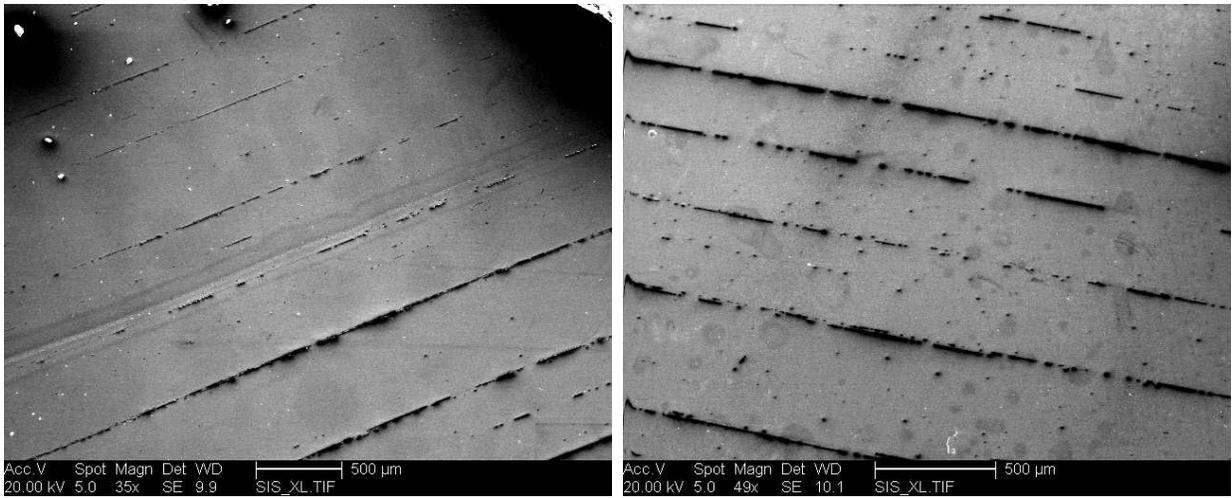
A piece of Lamina-thin straw that was never used was compared with a piece that was irradiated. A comparison at the lowest scale can be seen in Fig. 4. On this scale one can see black impurity lines on both straw pieces, probably due to the fabrication. A difference that can easily be seen is the dark gray areas on the irradiated straw which are not visible on the straw that was never used. When zoomed in one can clearly see in Fig. 5 that the irradiated straw shows a lot of black pits and that the dark gray areas in Fig. 4 are a different size and concentrations of those black pits. What caused those pits remains a question.

Figure 4: Comparison between a Lamina-thin straw that was not used (left) and the one that was irradiated (right) at 500 $\mu$ m scale.

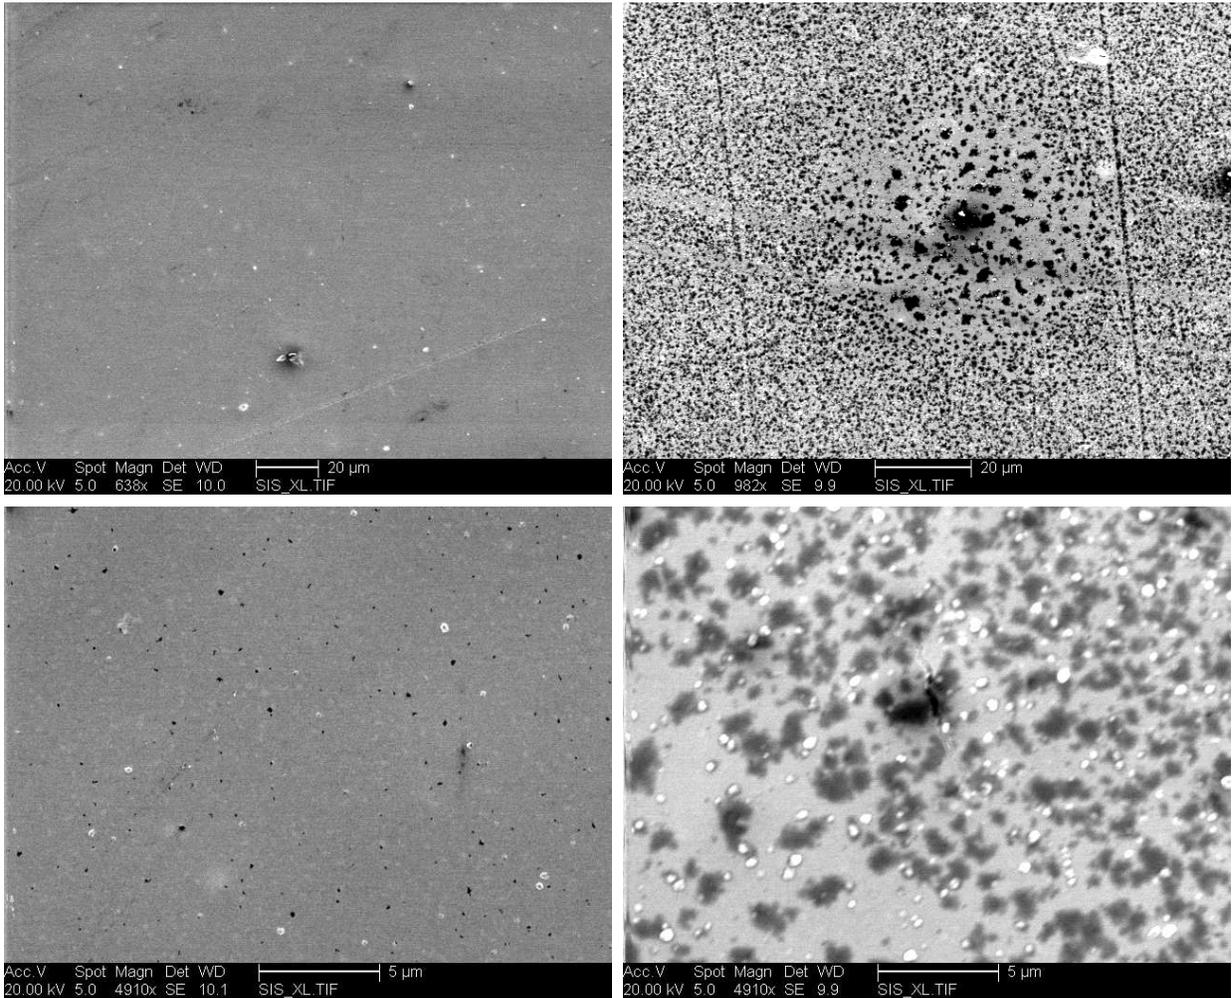
Figure 5: Comparison between a Lamina-thin straw that was not used (left) and the one that was irradiated (right) at 5 and 20 μm scale.

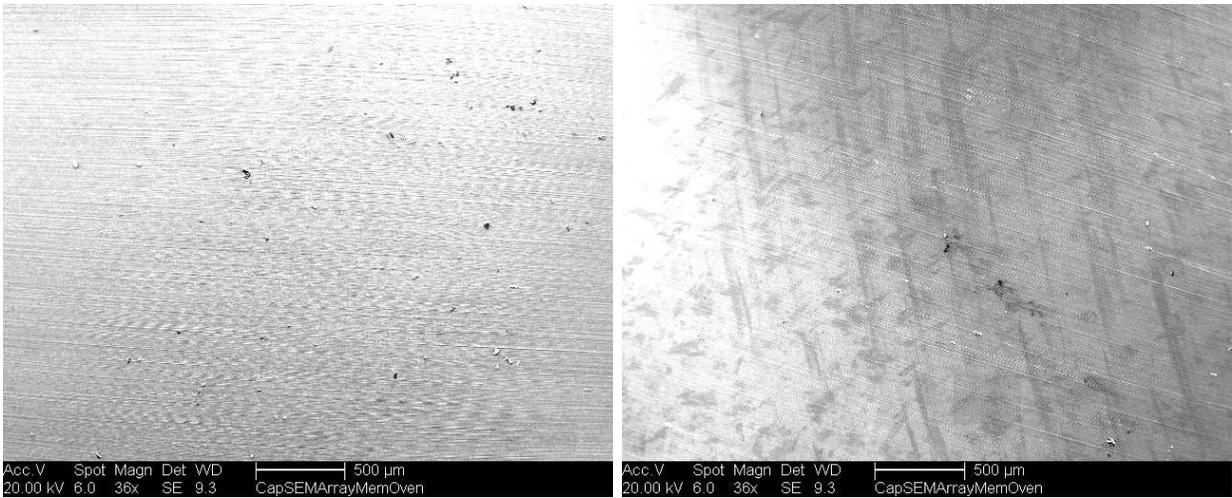
A piece of Lamina-thick straw that was never used was compared with a piece that was irradiated. A comparison at the lowest scale can be seen in Fig. ???. Both straws look very

Figure 6: Comparison between a Lamina-thick straw that was not used (left) and the one that was irradiated (right) at 500 $\mu$ m scale.

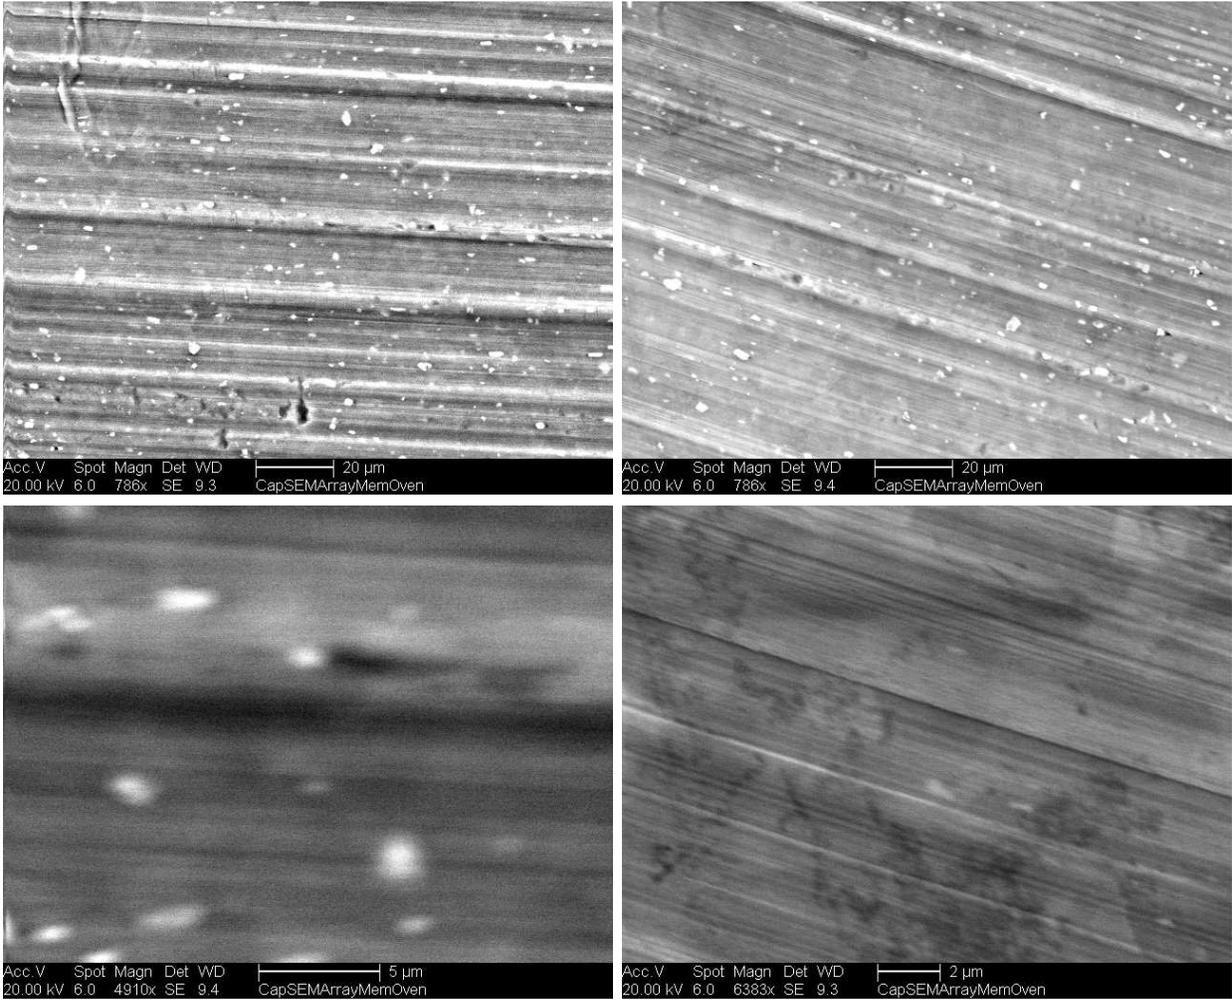
smooth compared to the same pictures taken of the Lamina-thick straw. On this scale one can see that there is no real difference between the two. Also if zoomed in (Fig. 7) no real difference can be seen. The white dots are Fe traces, how they got there is not known but probably it got there during fabrication. The fact that this straw did not show any difference makes it a good choice to be used in the final detector setup. The difference with previous straw (Lamina-thick) is, according to the manufacturer, that the aluminum is deposited on the mylar instead of glued. It might be that glue that caused the black pits on previous straw.

Figure 7: Comparison between a Lamina-thick straw that was not used (left) and the one that was irradiated (right) at 5 and 20 μm scale.

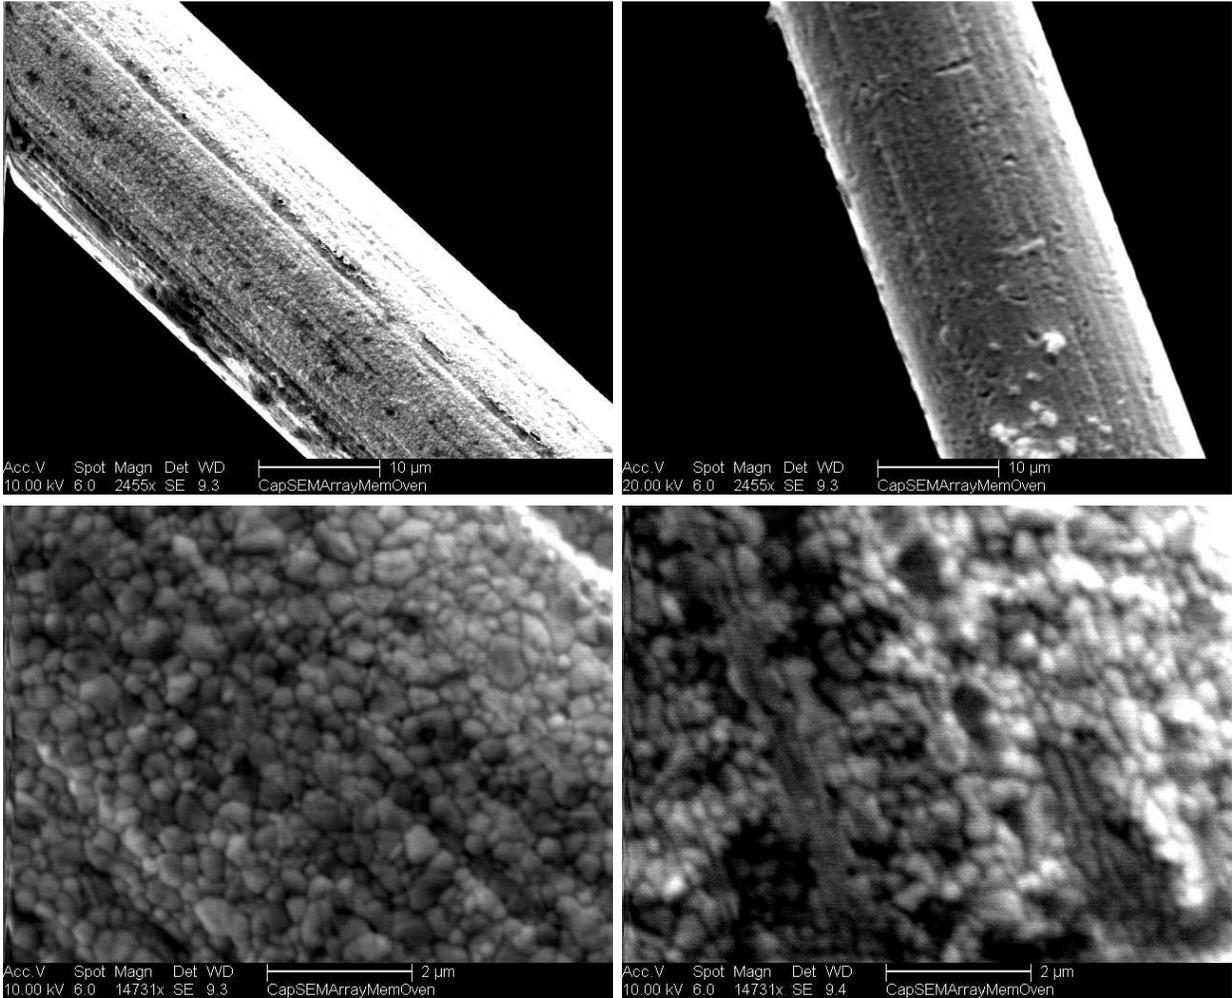
In Fig. 8 a new wire is compared with an irradiated one on different scales. No difference can be observed.

Figure 8: Comparison between a wire that was not used (left) and one that was irradiated (right) at 2 and 10  $\mu\text{m}$  scale).
