Polishing Tests

06/28/14

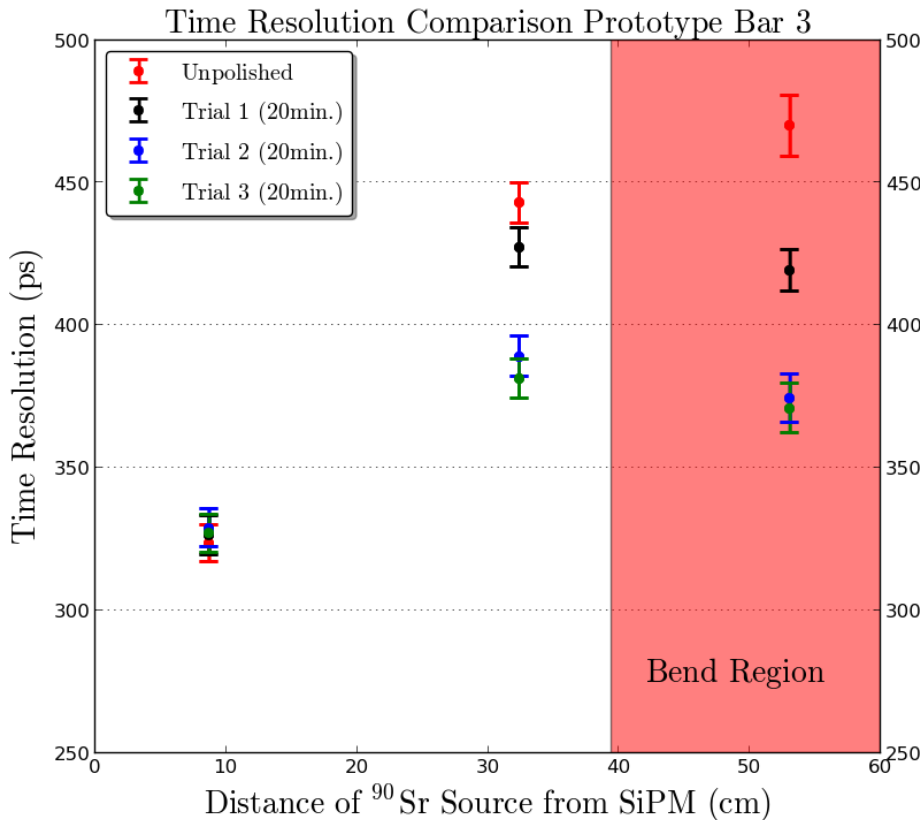
Polishing Trials (Prototype Bar 3 Results)

- Prototype Paddle 3 was heavily scratched during wrapping test
- Scratches on surface are considerably worse than the surface quality of the 50 machined scintillators
 - Bar 3 was handled improperly with medical examining gloves and exhibits localized crazing
- Average Time Resolution across entire length of paddle
 - Unpolished: 412 ps
 - Trial 1: 390 ps
 - Trial 2: 363 ps
 - Trial 3: 359 ps
- ~ 100 ps improvement in the nose region

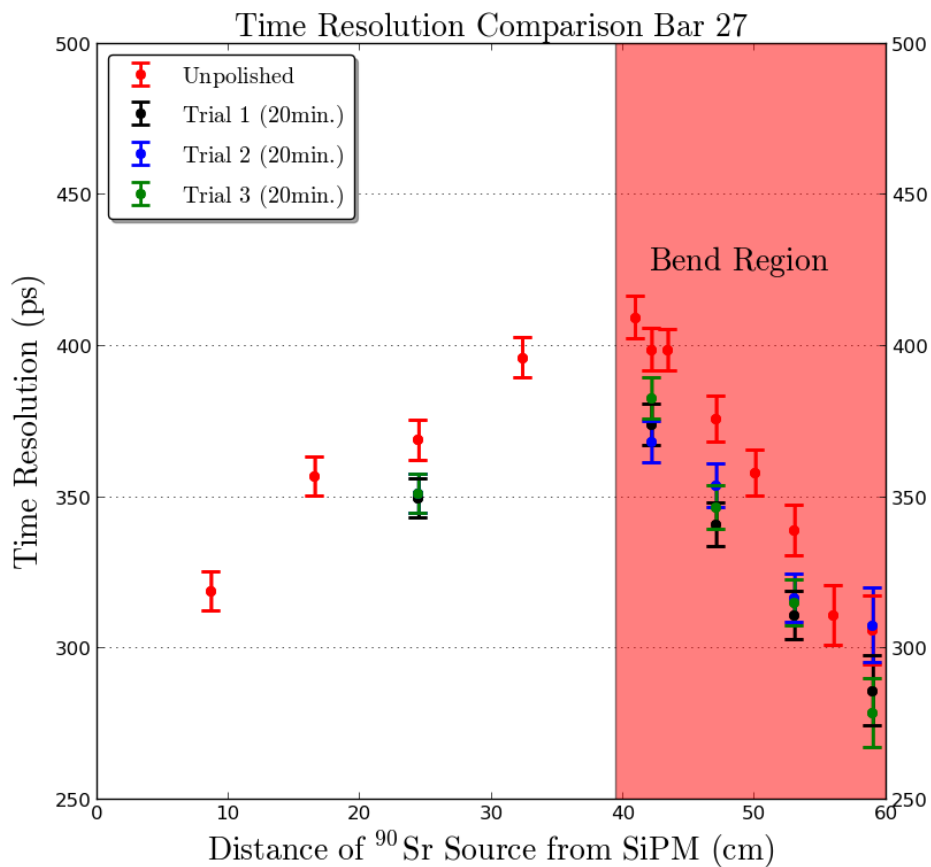
Polishing Trials (Paddle 27 Results)

- Paddle 27 received an initial rating of Poor
 - High density scratches in nose and straight section
 - Numerous scratches along entire length of scintillator
 - Large chip on the edge of the nose section
- Average Time Resolution
 - Unpolished: 361 ps
 - Trial 1: 332 ps
 - Trial 2: 339 ps
 - Trial 3: 334 ps
- Polishing (after 2 trials) rid the surface of virtually all fine scratches
 - Only scratches that remained were the deep scratches
 - 0.3 μm Alumina might help with this
 - If it weren't for the large chip on the edge of the nose section this scintillator would receive a grade of Excellent
- Possible to recover $\approx 25 - 50$ ps with current polishing methods
