# Large MWPC Electronics Testing

- Received all boards from manufacturer
- Tested boards for functionality
- Removed excess material below connector
- Sanded down to proper size

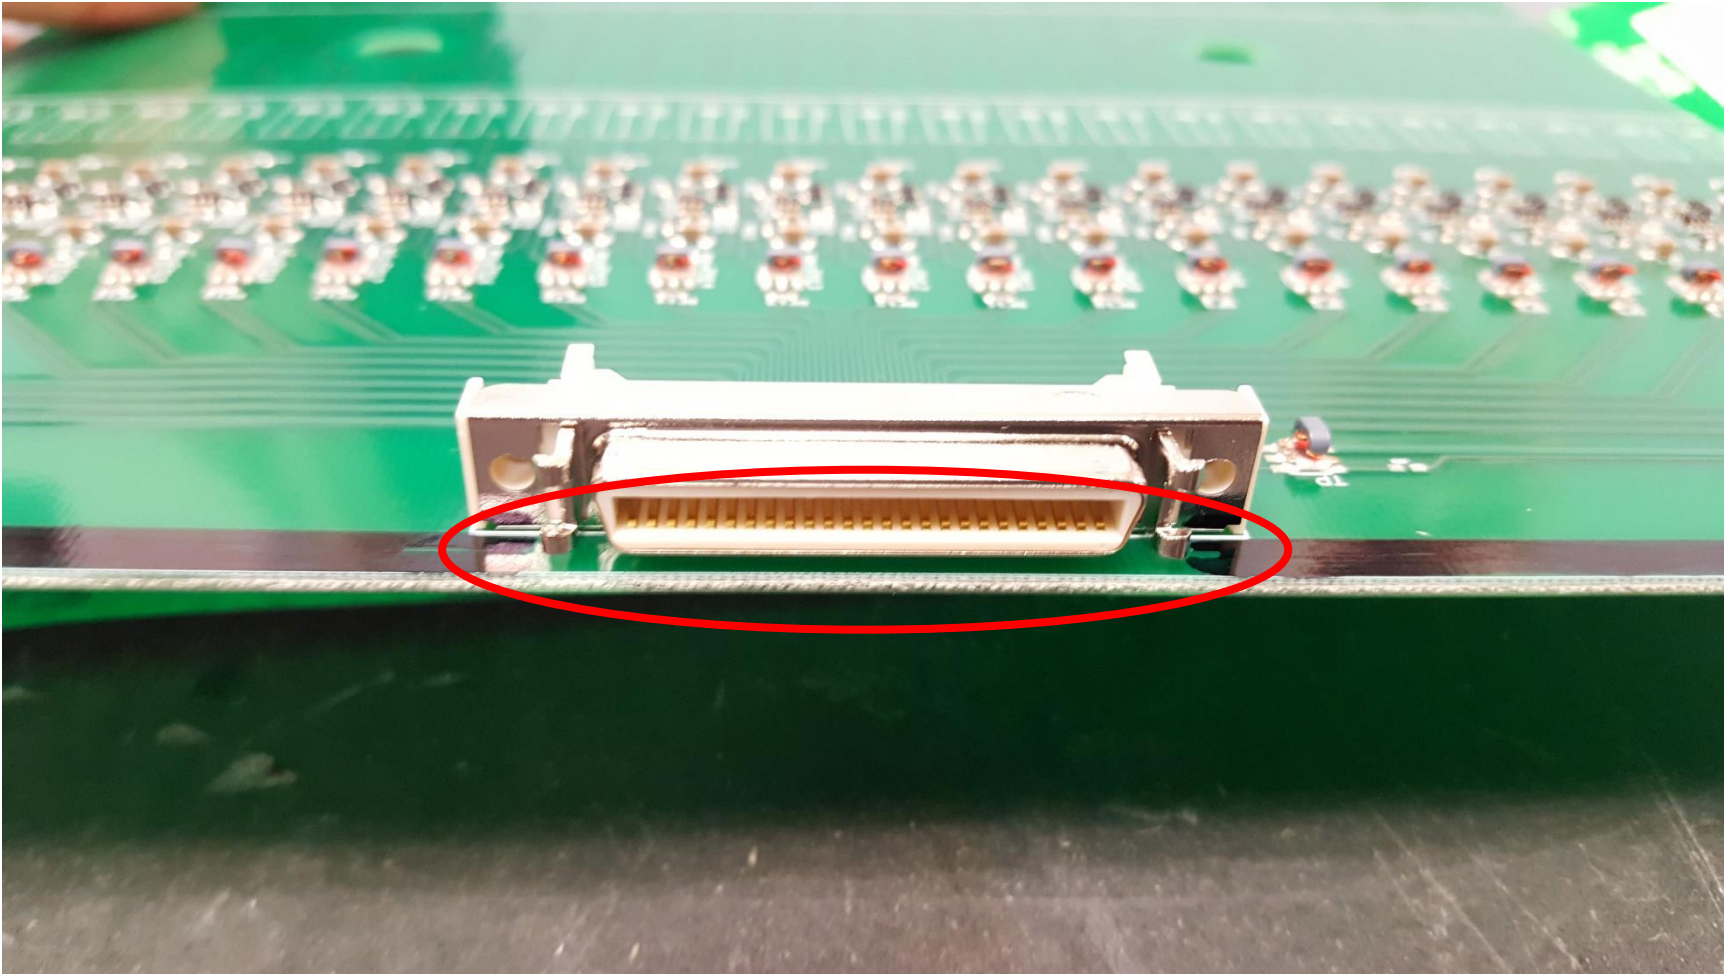
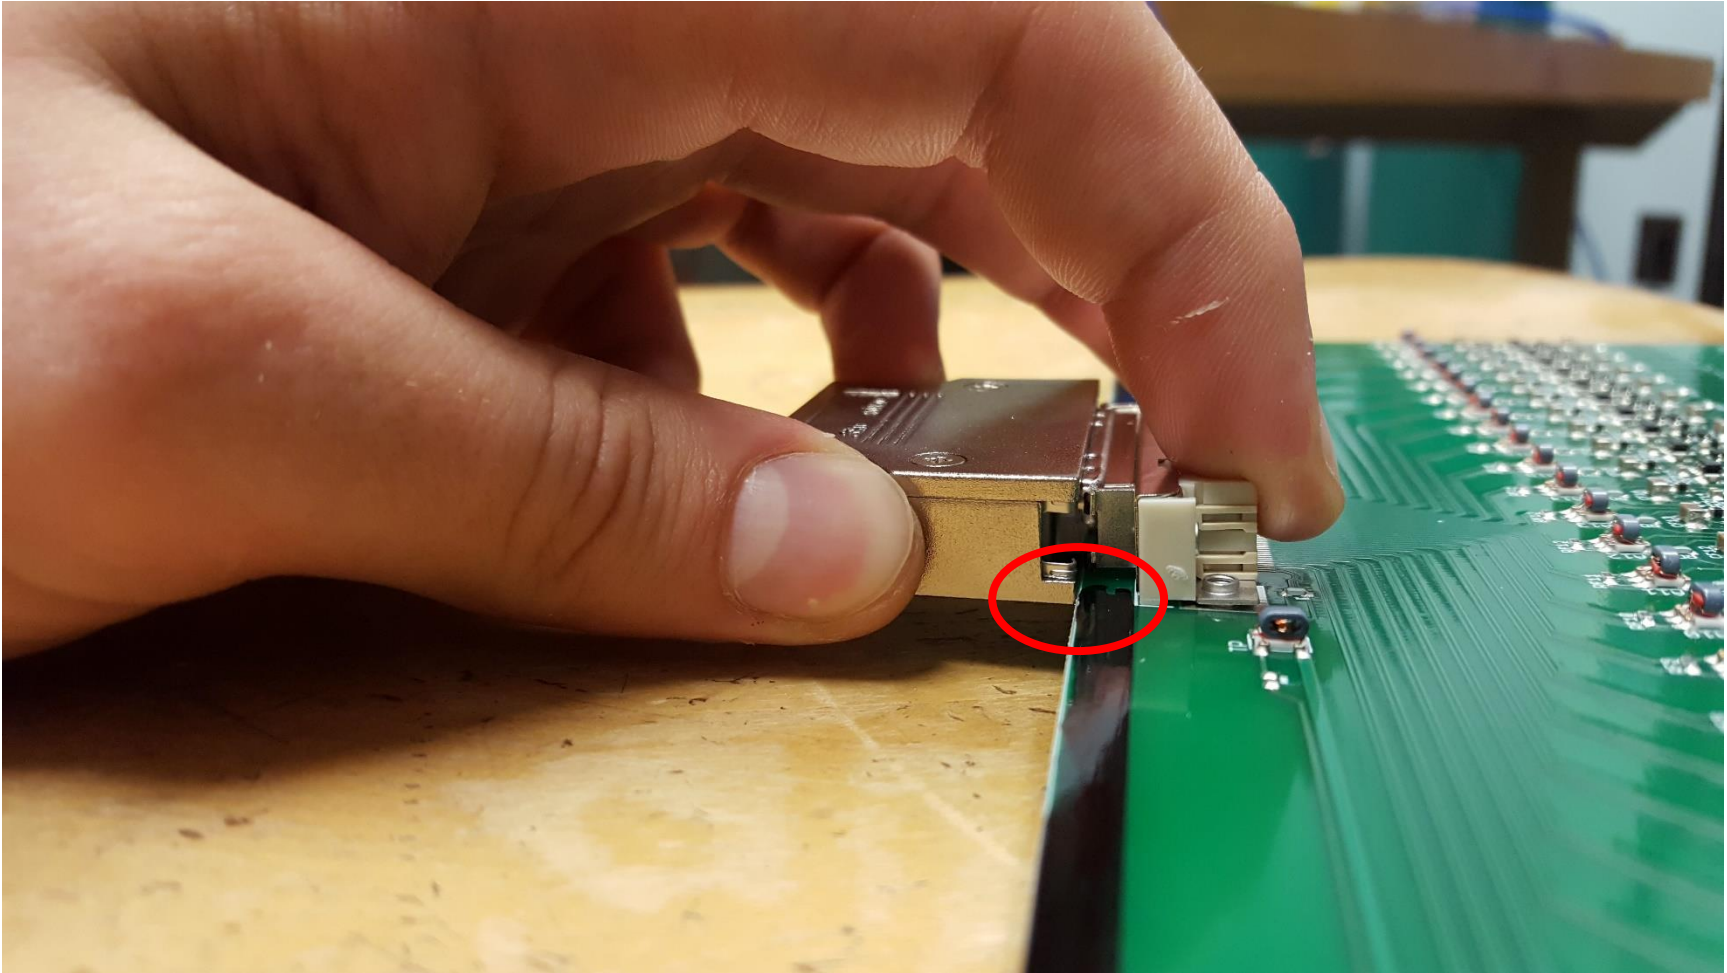
## Close-up View of MDR Connector

Issue: Cable does not connect due to presence of rail

The issue that the breakaway rails being present on the board causes is that the connector cannot attach to the board as the lower portion of the cable hits the board material before a connection is made

Solution: Remove material with Dremel cutting tool

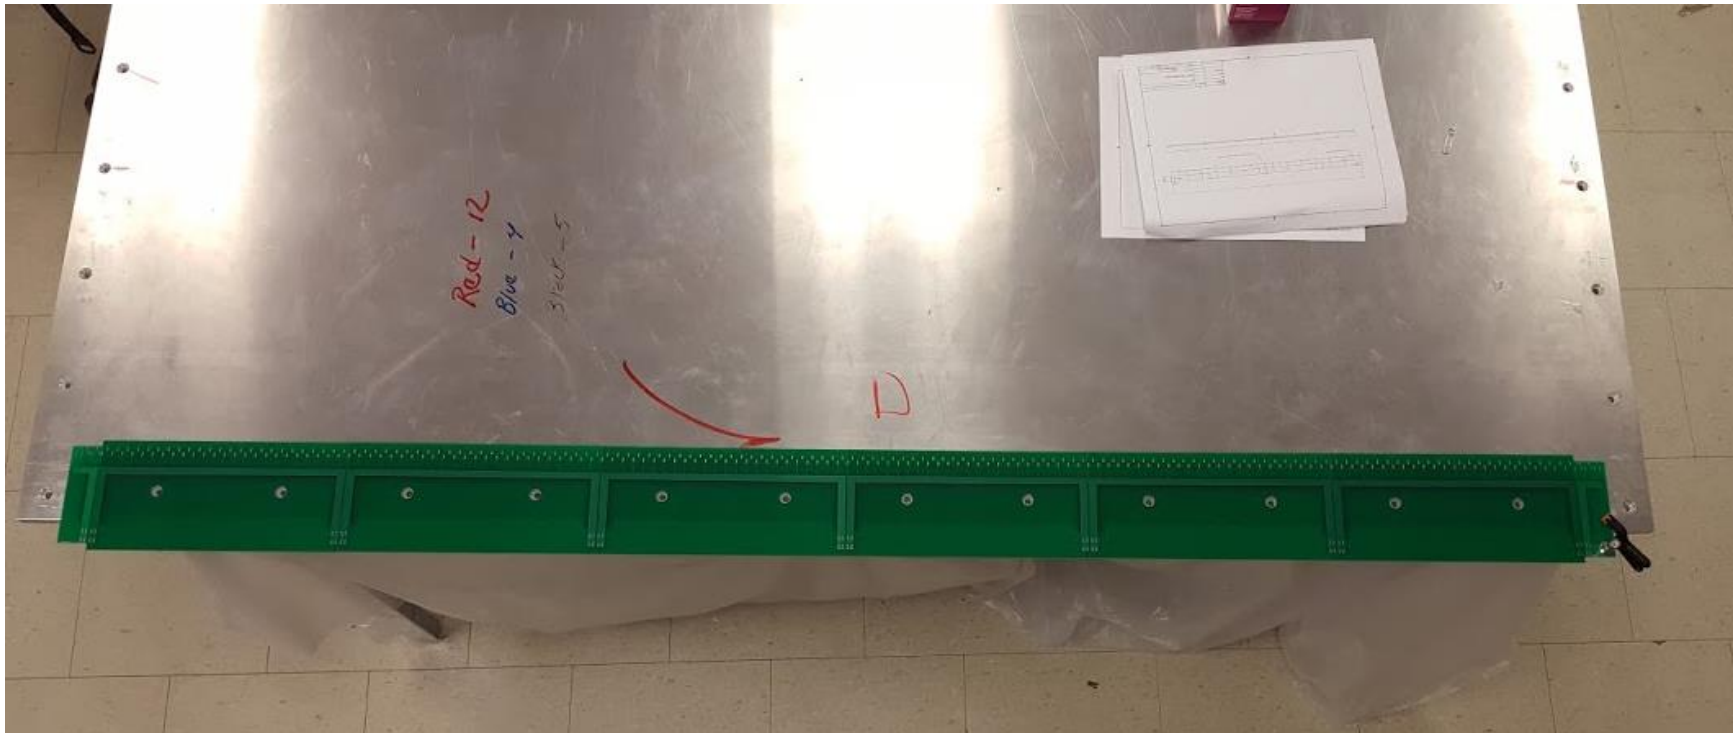
# Sanding down board edges

<b>Sense Boards</b>		
<b>Board Number</b>	<b>Length (inches)</b>	
	<b>Original</b>	<b>Sanded</b>
1	9.6060	9.6005
2	9.6045	9.6010
3	9.6080	9.6000
4	9.6075	9.6000
5	9.6035	9.5995
6	9.6030	9.6005

<b>Bias Boards</b>		
<b>Board Number</b>	<b>Length (inches)</b>	
	<b>Original</b>	<b>Sanded</b>
1	9.6070	9.6005
2	9.6060	9.6000
3	9.6045	9.6005
4	9.6050	9.6000
5	9.6060	9.6005
6	9.6065	9.6000
