TRIG1 measurements on FCAL North
Problem TI in one crate?

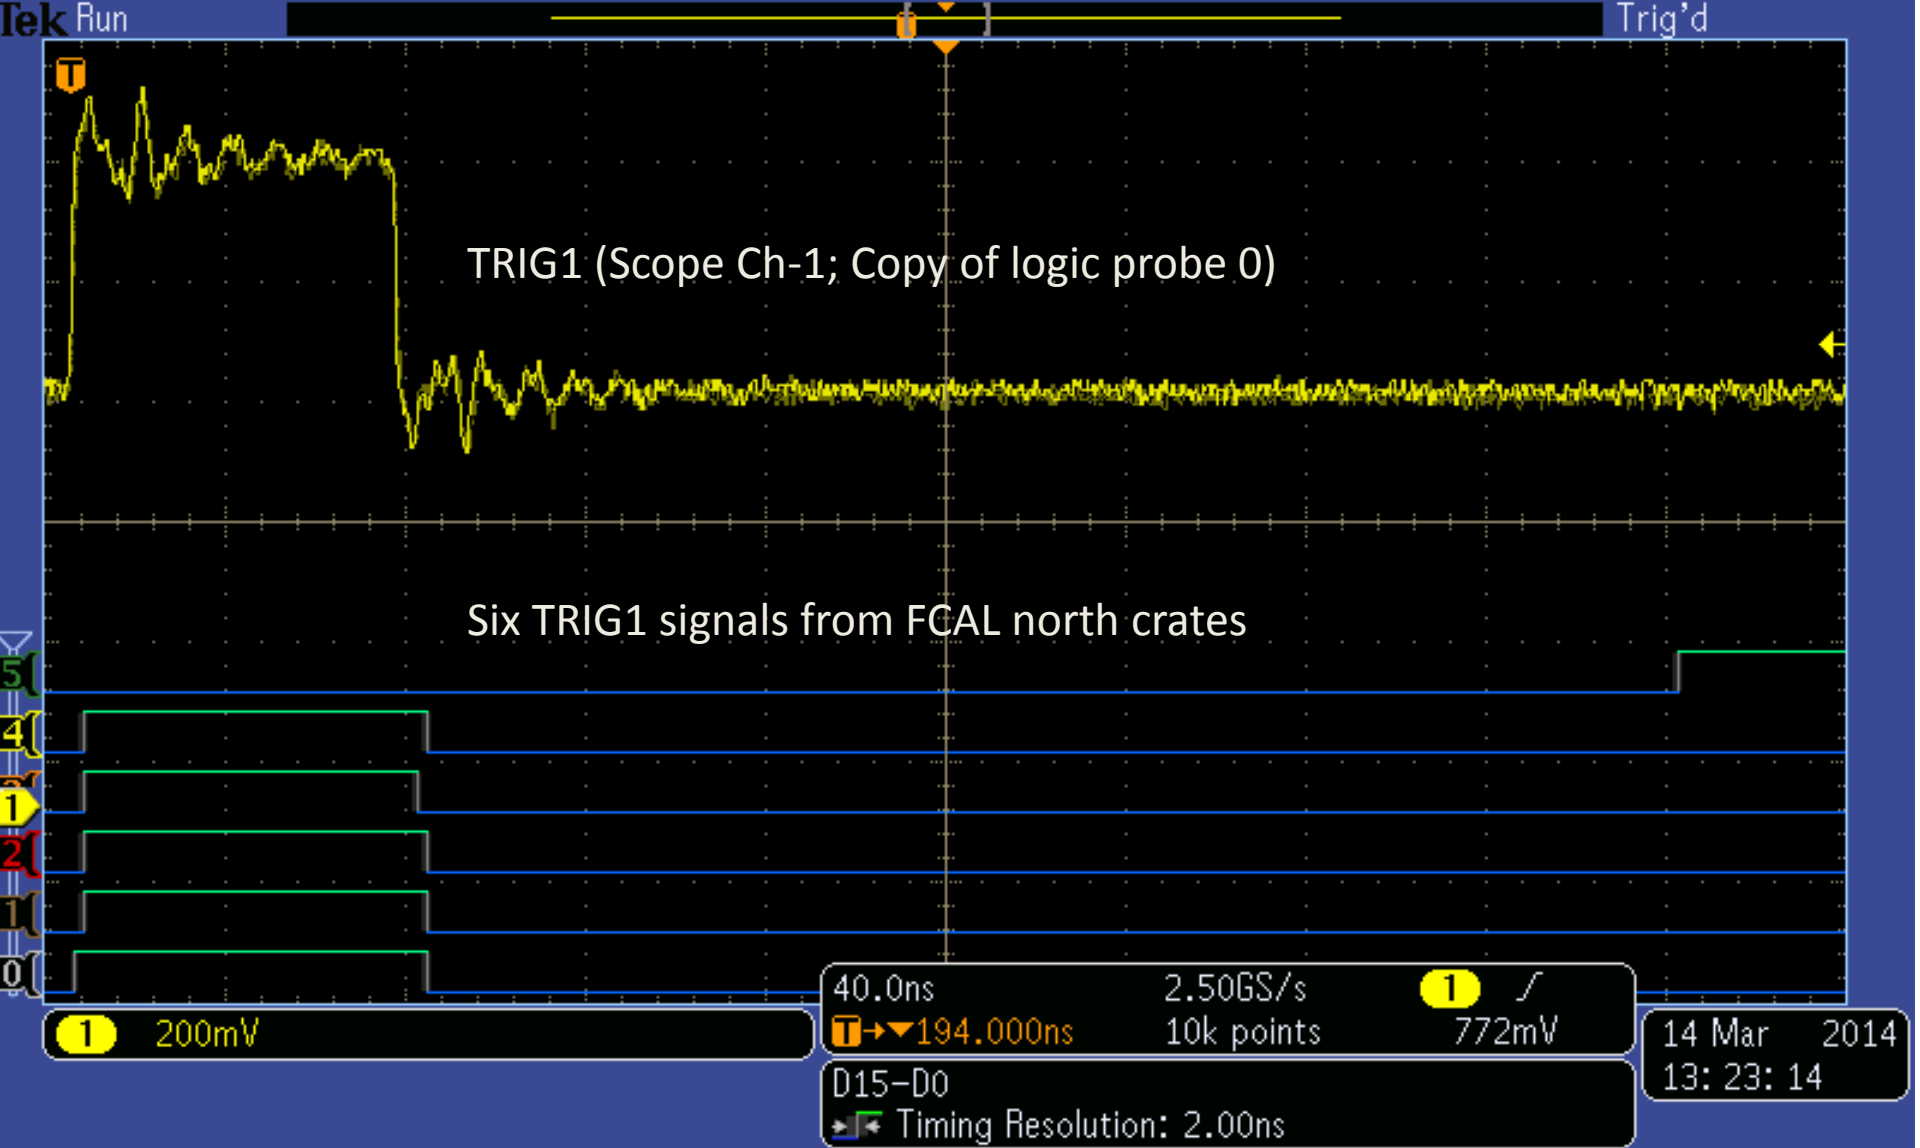
Zoom in of TRIG1 alignment
Note problem with one of the TRIG1 signals
Why the extra delay??

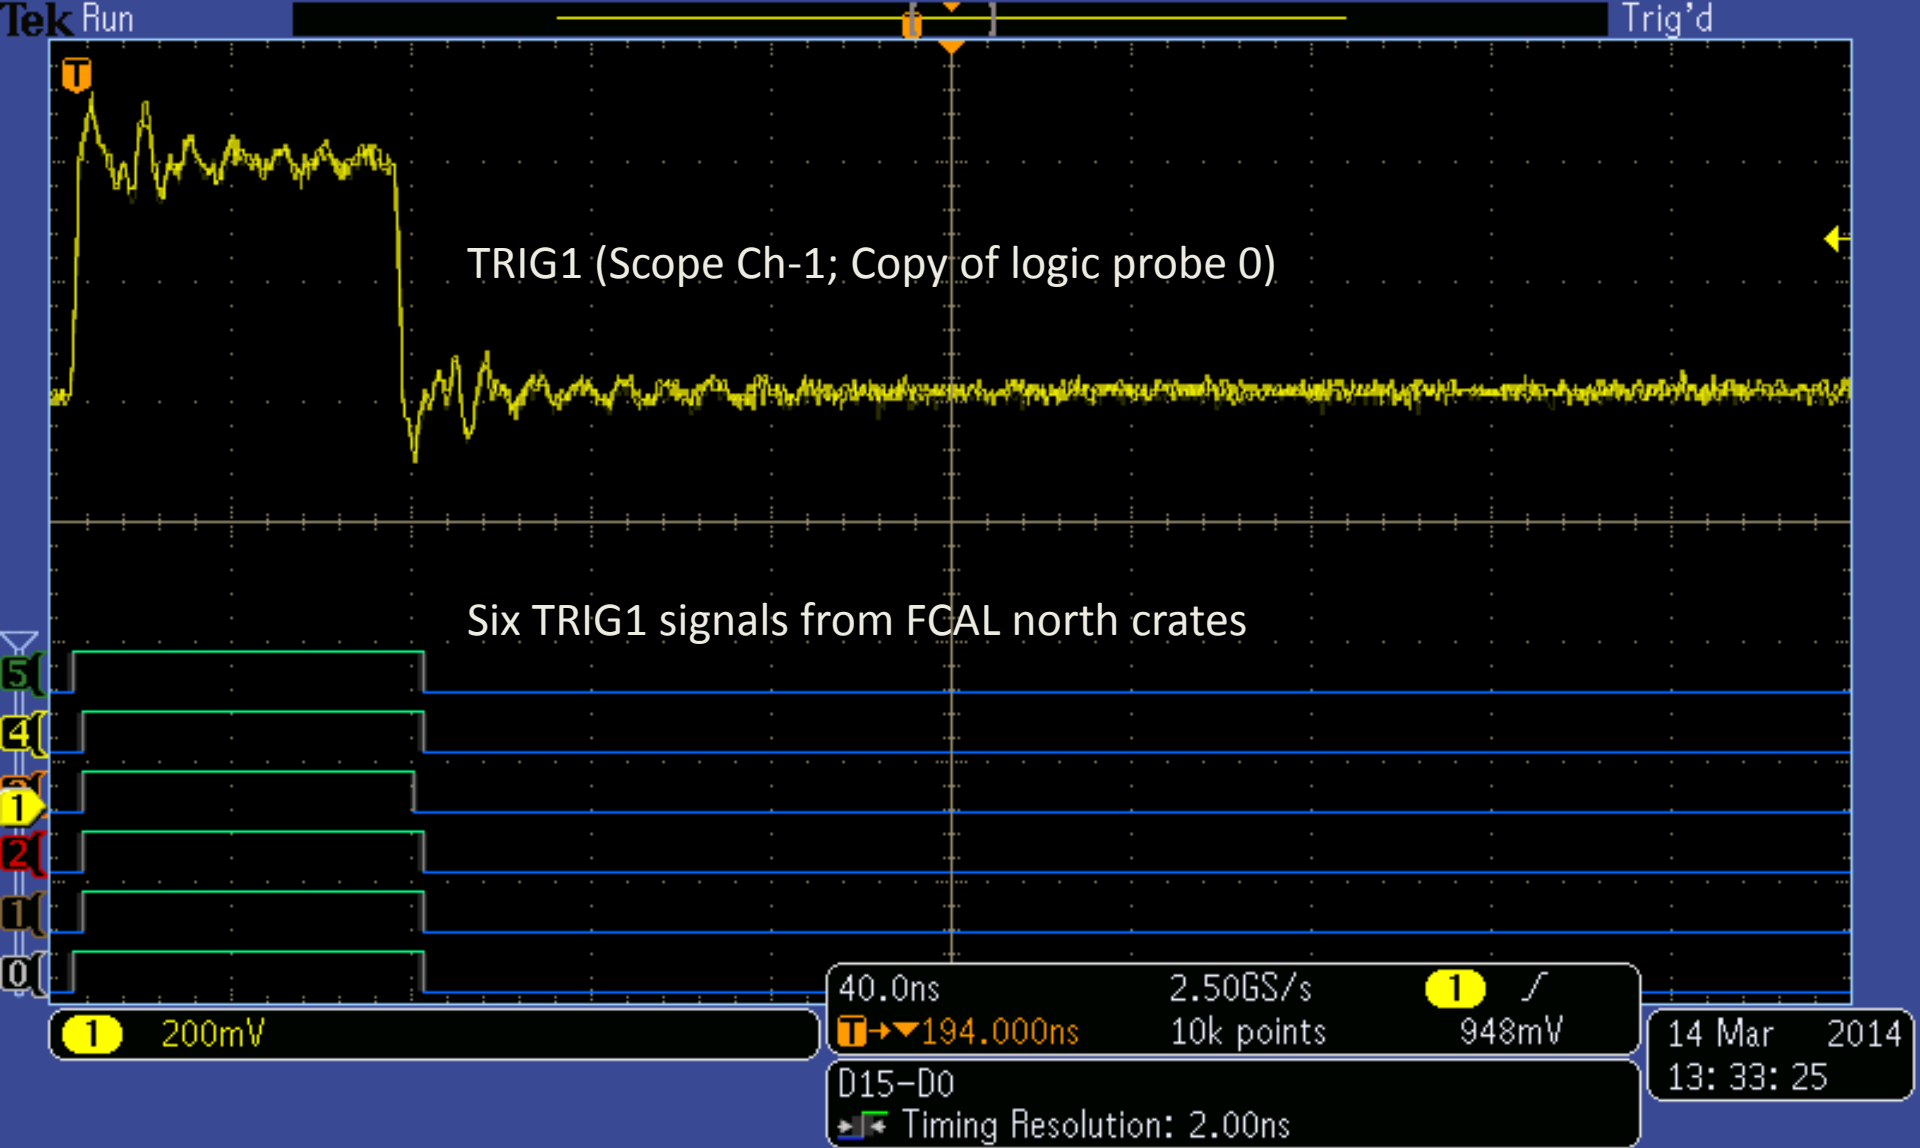
Replaced TI – Signals are now in alignment for TRIG1

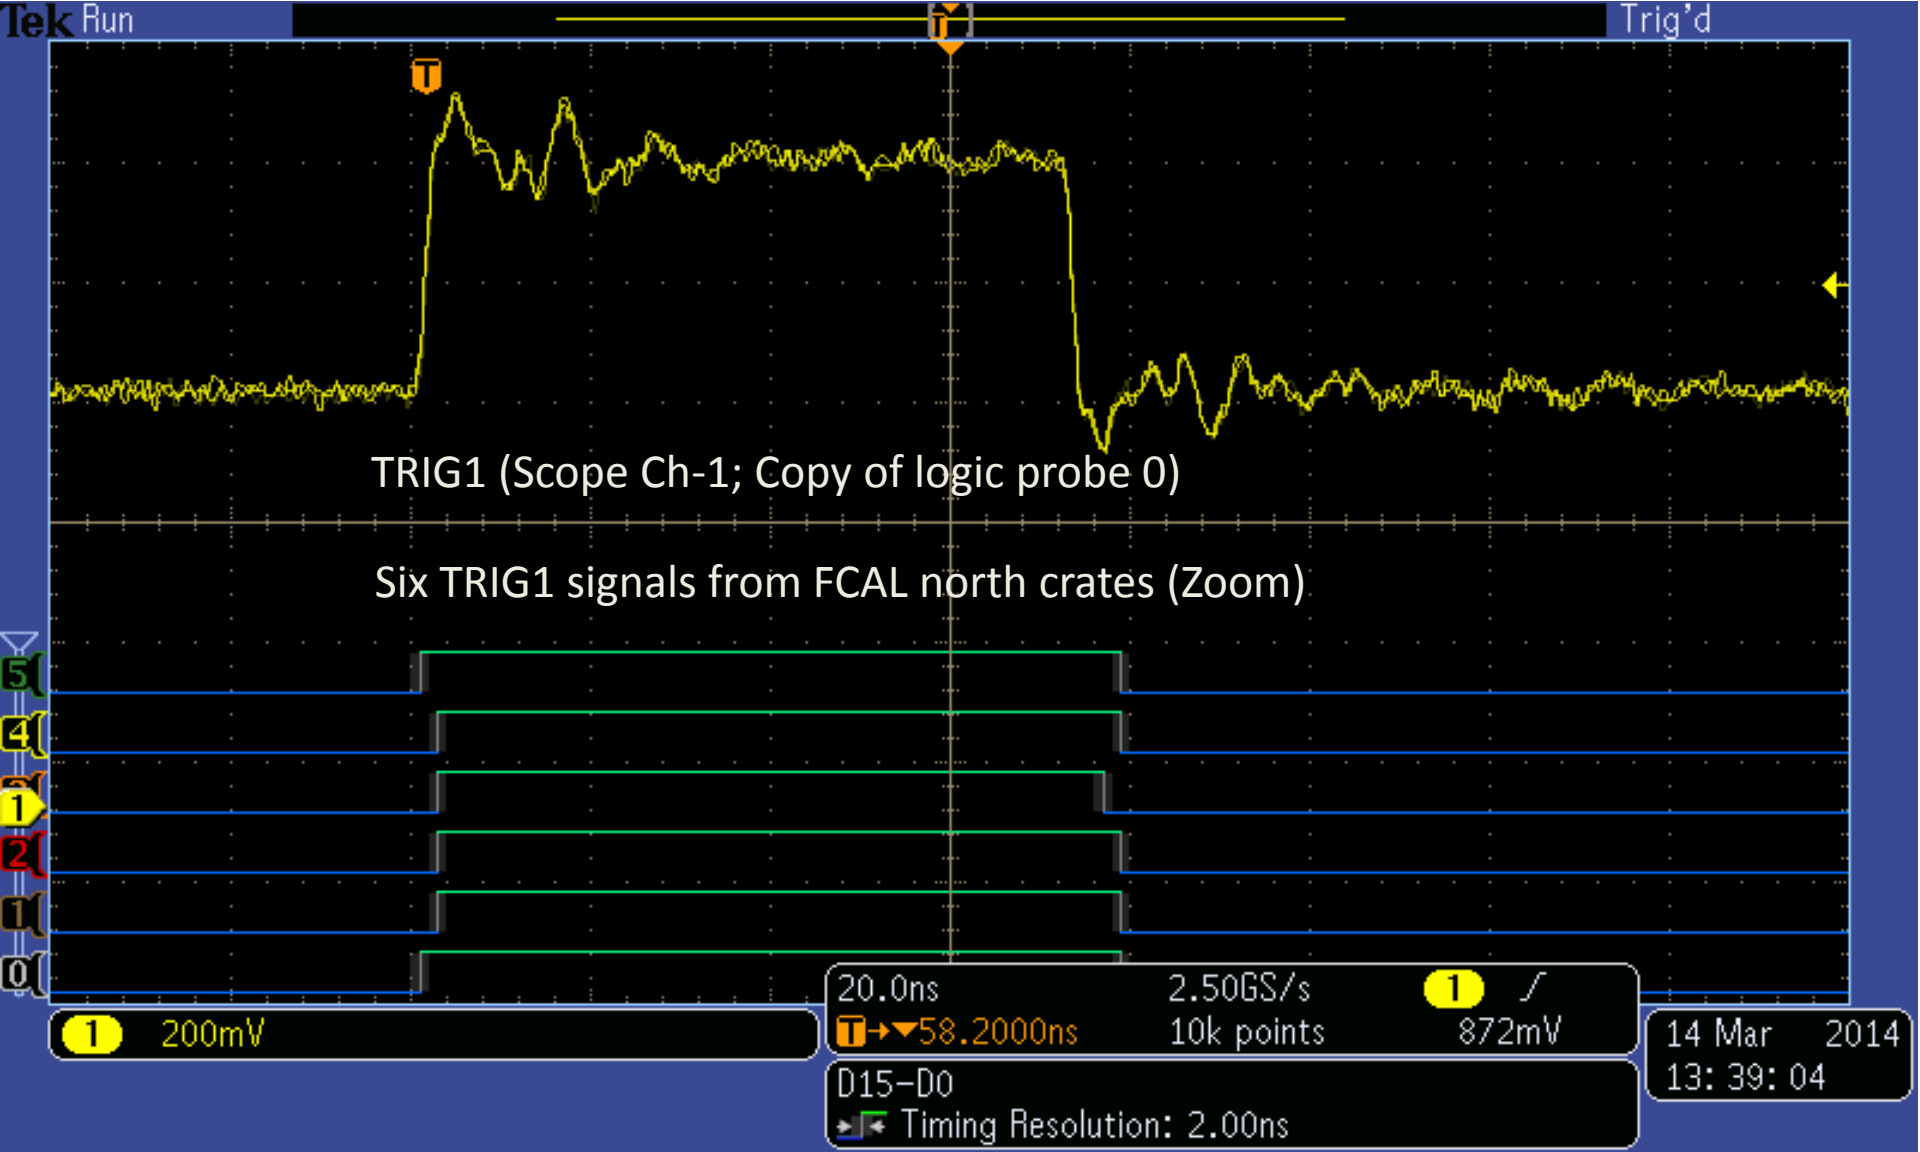
Replaced TI and all Trig1 signals are in alignment

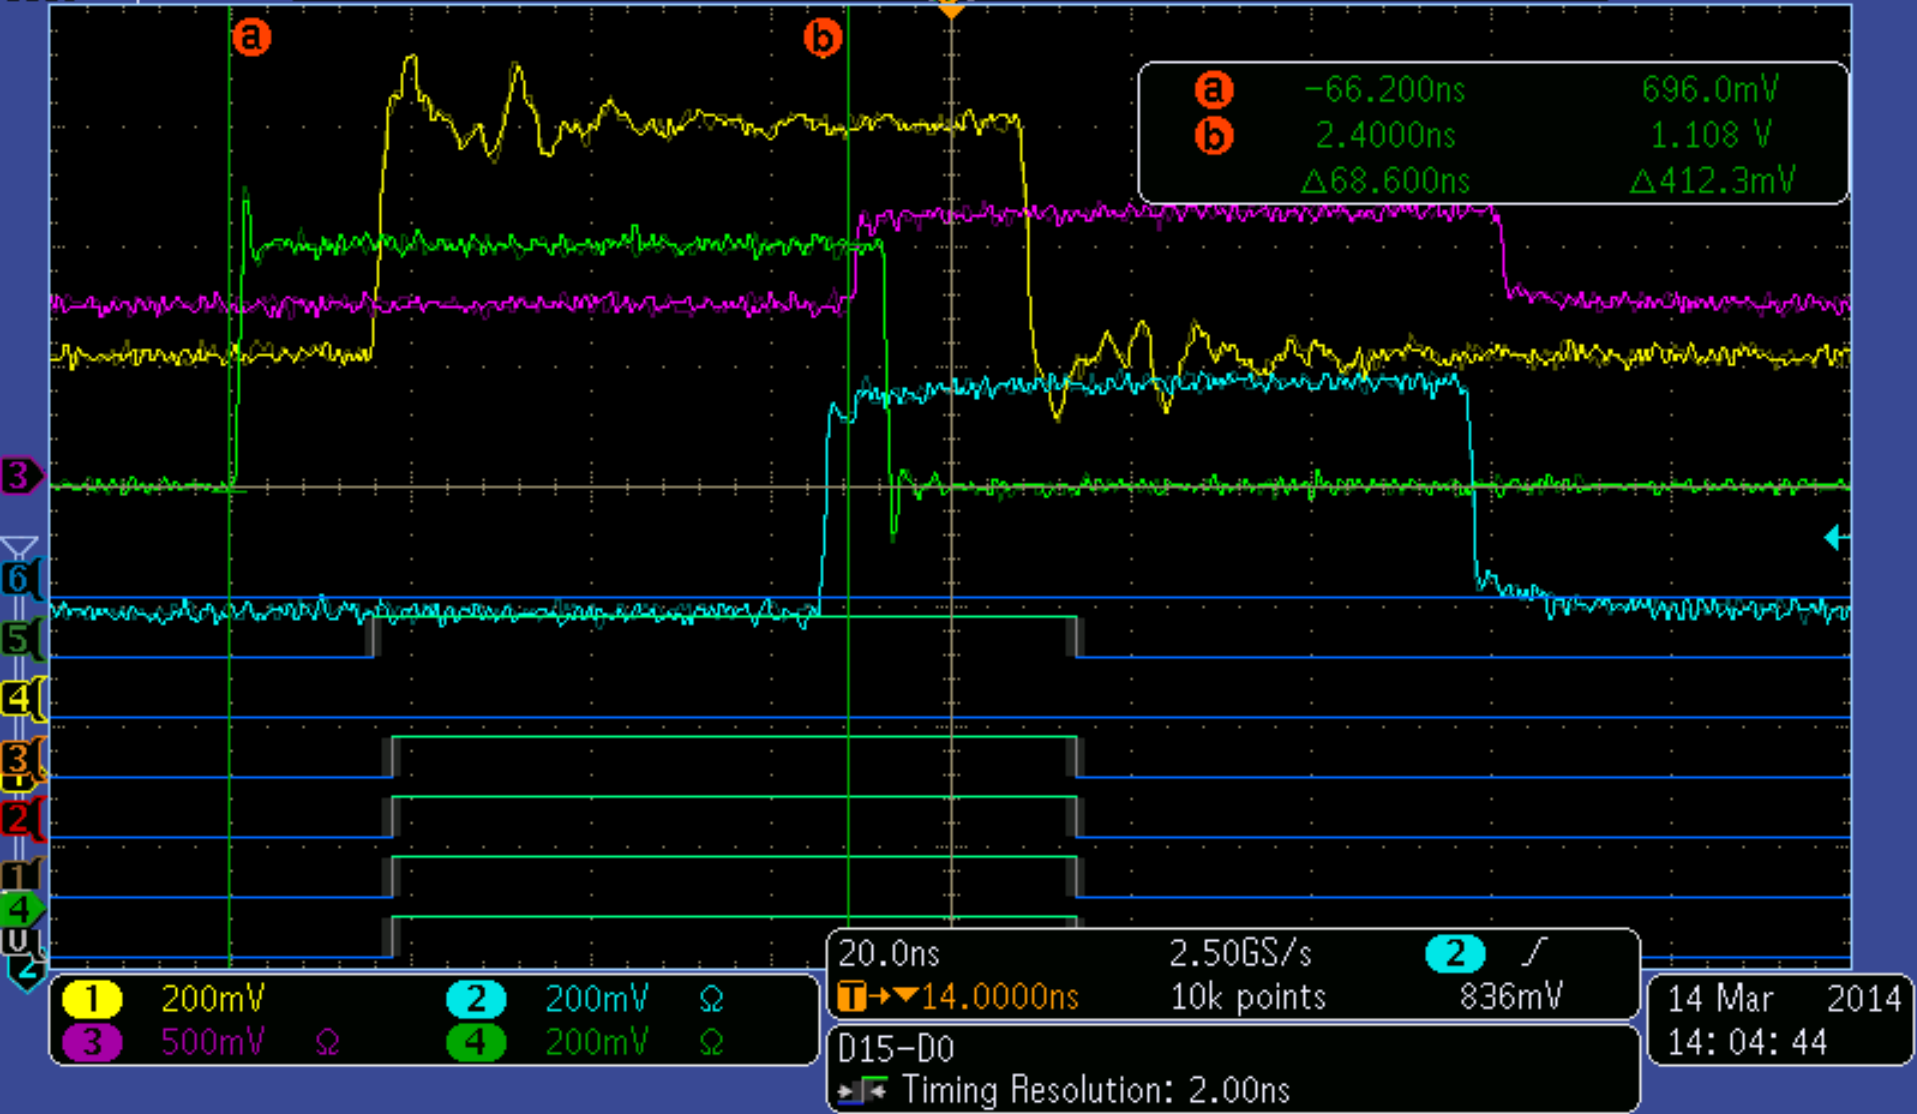
BCAL and FCAL TRIG1 signals --- OK!

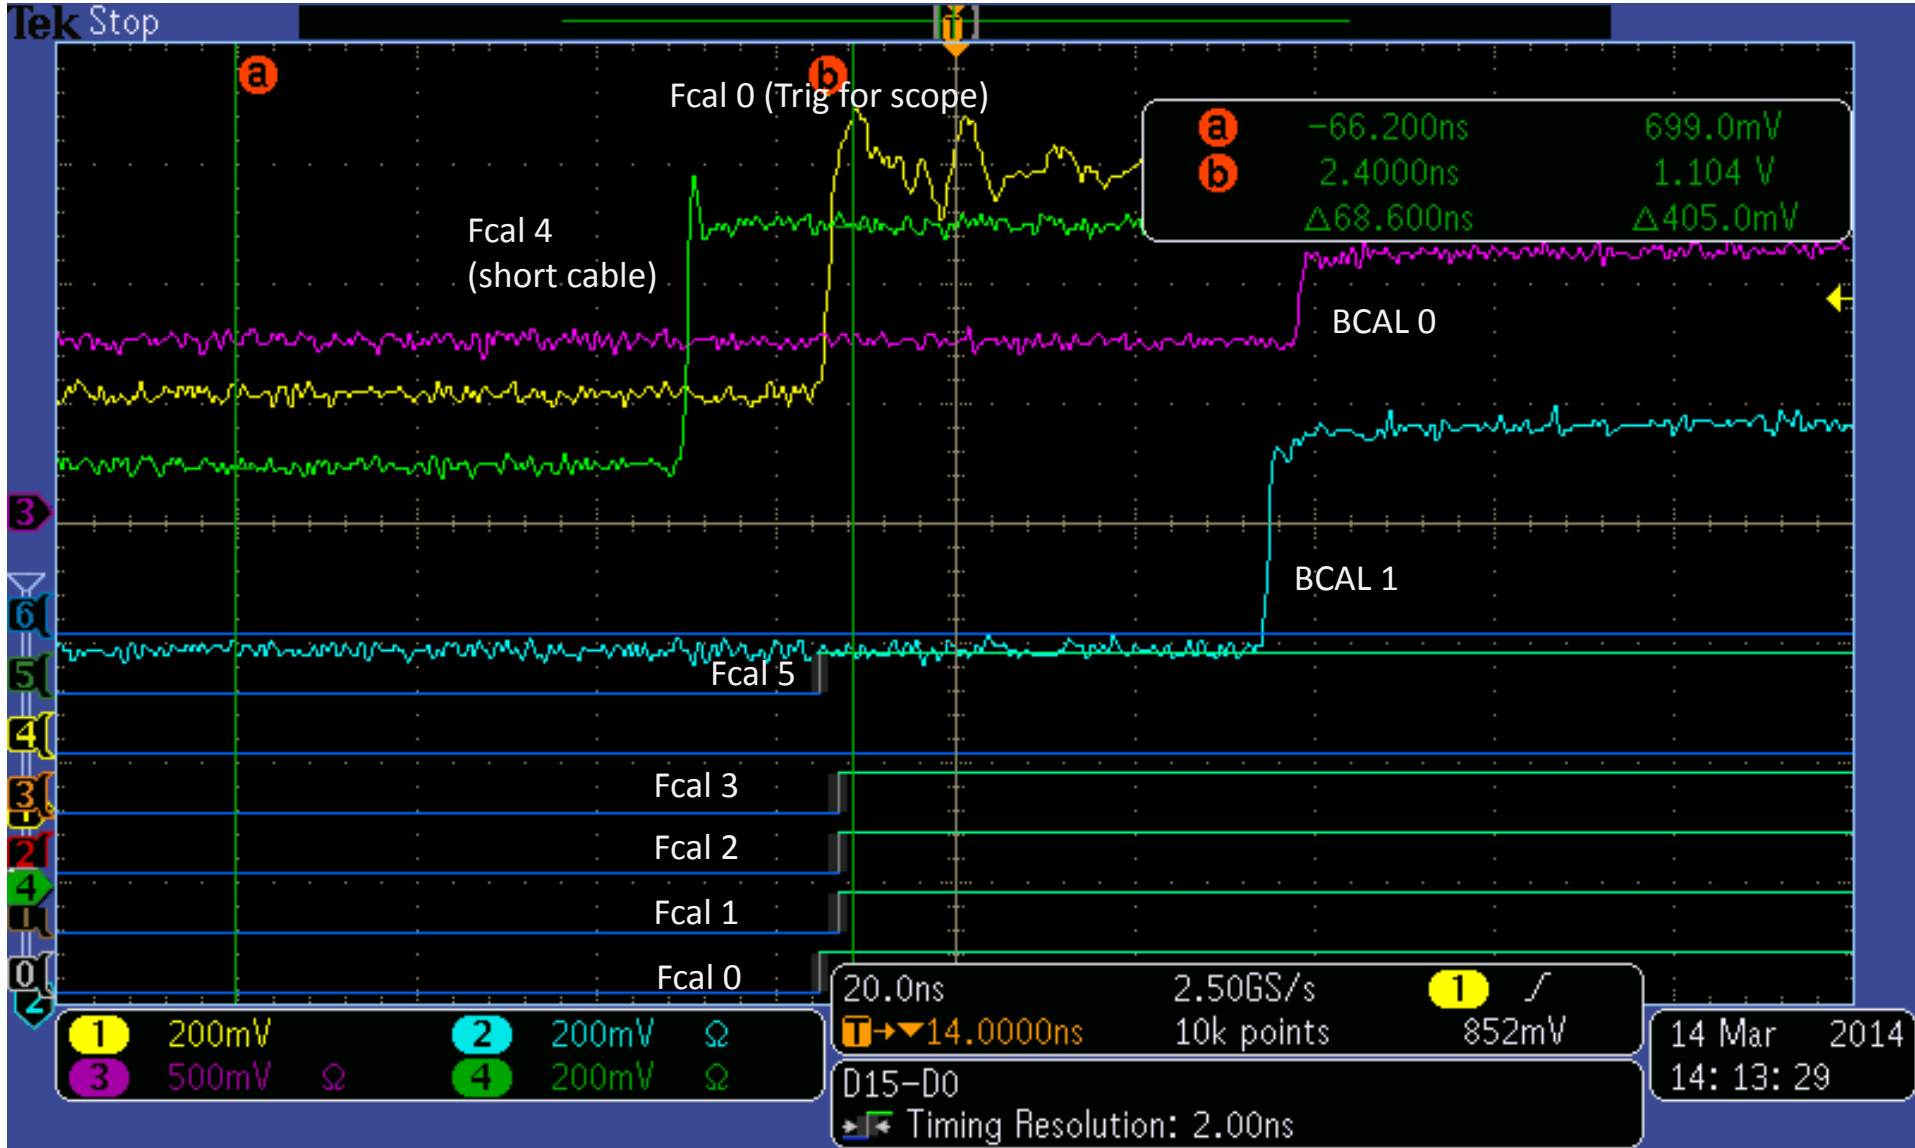
SYNC signals for FCAL north crates and two(2) BCAL south crates

Alignment looks fine. Note additional delay for BCAL signals matches extra cable length needed for measurement.

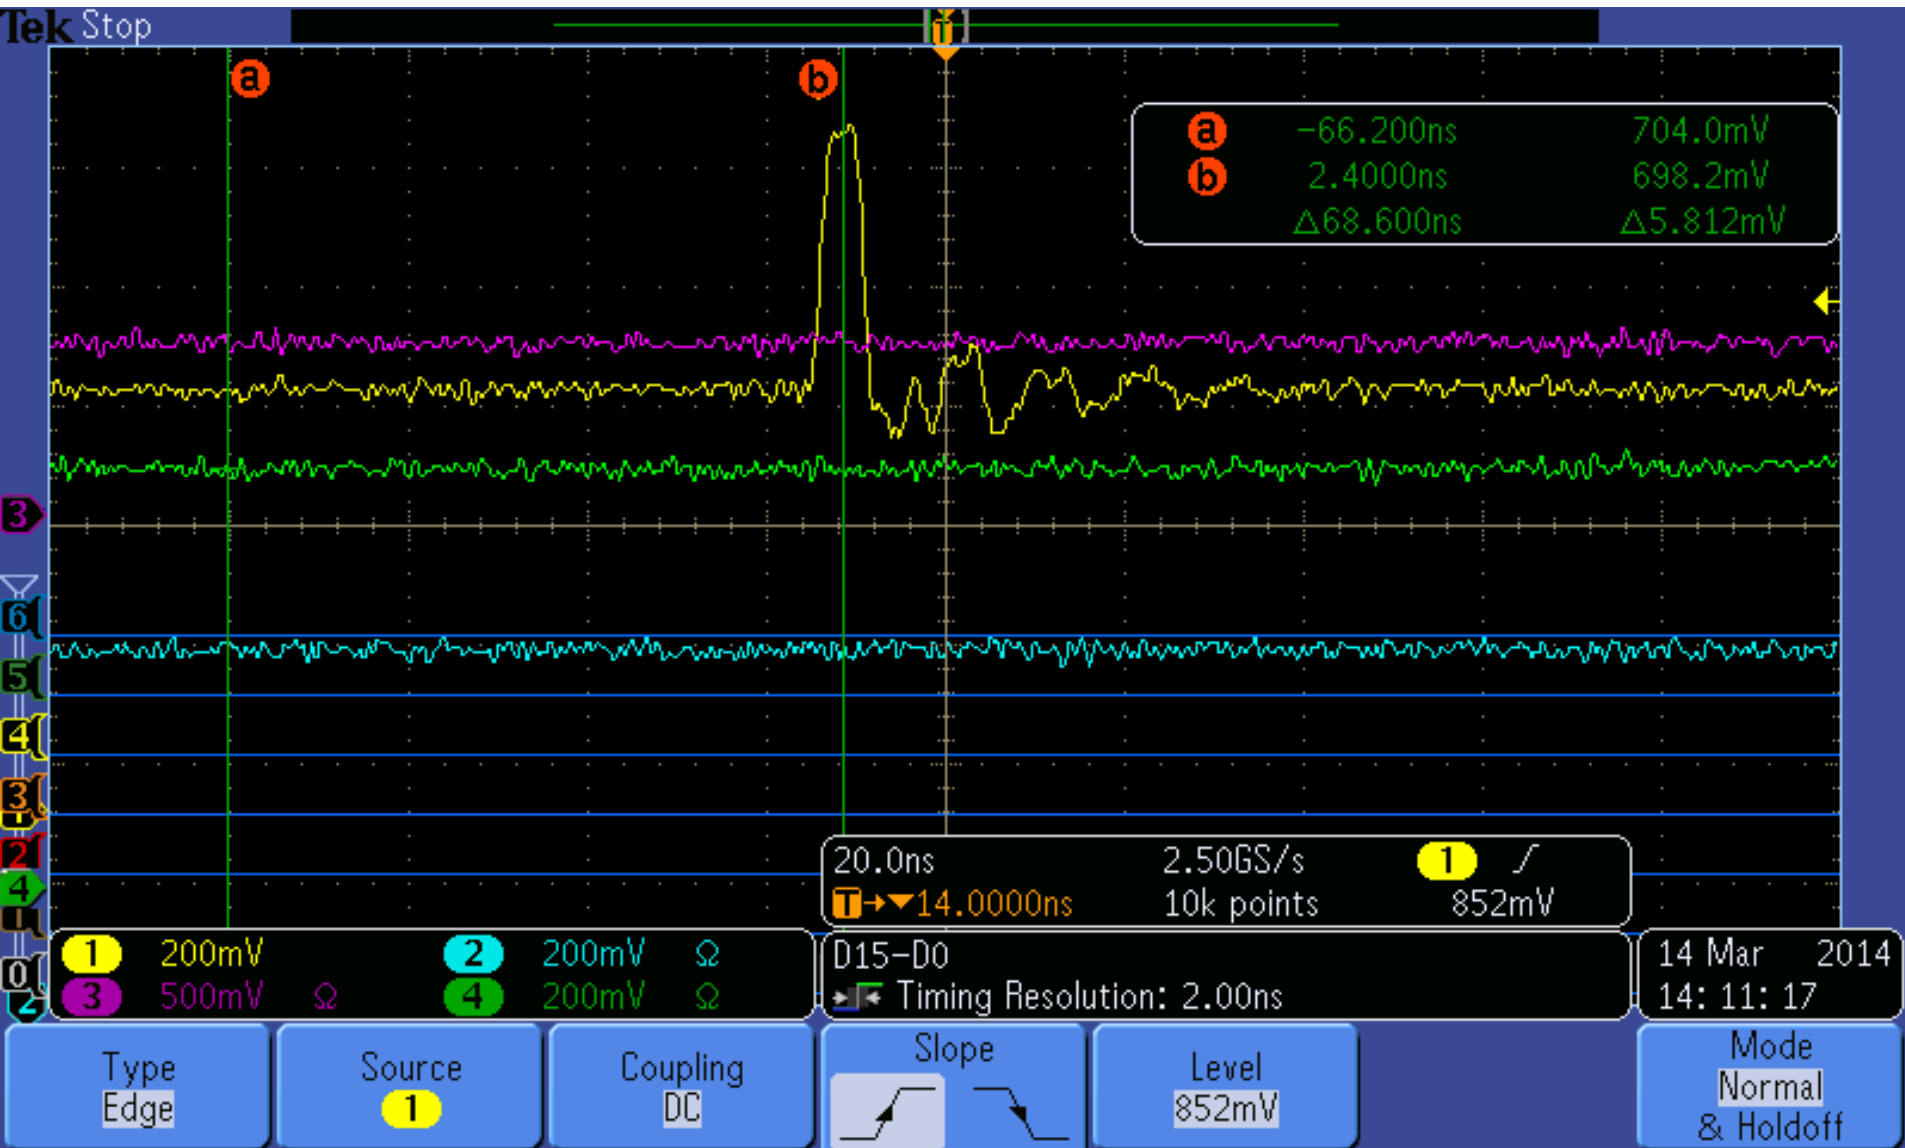
10ns SYNC pulse from SD front panel
 Only occurs at end of CODA "download"
 "Download" reloads the TI firmware and apparently this pulse is created when the FPGA is done loading. Not a serious issue, but this pulse occurs every time the TI is 'downloaded'
