## Central Drift Chamber straw radiation test results

Yves Van Haarlem Carnegie Mellon University GlueX-doc-1379 (version 7)

December 3, 2009

This note describes a radiation test done with a prototype of the GlueX Central Drift Chamber. The goal is to determine if the aluminum anode layer inside the straw would be damaged by radiation expected in GlueX.

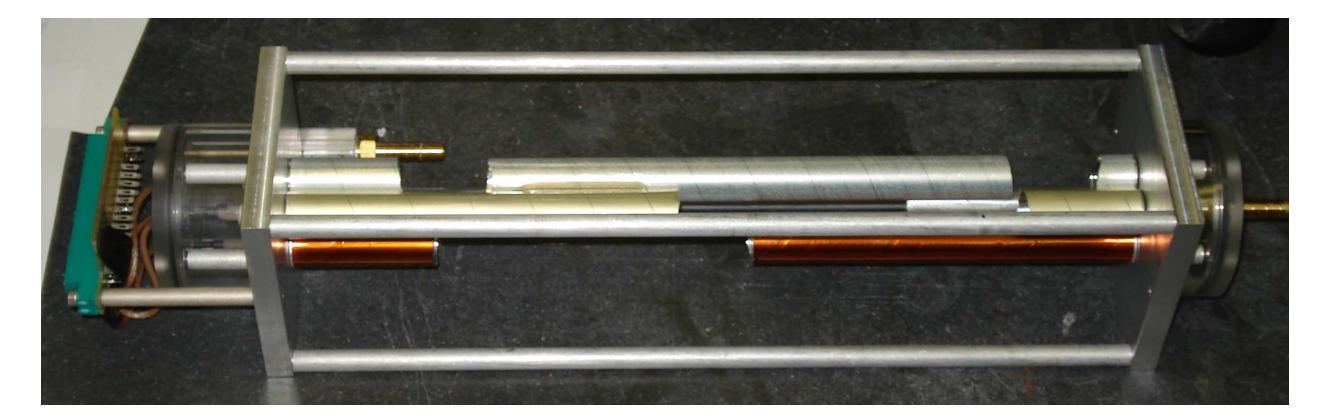
A picture of this prototype after irradiation (some pieces of straw are cut out) can be seen in Fig. 1. The prototype was made and tested (for normal operation) at Carnegie Mellon University (CMU). It was then transported to Jefferson Lab for irradiation and brought back to CMU for follow-up testing.

Figure 1: Picture of a four straw prototype after radiation and examining of the straws.

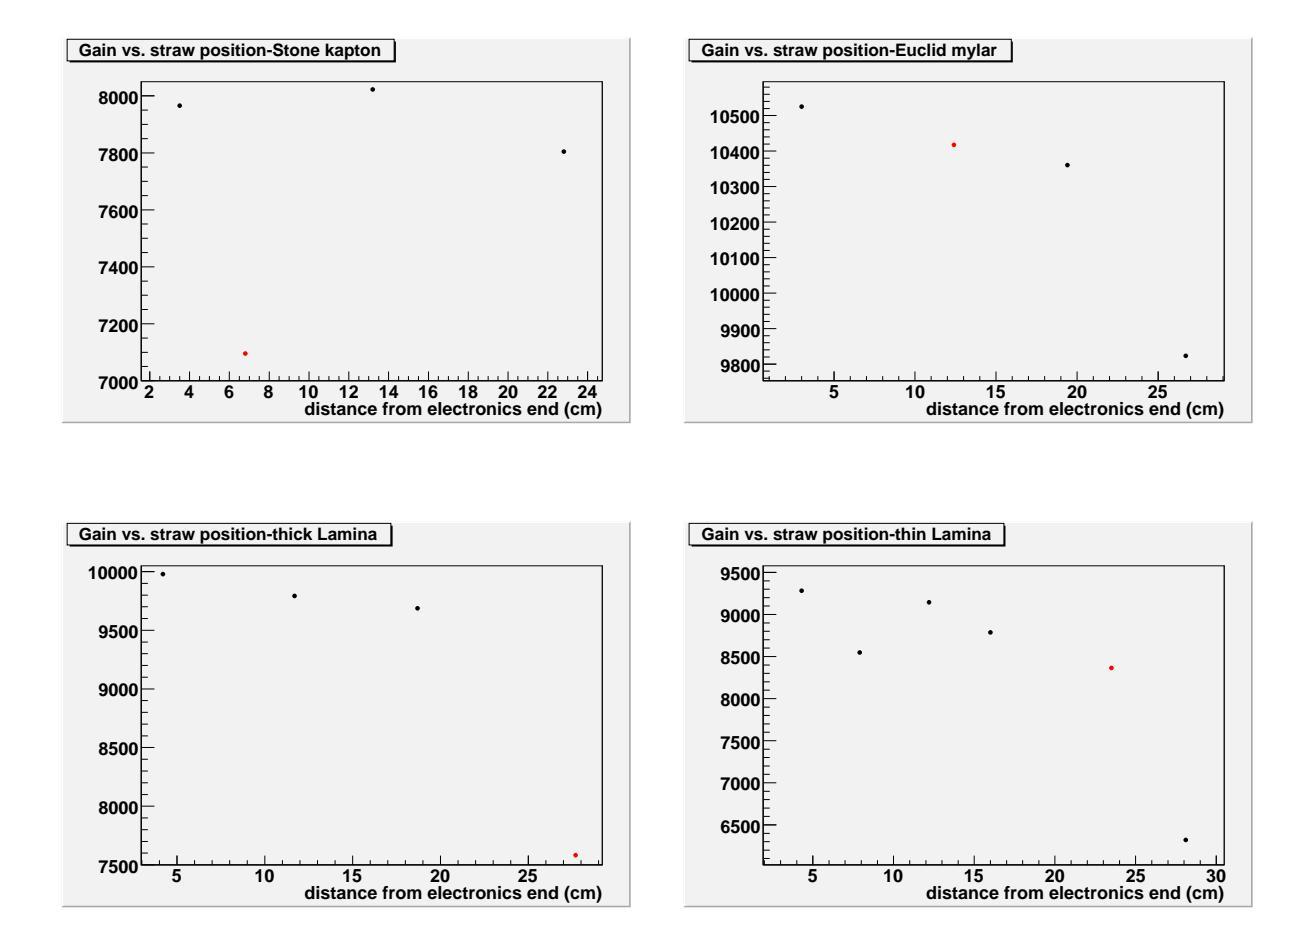
In Fig. 2 the gain of the straw is shown as a function of distance from the read out electronics. The gain is measured using an <sup>55</sup>Fe source. The red point indicates the spot where the straw was irradiated. In general one expects a slowly decreasing gain as a function of distance from the read out electronics followed by a more drastic drop if one gets close to the end of the straw (the electric field lines get distorted due to the presence of material that holds the straw). This behavior is observed in all the straws except in two points: at 7 cm distance there is a dip in the Stone-kapton and the Lamina-thin straw. The dip in the Stone-kapton straw might be due to the irradiation. Although the Lamina-thin straw was located under the other way around there is no dip in the gain observed for the Stone-kapton straw where the Lamina-thin straw got irradiated (at 24 cm distance). It also seems that the Lamina-thick straw got irradiated quite close to the end where you expect to see a drop in gain due to electrostatic effects.

Figure 2: Gain as a function of distance from the readout electronics for the four tested straws. The red point indicates where the straw was irradiated.

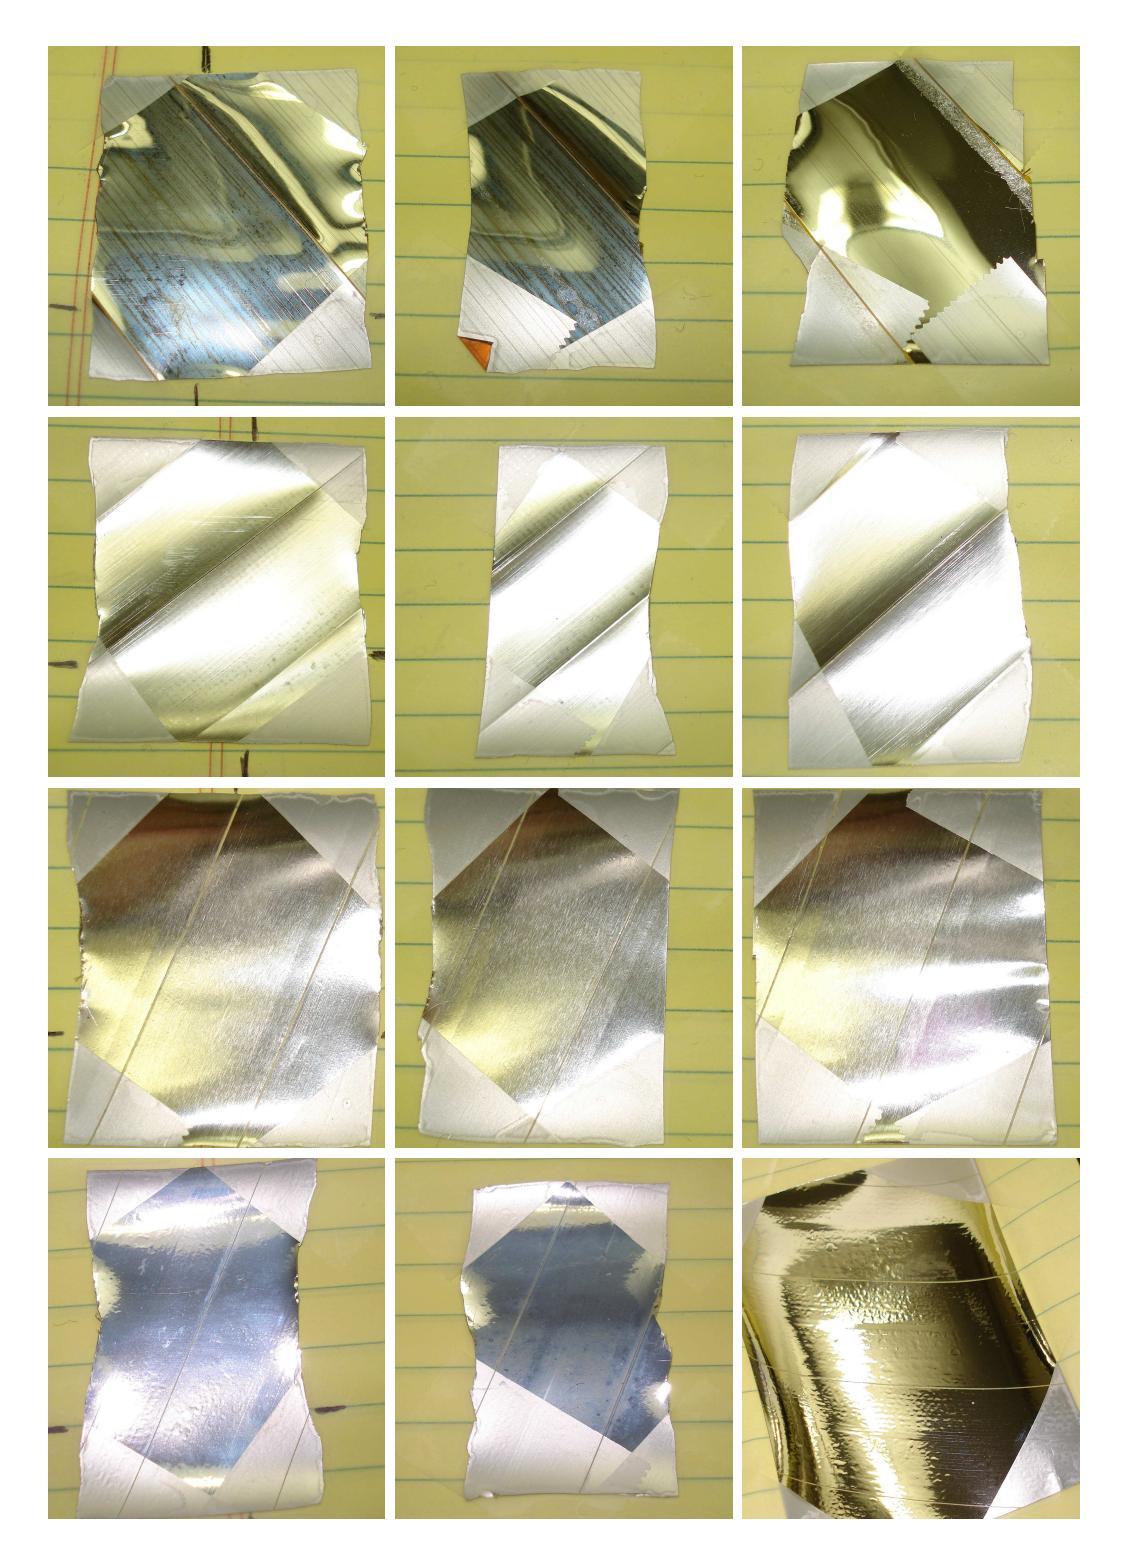
After irradiation and the  ${}^{55}Fe$  measurements, the straws were cut open to visually inspect them. The area that was irradiated was compared with an area that was not irradiated and a straw that was never used. The results are shown in Fig. 3. First of all, all Al layers seem to be intact and no cracks were observed. Although one cannot see differences between irradiated areas and not irradiated areas, there is a clear difference between the straw that was not used and the straw that was irradiated for the Stone-kapton and Lamina-thick type straws. It seems that something got deposited on/etched the aluminum layer, the questions is what it and what caused it. The same thing probably happened for the other two straw types but due to different finish it cannot be seen with the naked eye.

Figure 3: Pictures of the straws that were visually inspected. From left to right: area of the straw that was irradiated, area of the straw that was not irradiated, and area of the same type of straw that was never used. From top to bottom: Stone-kapton, Euclid-mylar, Lamina-thick, and Lamina-thin straw.

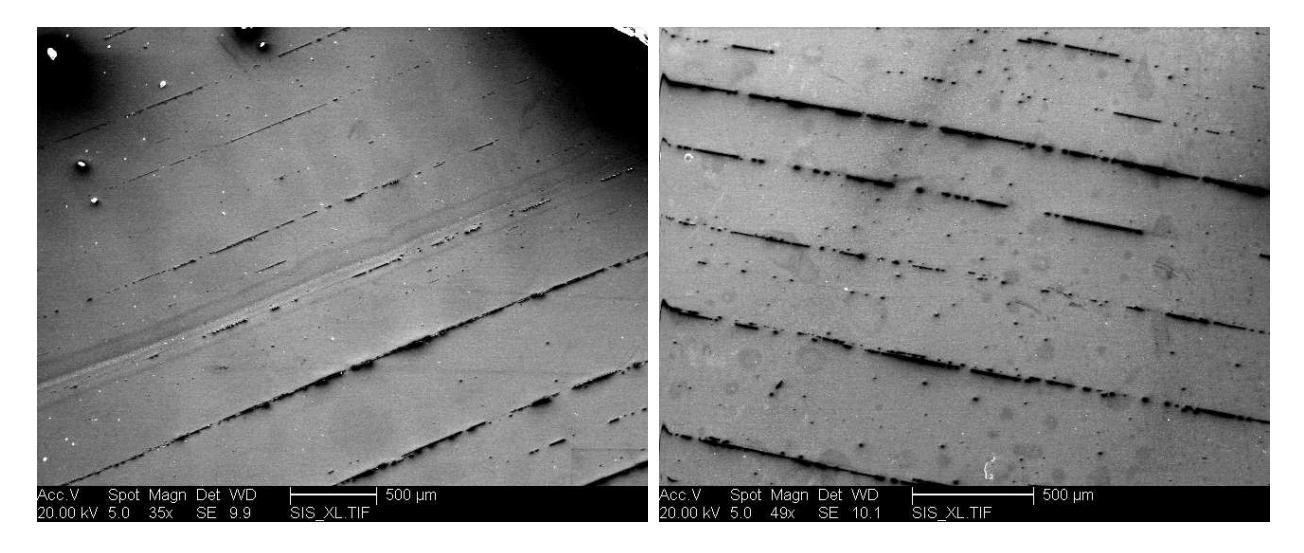
A piece of Lamina-thick straw that was never used was compared with a piece that was irradiated. A comparison at the lowest scale can be seen in Fig. 4. On this scale one can see black impurity lines on both straw pieces, probably due to the fabrication. A difference that can easily be seen is the dark gray areas on the irradiated straw which are not visible on the straw that was never used. When zoomed in one can clearly see in Fig. 5 that the irradiated straw shows a lot of black pits and that the dark gray areas in Fig. 4 are a different size and concentrations of those black pits. What caused those pits remains a question.

Figure 4: Comparison between a Lamina-thick straw that was not used (left) and the one that was irradiated (right) at  $500\mu$ m scale.

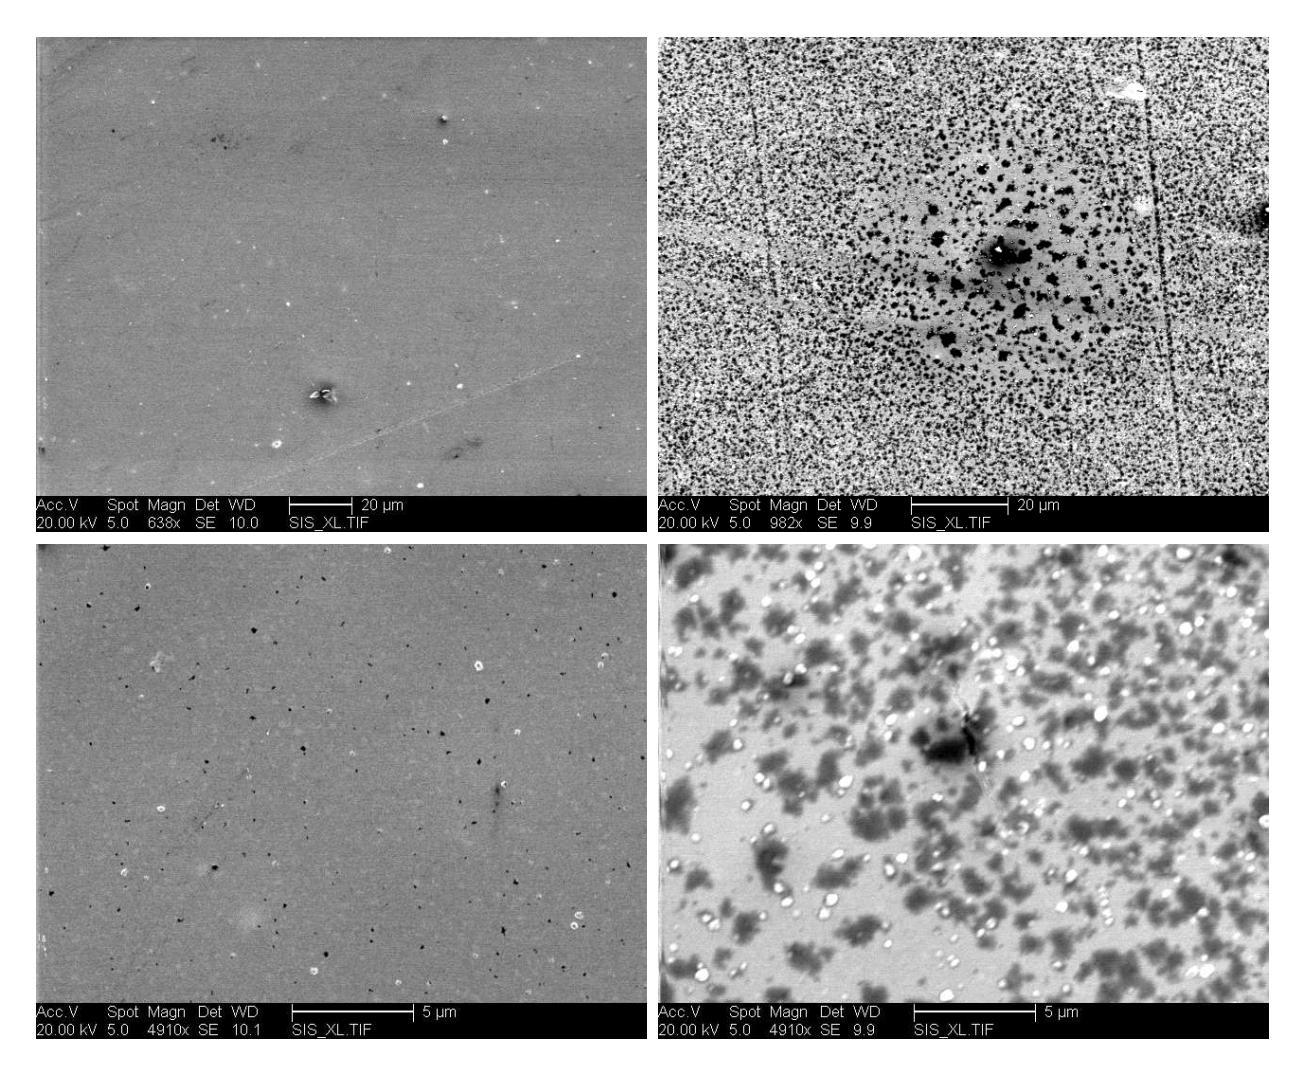
Figure 5: Comparison between a Lamina-thick straw that was not used (left) and the one that was irradiated (right) at 5 and  $20\mu$ m scale.

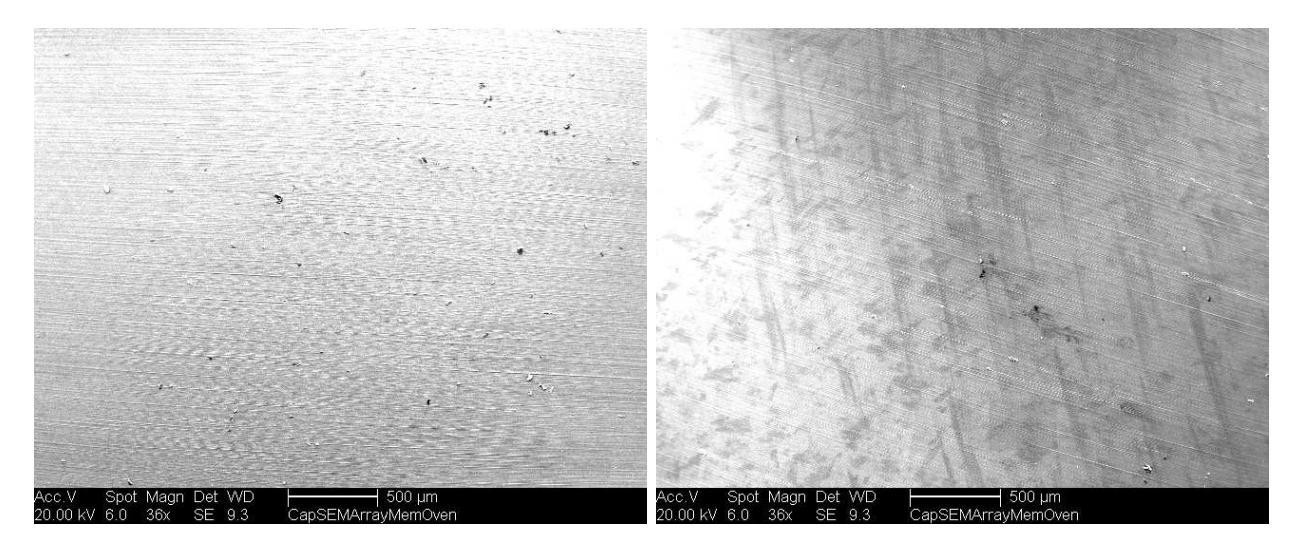
A piece of Lamina-thin straw that was never used was compared with a piece that was irradiated. A comparison at the lowest scale can be seen in Fig. 6. Both straws look very

smooth compared to the same pictures taken of the Lamina-thick straw. On this scale one can see that there is no real difference between the two. Also if zoomed in (Fig. 7) no real difference can be seen. The white dots are Fe traces, how they got there is not known but probably it got there during fabrication. The fact that this straw did not show any difference makes it a good choice to be used in the final detector setup. The difference with previous straw (Lamina-thick) is, according to the manufacturer, that the aluminum is deposited on the mylar instead of glued. It might be that glue that caused the black pits on previous straw.

Figure 6: Comparison between a Lamina-thin straw that was not used (left) and the one that was irradiated (right) at  $500\mu$ m scale.

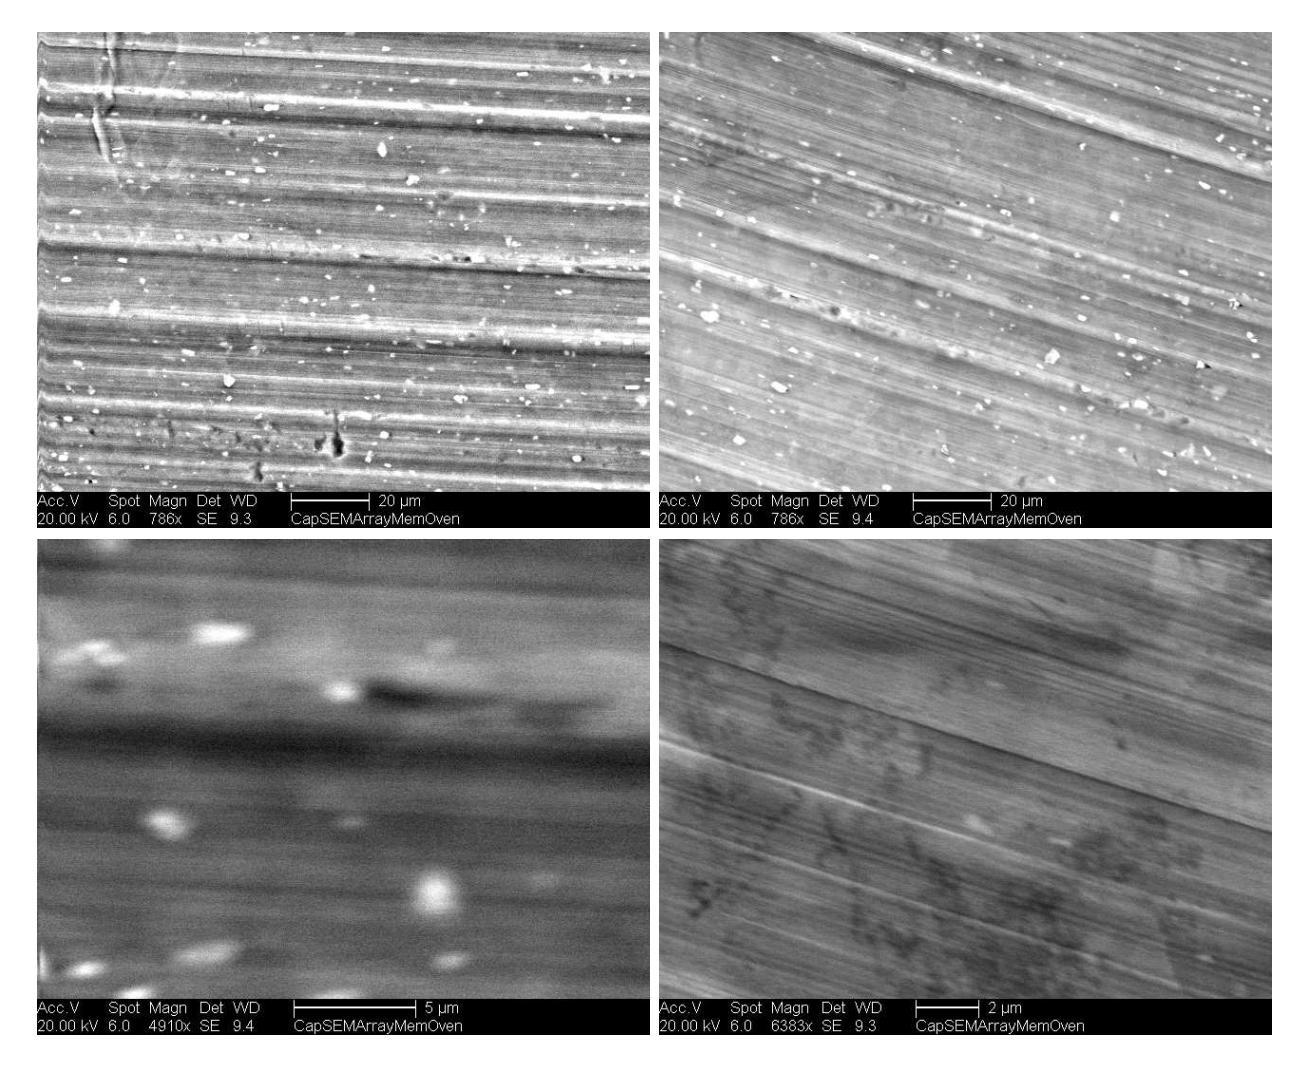
Figure 7: Comparison between a Lamina-thin straw that was not used (left) and the one that was irradiated (right) at 5 and  $20\mu$ m scale.

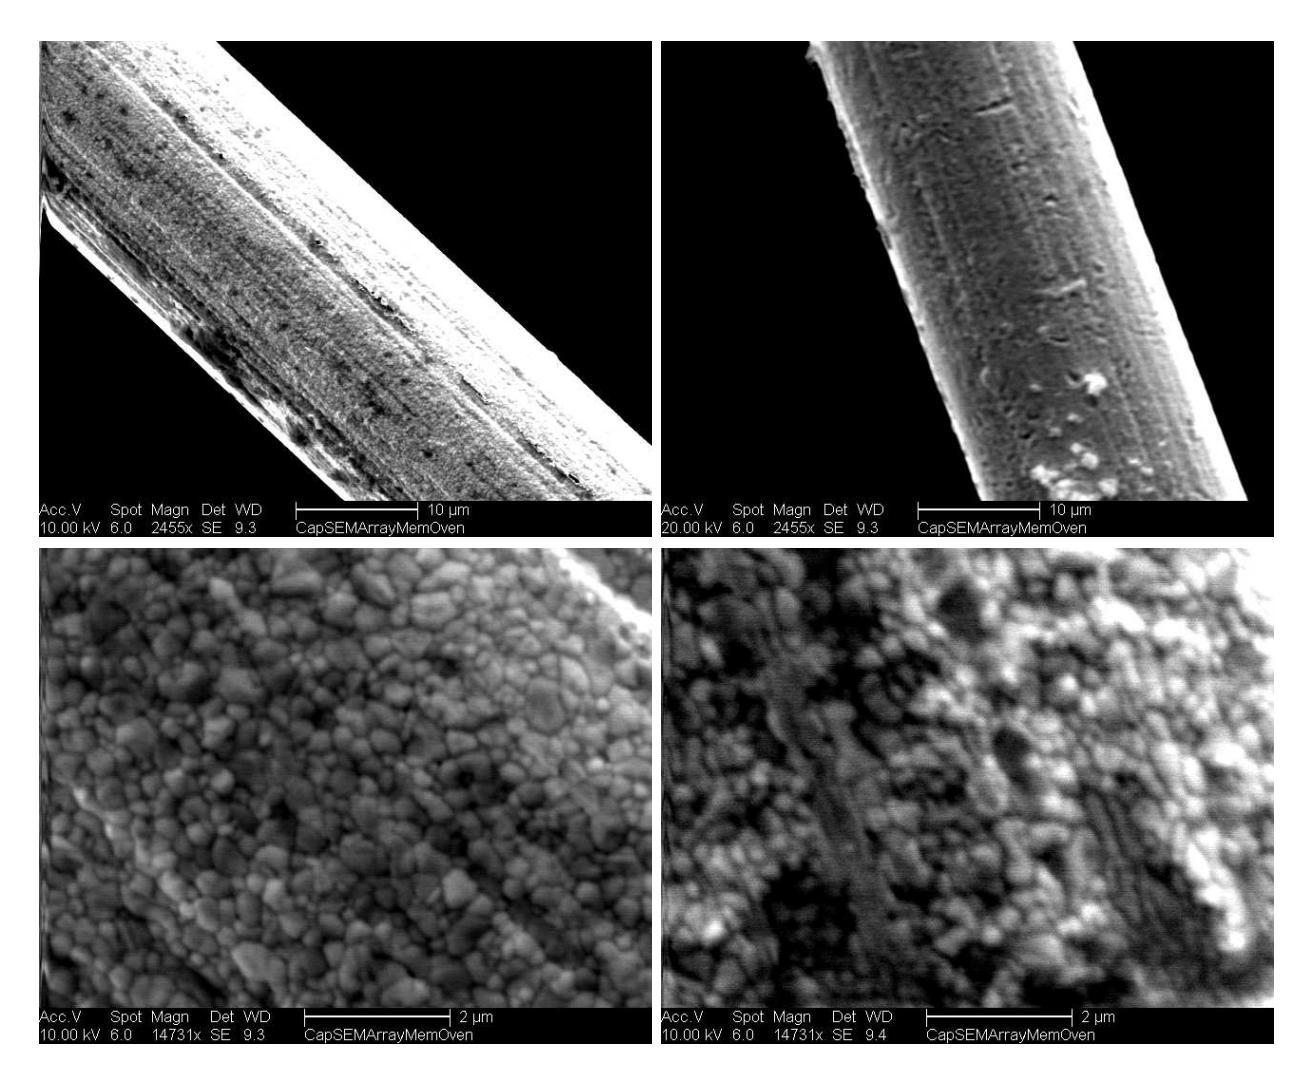
In Fig. 8 a new wire is compared with an irradiated one on different scales. No difference can be observed.

Figure 8: Comparison between a wire that was not used (left) and one that was irradiated (right) at 2 and 10  $\mu$ m scale).
