Comments and suggestions:

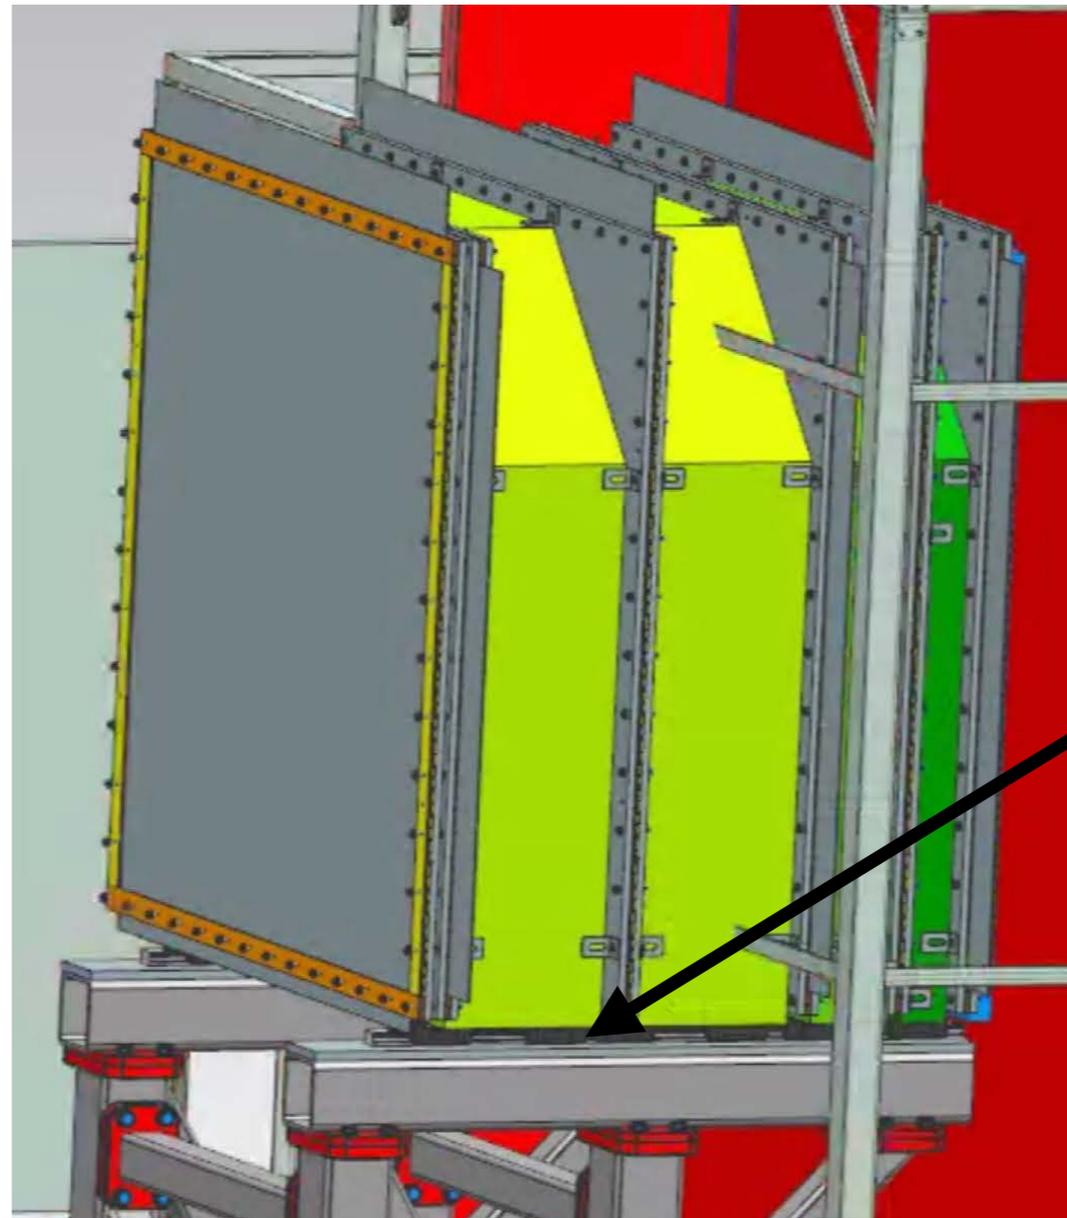
1. I assume on top and sides the absorber iron reaches to within 2" of the detector plate edge.
2. There's a clearance issue at the bottom when the preamp cards are in the "up" direction. The SHV cable is attached on the "down" HV side of the detector in the direction perpendicular to the chamber plane. We need clearance from the iron absorber to bring out the HV cable, and for attachment of grounding cables for the HV boards

This is a problem area !

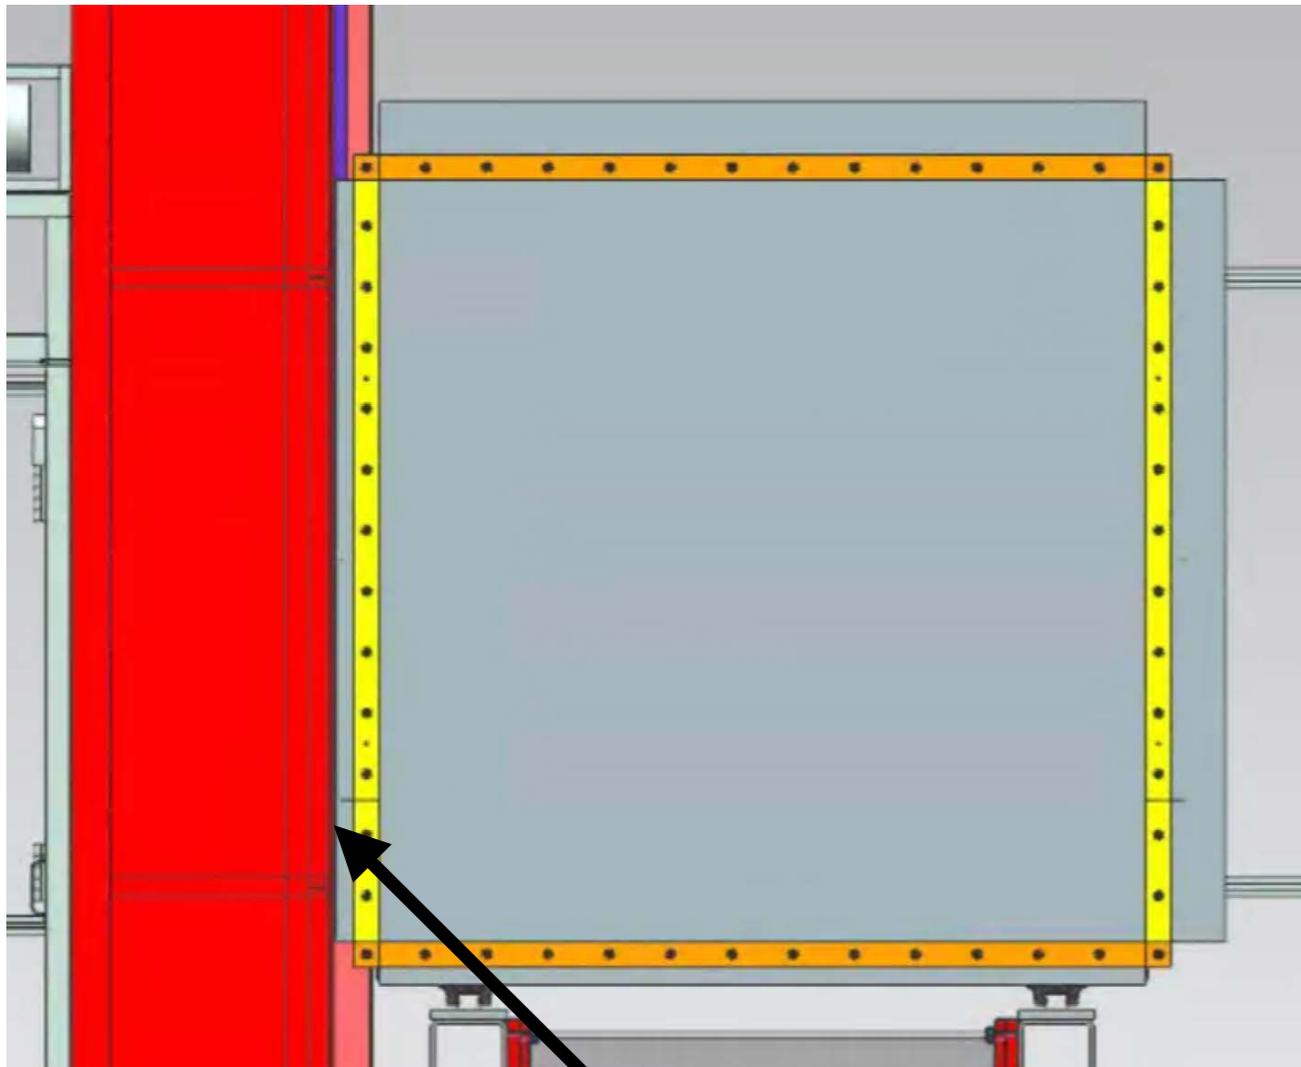
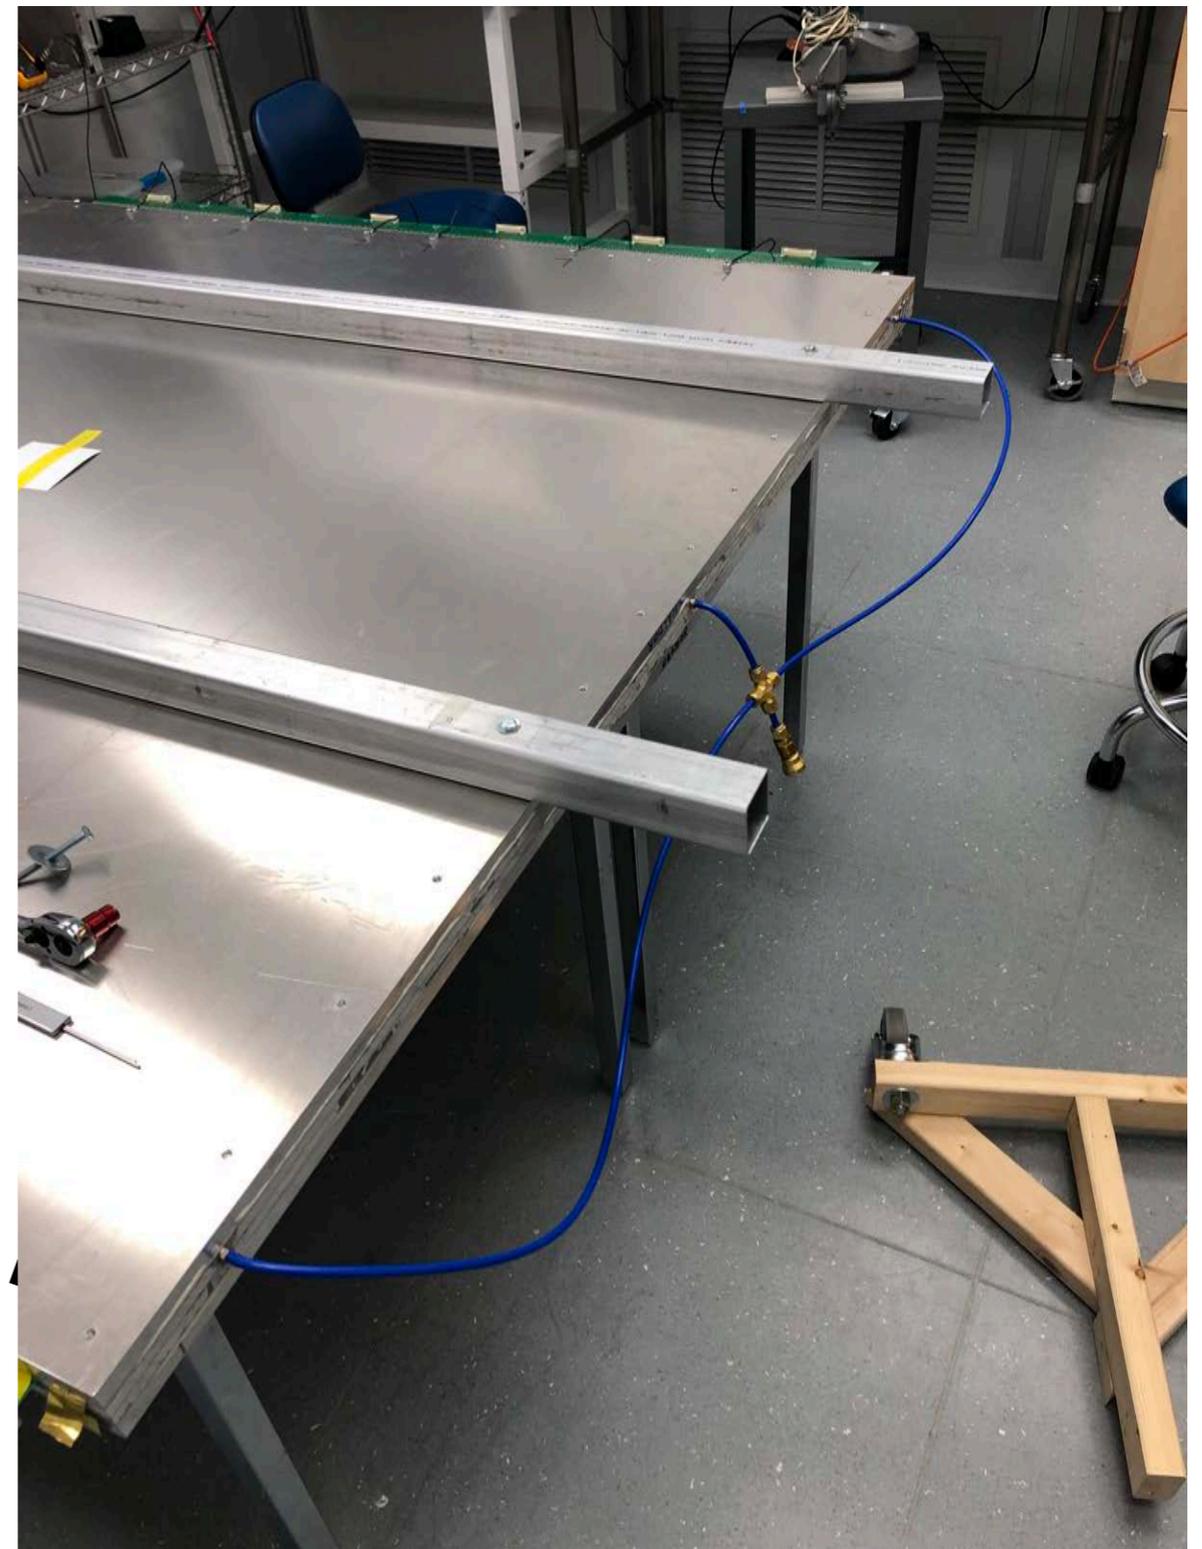
4. Clearance problem on the beam-right side of the detectors? When the preamp cards are in the "up" orientation, there are gas lines and fittings that come out on that side of the detector.

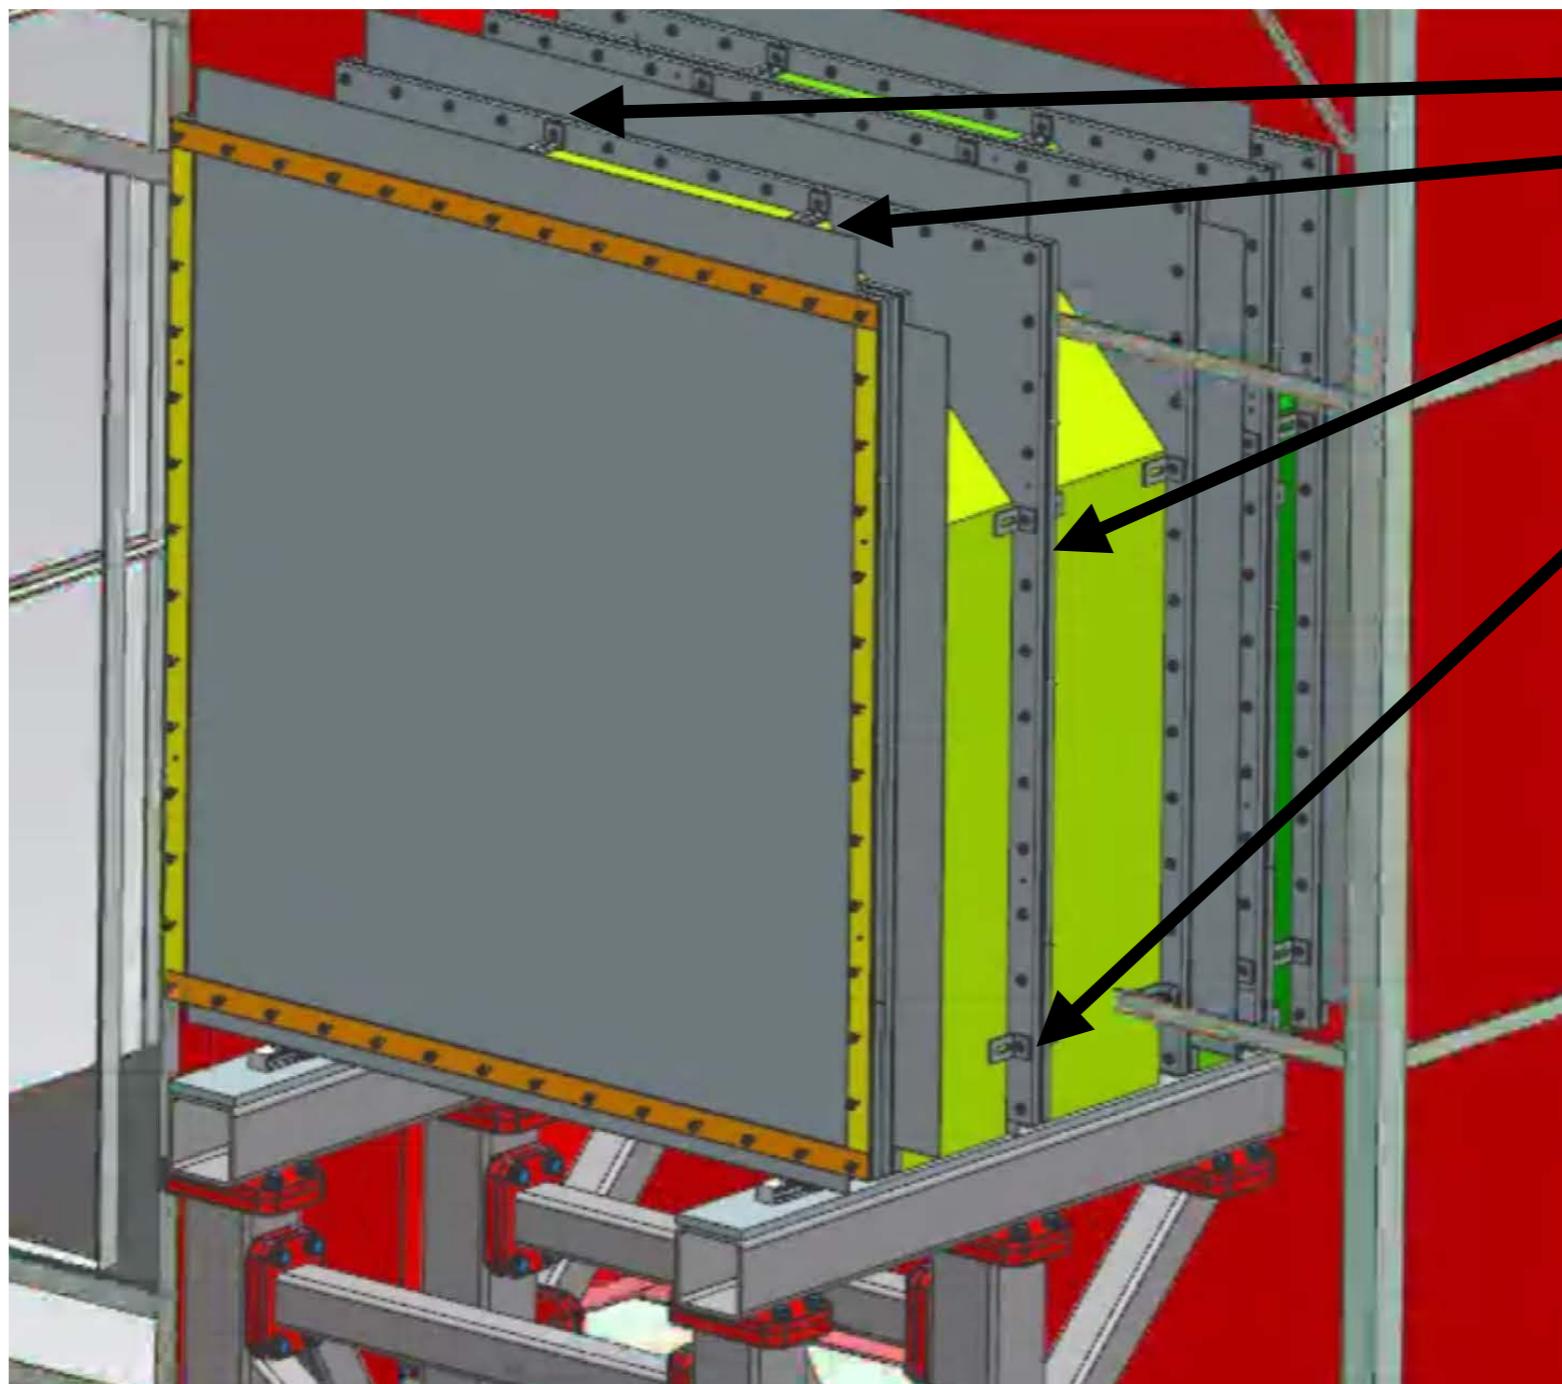
5. I believe the attachment points shown for the chambers will work. The thickness of the aluminum used for the shielding boxes is .031". The box extends in 1.5" from the edge of the chamber plate. The iron starts at 2" from the edge of the chamber plate
