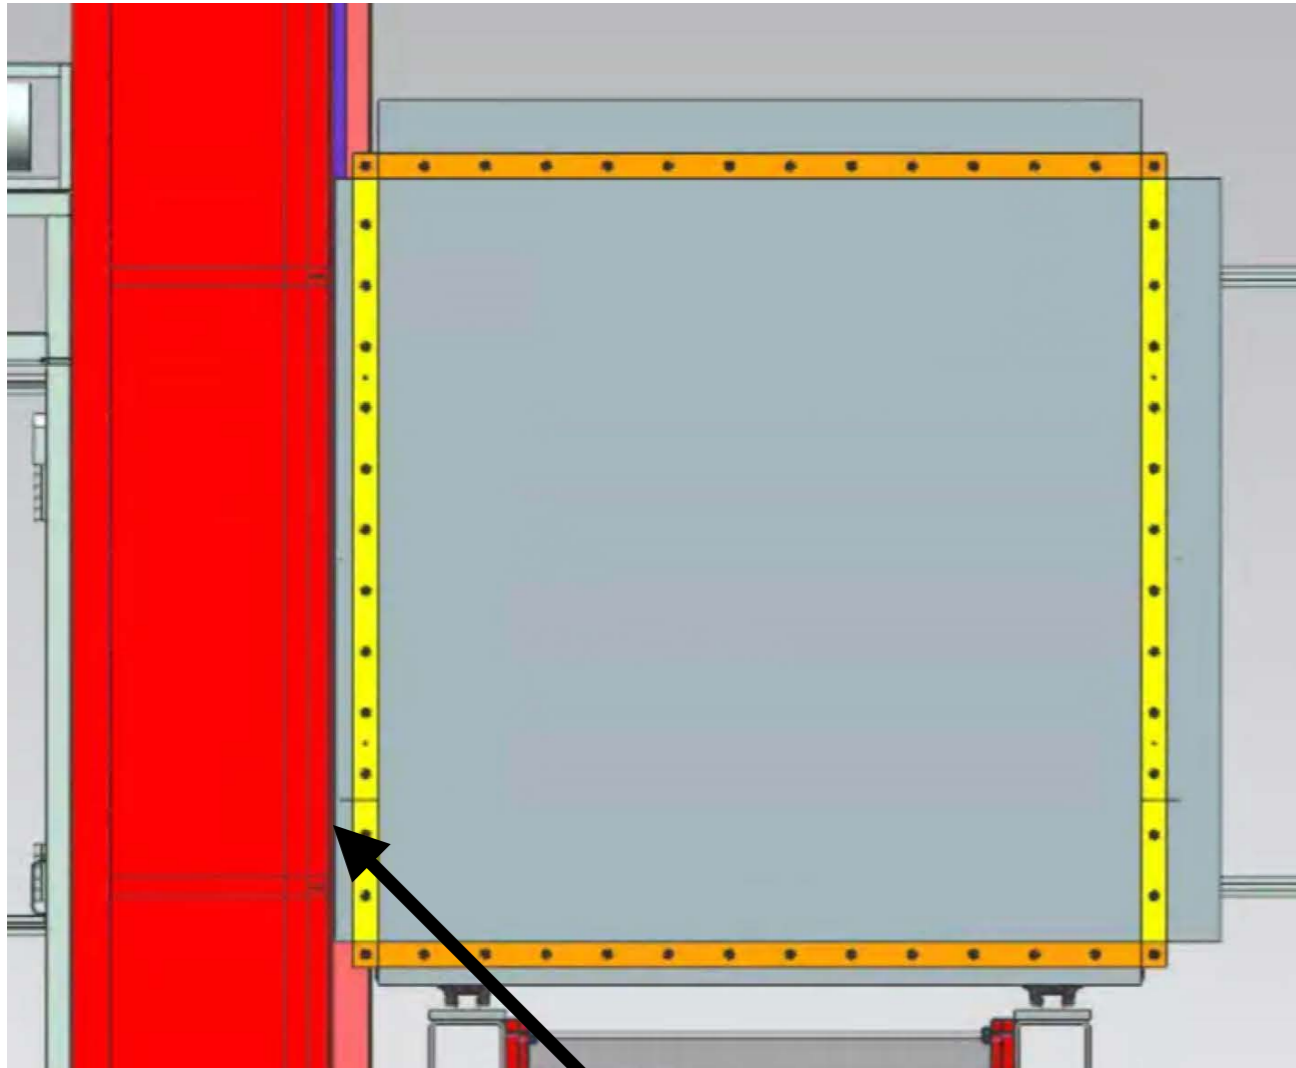
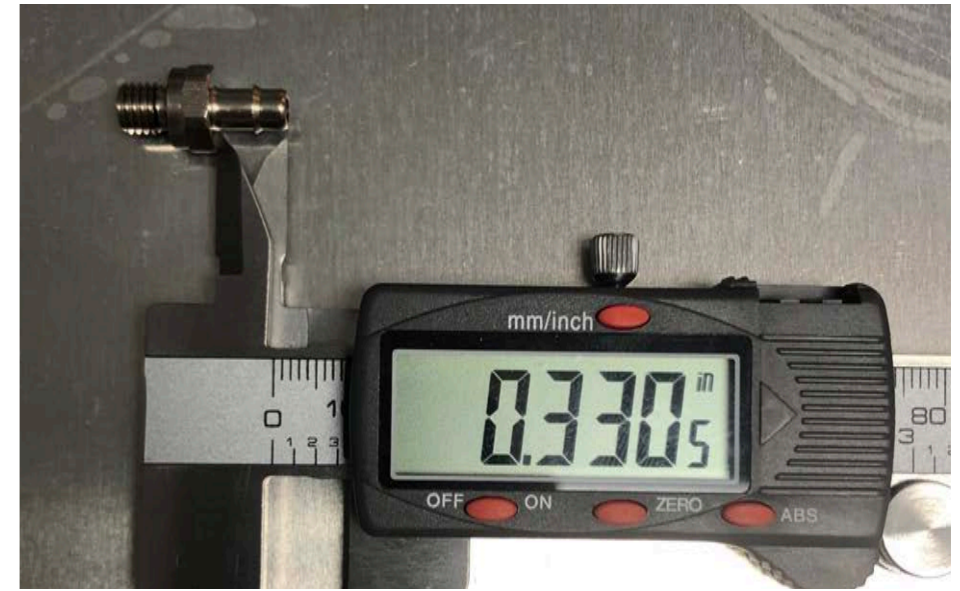
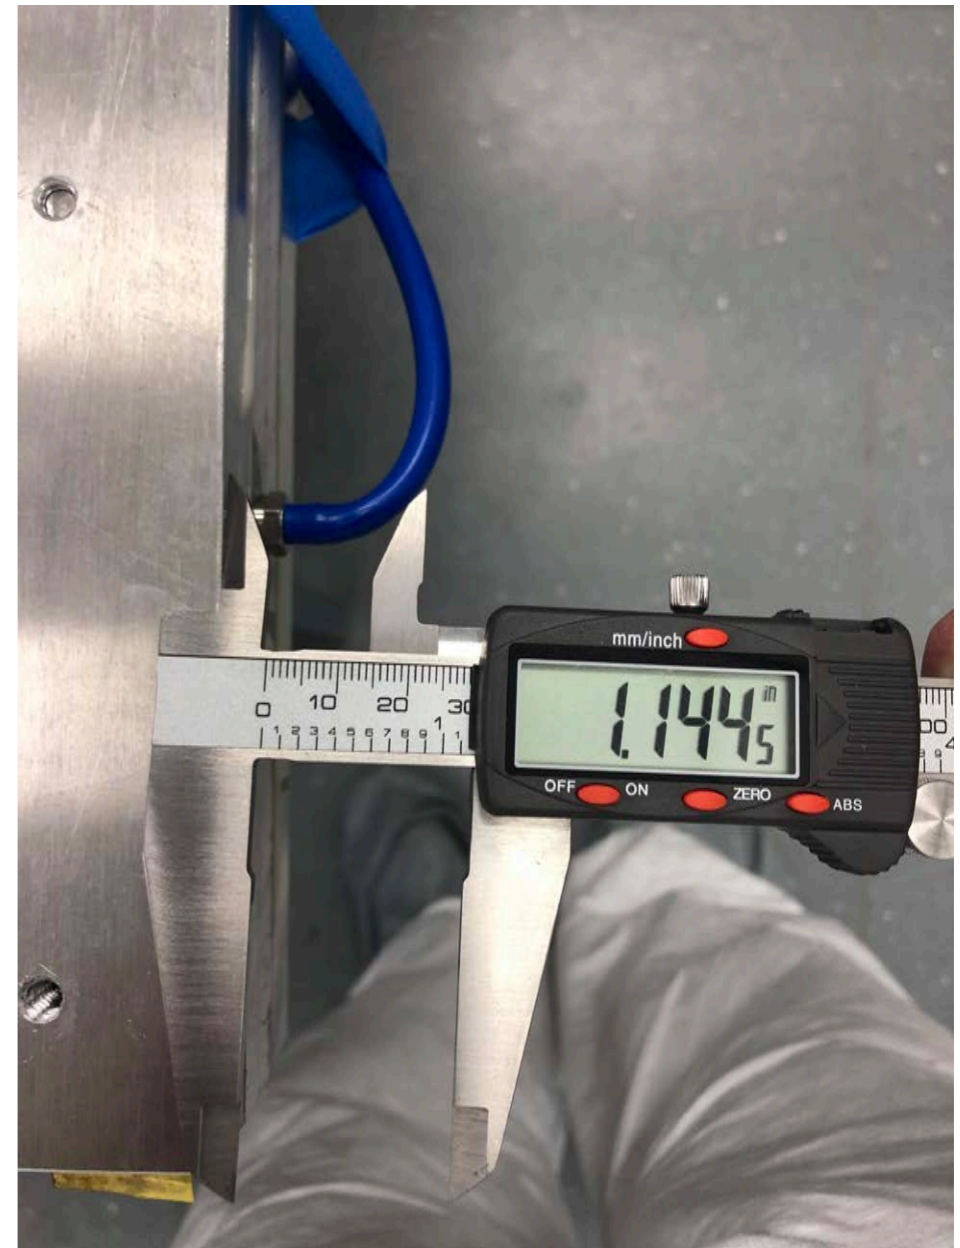
Clearance on beam-right side of the detector for gas lines.

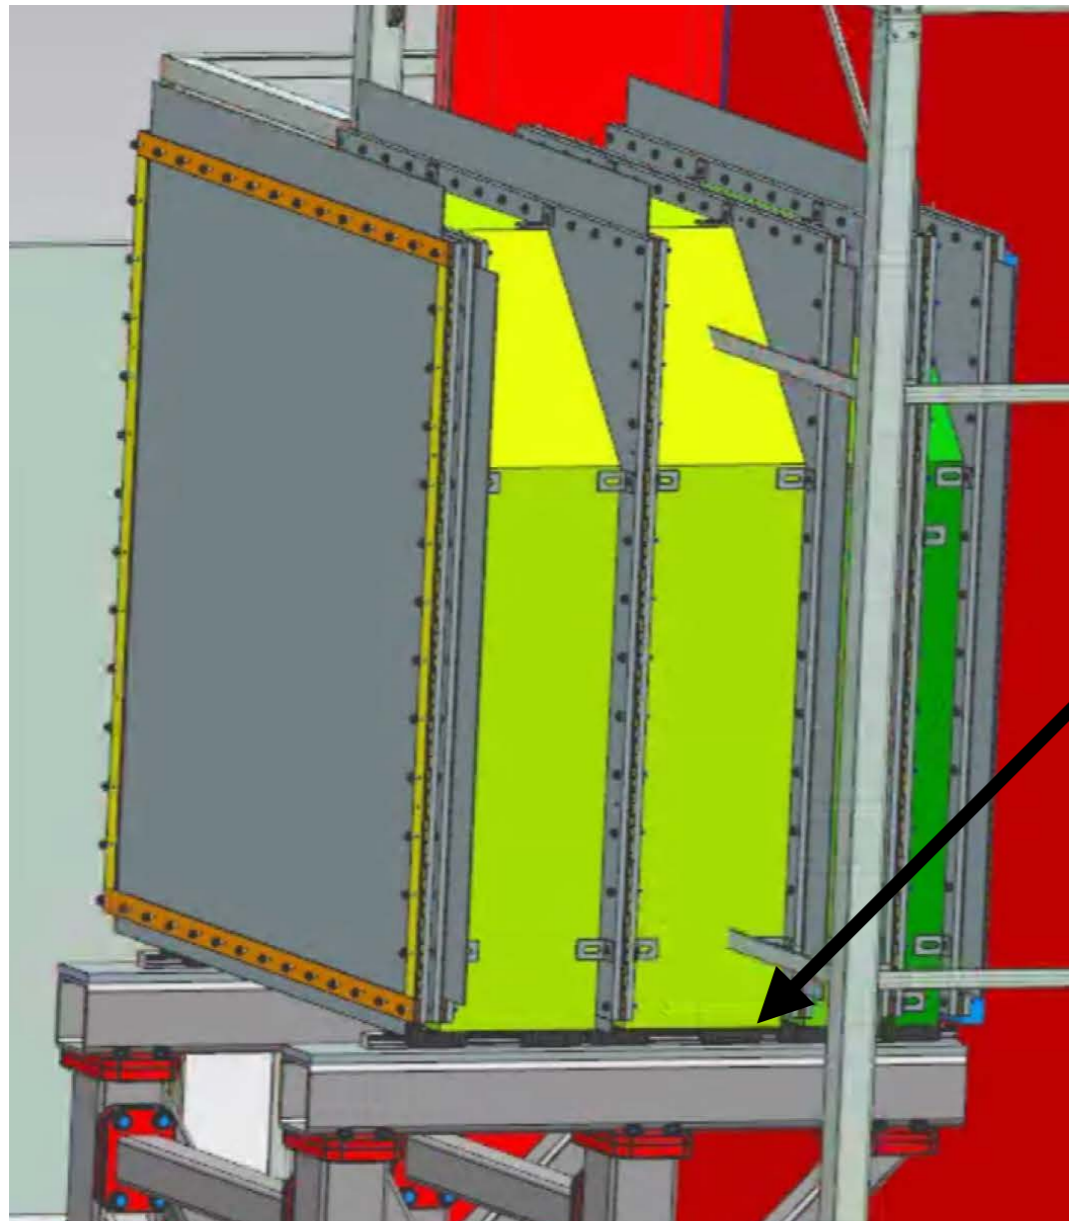
We should check that when the preamp cards are in the horizontal orientation, there's clearance at the bottom of the detector for the gas lines.

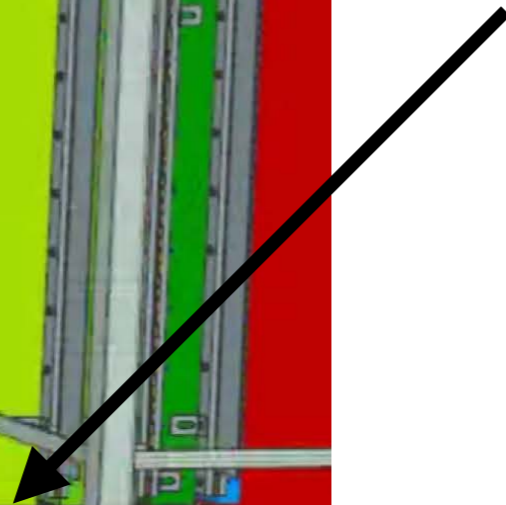
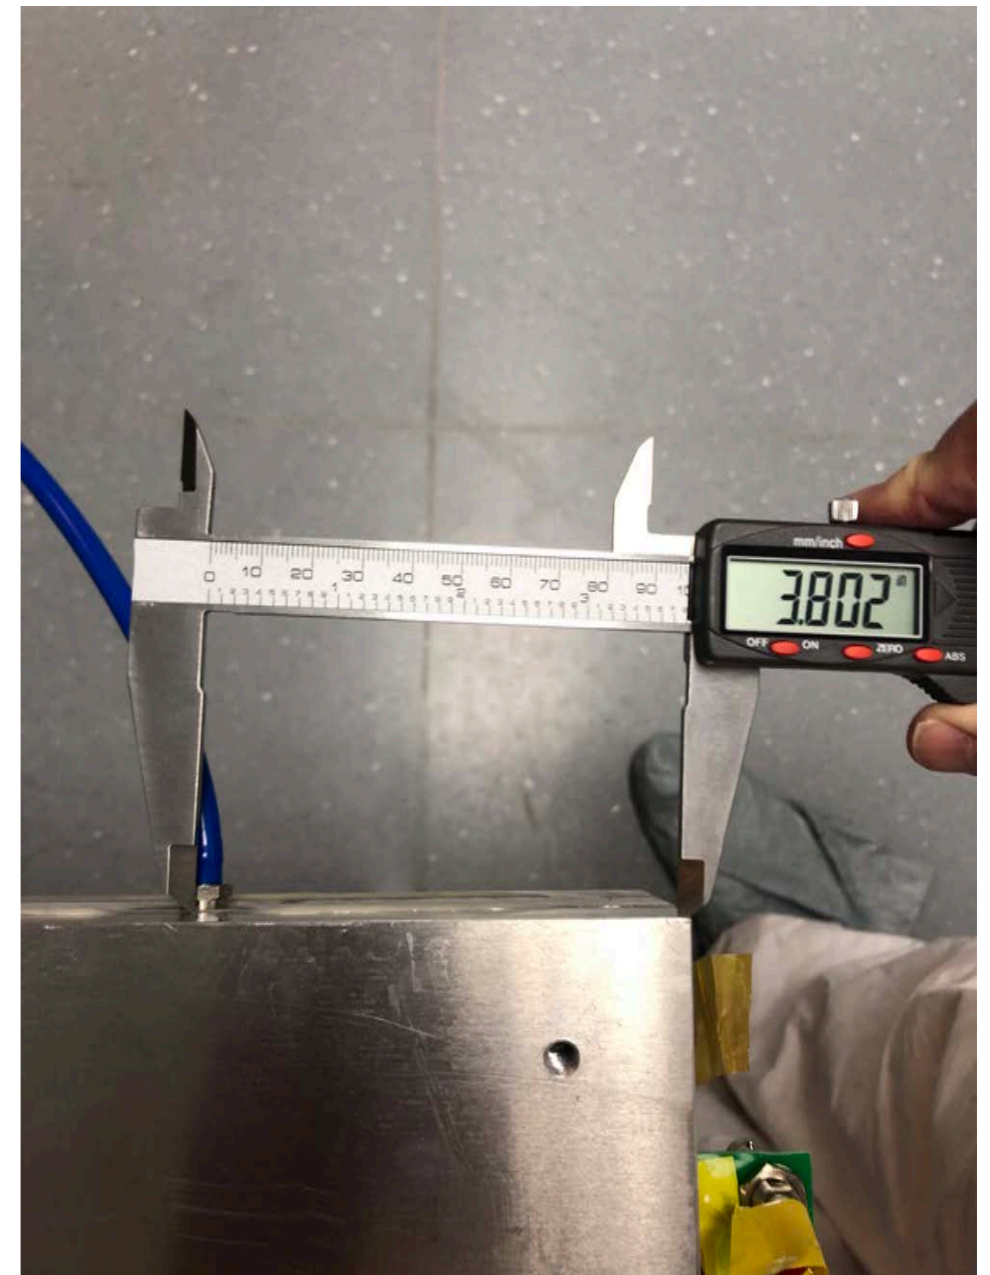
Is there a problem here ?
