Accuracy Measurements of the Straw Tube Endplates

Curtis A. Meyer

Carnegie Mellon University, Pittsburgh, PA 15213

May 28, 2003

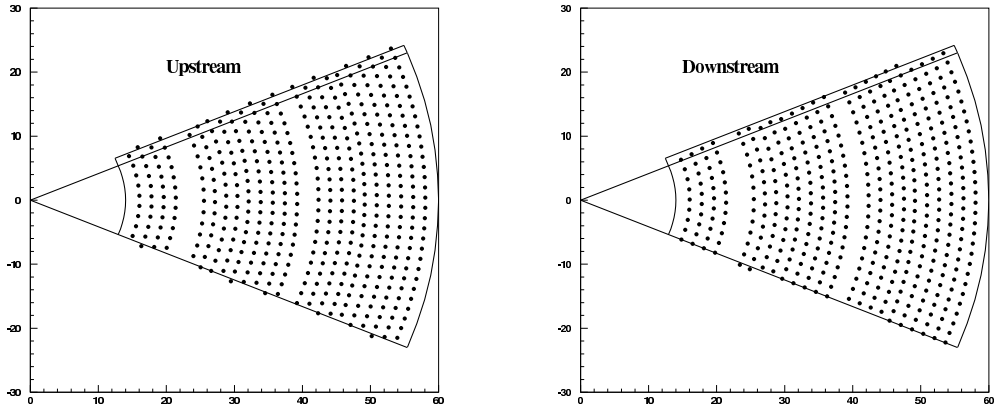
Figure 1: The hole patterns as seen on the outside of plate zero for both the up stream and down stream plates. The machining axes have x and y centered at the center of the wedge and running in the normal directions. x from left to right and y from bottom to top.

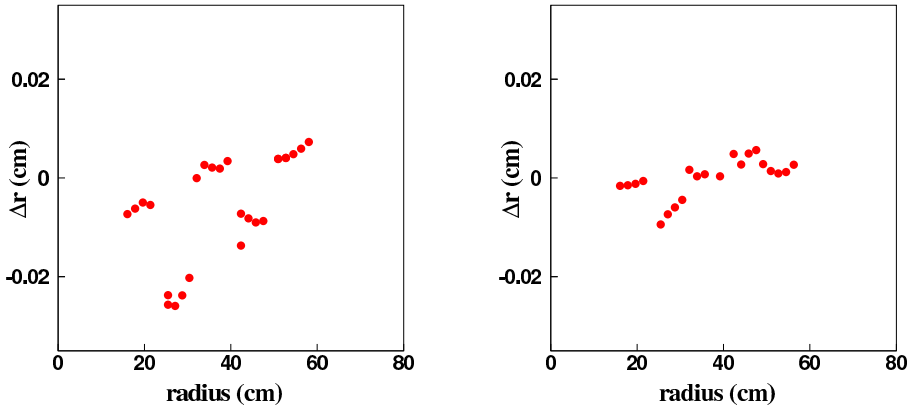
The measured location of the stereo hole appears off in the measurements. As far as we can tell, this is wholly associated with the way that the positions of the holes are measured. The measuring machine taps three positions on the sides of the hole walls. From these, it is possible to determine where the center is located. This is done at two different depths, and the average of the two is taken. For the straight through holes, this works fine. However, for the stereo holes, this will return a position that is somewhere near the middle (thickness) of the plate. Because of the stereo angles, this will be shifted away from the position at the surface of the plate. Unfortunately, the depth below the surface of the plates of the two measurements was not recorded during measurement. As such, it is not possible to precisely correct for the location

Figure 2: A plot of Δr versus r for the upstream (left column) and downstream (right column) plate zero. The data shown here are bfore any corrections have been made. The data that are consistently low correspond to the stereo layers in the end plates.

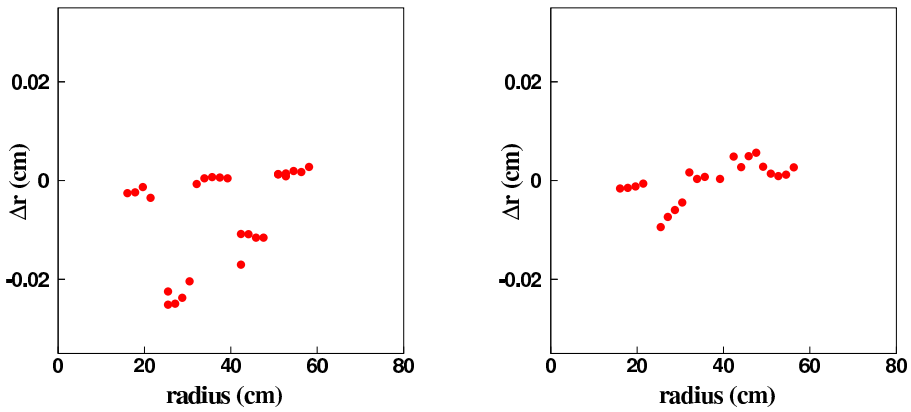
It was determined after the construction of the upstream plates that the milling machine bed was tilting slightly as the plates were moved back and forth along the plate. The tilting was measured by placing an accurate scale on the mill bed, and then comparing the positions of the mill head and the electronic readout for the head. These problems did not appear to affect the downstream plate as there was less material on the mill bed. The measured corrections for the up stream plates are given in Table 6. Figure 2 shows measurements of Δr versus r for both the up stream and the down stream set of plates. The top row are the direct measurements of the plates compared with the expected positions. The two clusters of data that lie below the rest correspond to the stereo wires in the chamber. The slope of the remaining points is largely due to the mill corrections. After the corrections in Table 6 have been applied, the results are shown in the middle row. The agreement is now significantly better, but there is still a small slope to the Δr versus r plot. We believe that this is due to temperature differences between the rooms in which the plates were machined, and where they were measured. If the slope of the line is fit, and a final correction is applied, then the data shown in the bottom row of Figure 2 is obtained. The same thermal correction is applied to both the upstream and the down stream plates, as no data at the level of $0.5°C$ are available.

Figure 3: A plot of Δr versus r for the upstream (left column) and downstream (right column) plate zero. These data include corrections for the measured tilt in the mill during manufacture of the upstream plate. The data that are consistently low correspond to the stereo layers in the end plates.

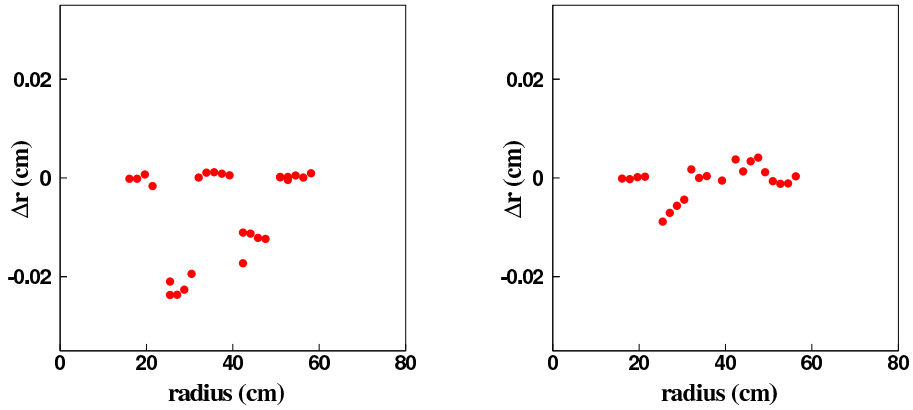
Figure 4: A plot of Δr versus r for the upstream (left column) and downstream (right column) plate zero. These data include both the mill corrections to the upstream plate, and a correction attributed to thermal expansion. The data that are consistently low correspond to the stereo layers in the end plates.

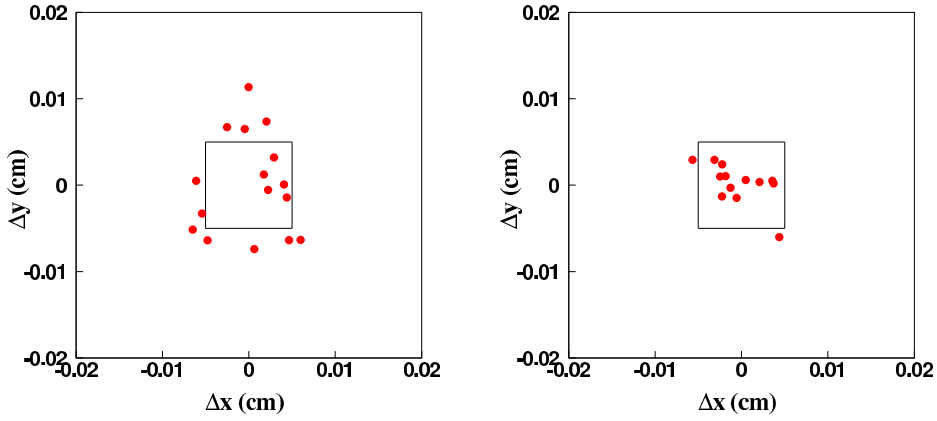
Figure 5: A plot of Δy versus Δx for the upstream (left column) and downstream (right column) plate zero. These data are without any corrections and have excluded the stereo layers.

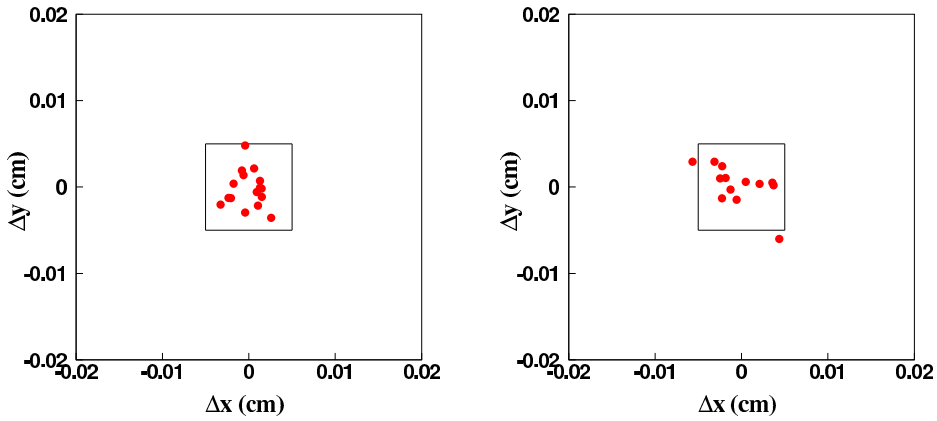
Figure 6: A plot of Δy versus Δx for the upstream (left column) and downstream (right column) plate zero. These data include correction to the upstream plate for the measured tilt in the mill. The stereo layers have been excluded.

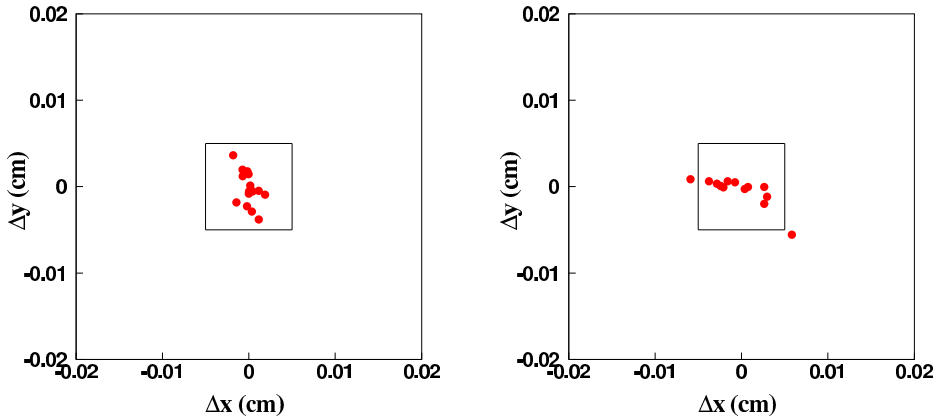
Figure 7: A plot of Δy versus Δx for the upstream (left column) and downstream (right column) plate zero. These data include correction to the upstream plate for the measured tilt in the mill and an estimated correction for thermal expansion. The stereo layers have been excluded.

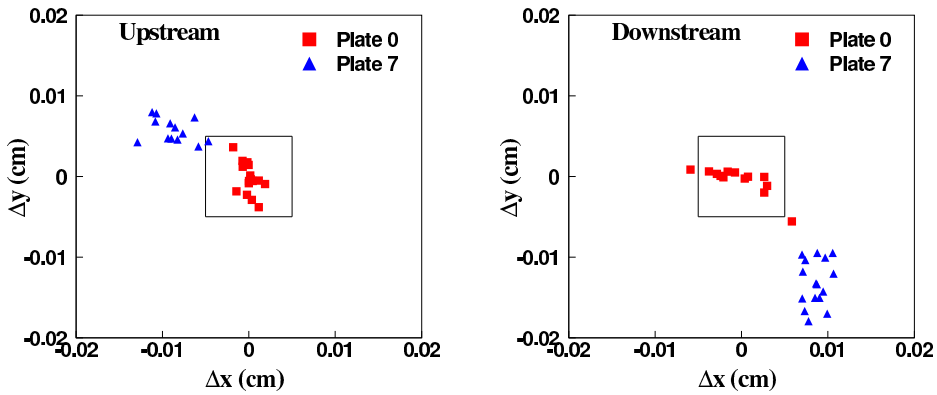
Figure 8: A plot of the deviation in y versus that in x for the upstream and downstream sections. The data have been optimized to plate 0, so all points there are easily withing $\pm 50 \mu m$. The data for plate 7 are systematically off indicating that the matching of one plate to the next is not perfect. Note that the upstream plate is significantly better matched than the downstream.

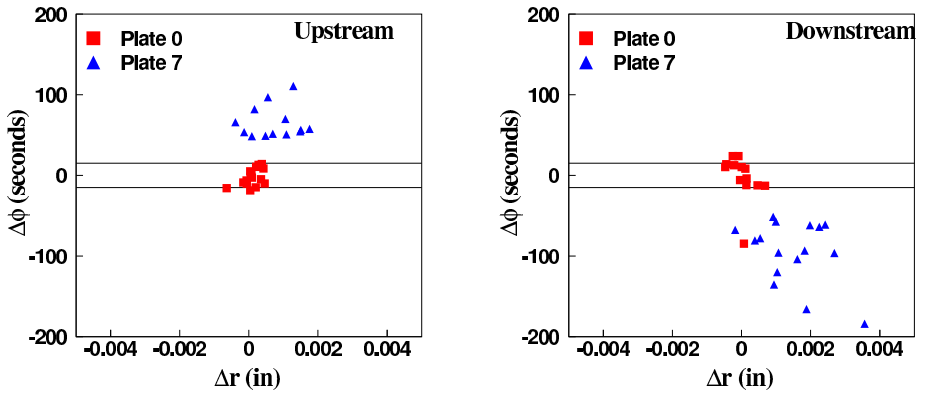
Figure 9: A plot of the deviation in ϕ versus that in r for the upstream and downstream sections. The data have been optimized to plate 0, so all points there are easily withing $\pm 15 sec$ in ϕ and $\pm 0.001\, in$ in r. The data for plate 7 are systematically off indicating that the matching of one plate to the next is not perfect. Note that the upstream plate is significantly better matched than the downstream.
