Lead Glass and Photomultiplier Evaluation A Progress Report*

Jonathan Dickey, Eric Scott, Paul Smith and Scott Teige
Department of Physics
Indiana University, Bloomington, IN 47405

The GlueX collaboration intends to reuse the Lead Glass Detector previously used for Brookhaven National Laboratory Experiment 852. Since lead glass is subject to radiation damage and photomultiplier tubes subject to various aging mechanisms evaluation of the suitability for use of these components is essential. This document describes methods developed and the progress of the evaluation.

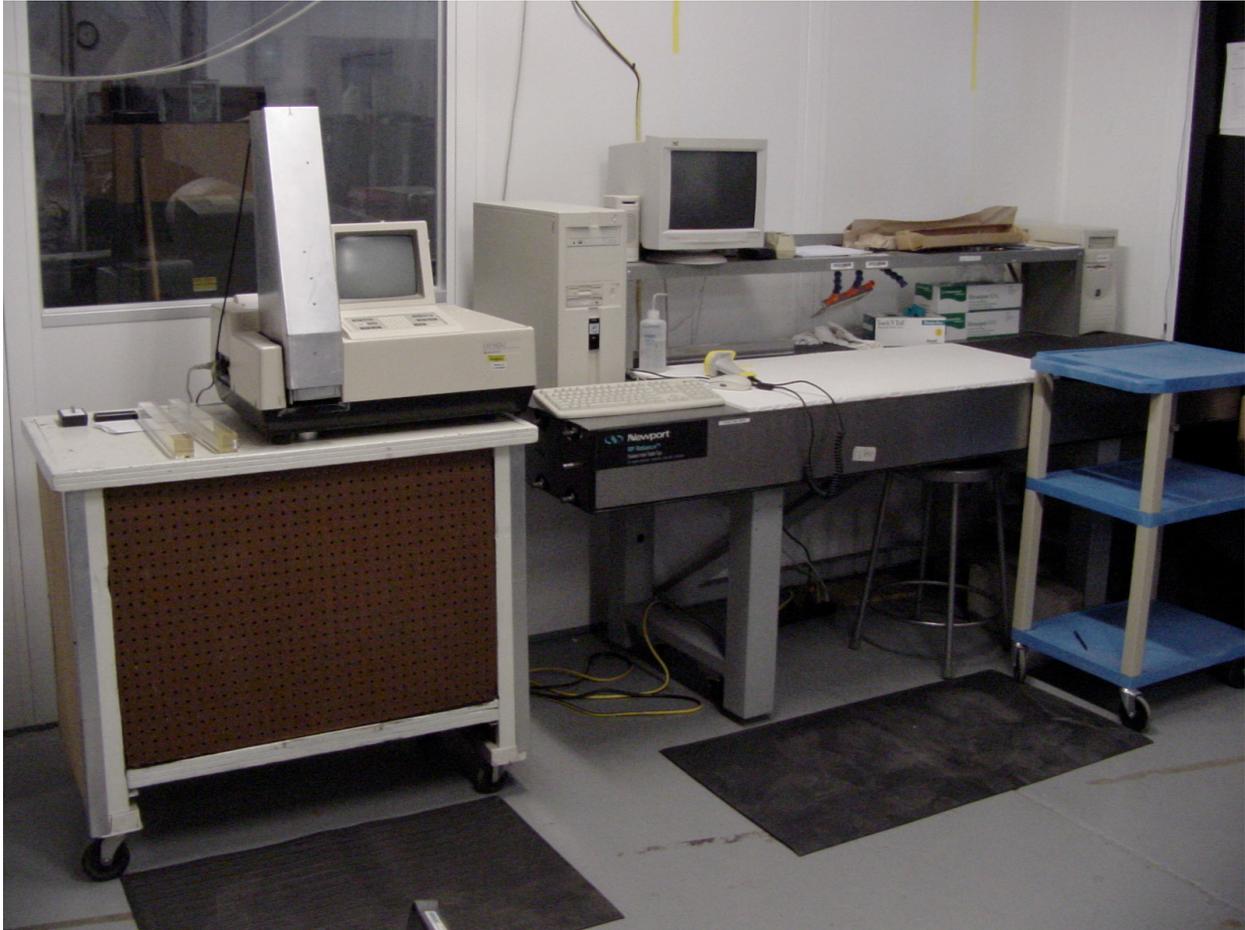
Figure 3: The lead glass testing station. Visible on the left is the modified spectrophotometer. The aluminum structure forms a light-tight enclosure for the block under test. Beneath this (enclosed by the table) is a mechanism that raises and lowers the block under computer control. On the right is the data acquisition/control computer and a table used to unwrap and rewrap blocks before and after testing

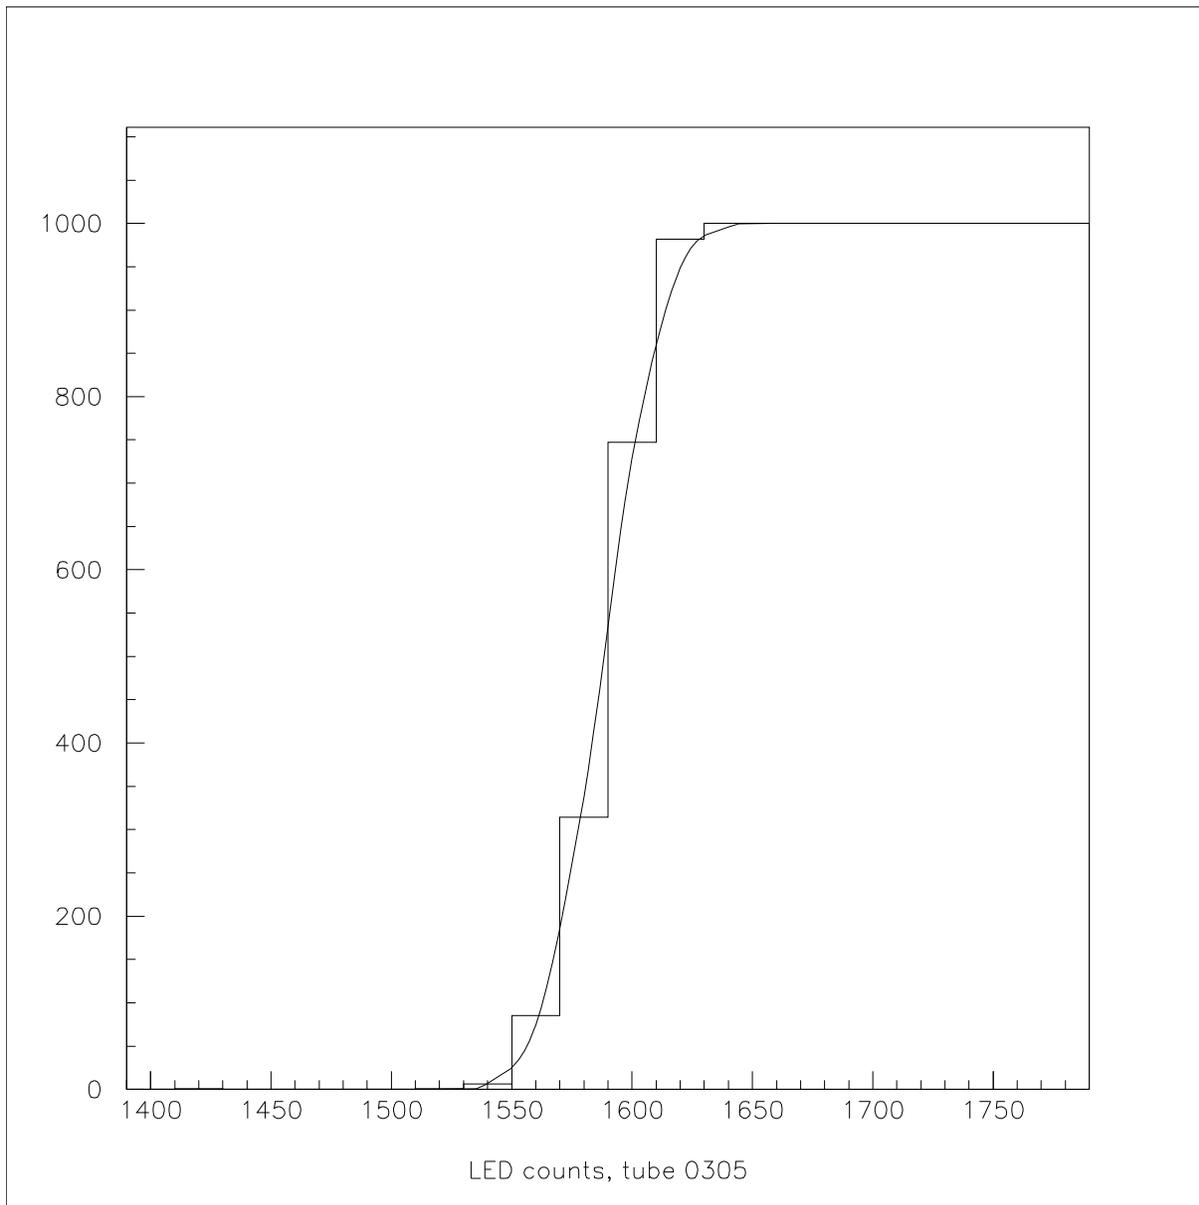
The parameters N , V_0 and σ are determined on a tube by tube basis by a fit to the data. V_0 is the voltage where eqn. 3 achieves a value[†] of $N/2$, that is, where the tube is 50% efficient. The parameter σ measures the width of the rise of the curve. A typical value for σ is about 20 Volts. For the tube shown in figure 11 the 50% voltage was found to be 1588 volts. Shown in figure 12 is the distribution of values found for V_0 .

The data from the tester was analyzed offline. A tube was flagged as "suspect" if the function given by 3 failed to reach 90% efficiency over the tested range of voltages. Diagnostic output was printed to the screen identifying the tube and giving the location of further diagnostic data. The distributions shown in figure 11 for flagged tubes were examined. About 10% of all tested tubes were initially flagged by this process. The detailed examination revealed that most flagged tubes were, in fact, operational but the fit failed to converge. In nearly all cases this failure to converge was caused by a "late turn on" of the phototube response. That is, the 50% voltage was in excess of ≈ 1850 volts. The fit was initialized so that it would converge for most tubes thereby minimizing the number of distributions to be examined in detail. However, this choice of initialization resulted in the $\approx 10\%$ false positive test rate.

Figure 11: The response of a tube to the LED as a function of voltage. On the vertical axis is the number of times the tube had a pulse over threshold associated with an LED pulse. The LED was pulsed 1000 times at each voltage. The smooth curve is a fit to the data and gives the voltage where the PMT was 50% efficient.

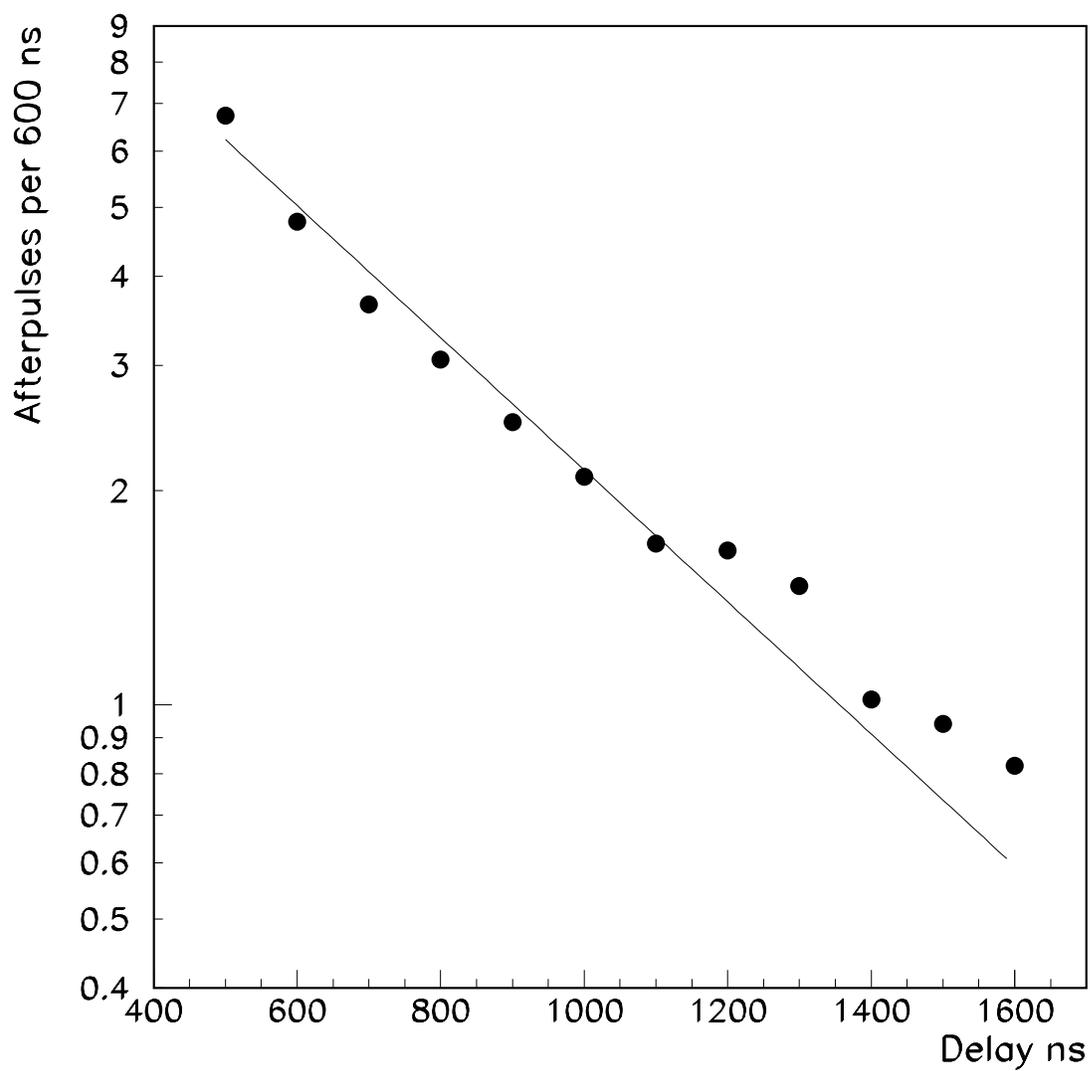
The average number of after-pulses in the 600 *ns* window pulses as a function of the start time of the gate is shown in figure 13. The after-pulsing rate is seen to decay exponentially. A fit to the data gives a characteristic time for this decay of 470 *ns*.

Figure 13: After-pulsing rate as a function of gate start time from the initial pulse. A decay constant of 470 ns is obtained from a fit to the data.

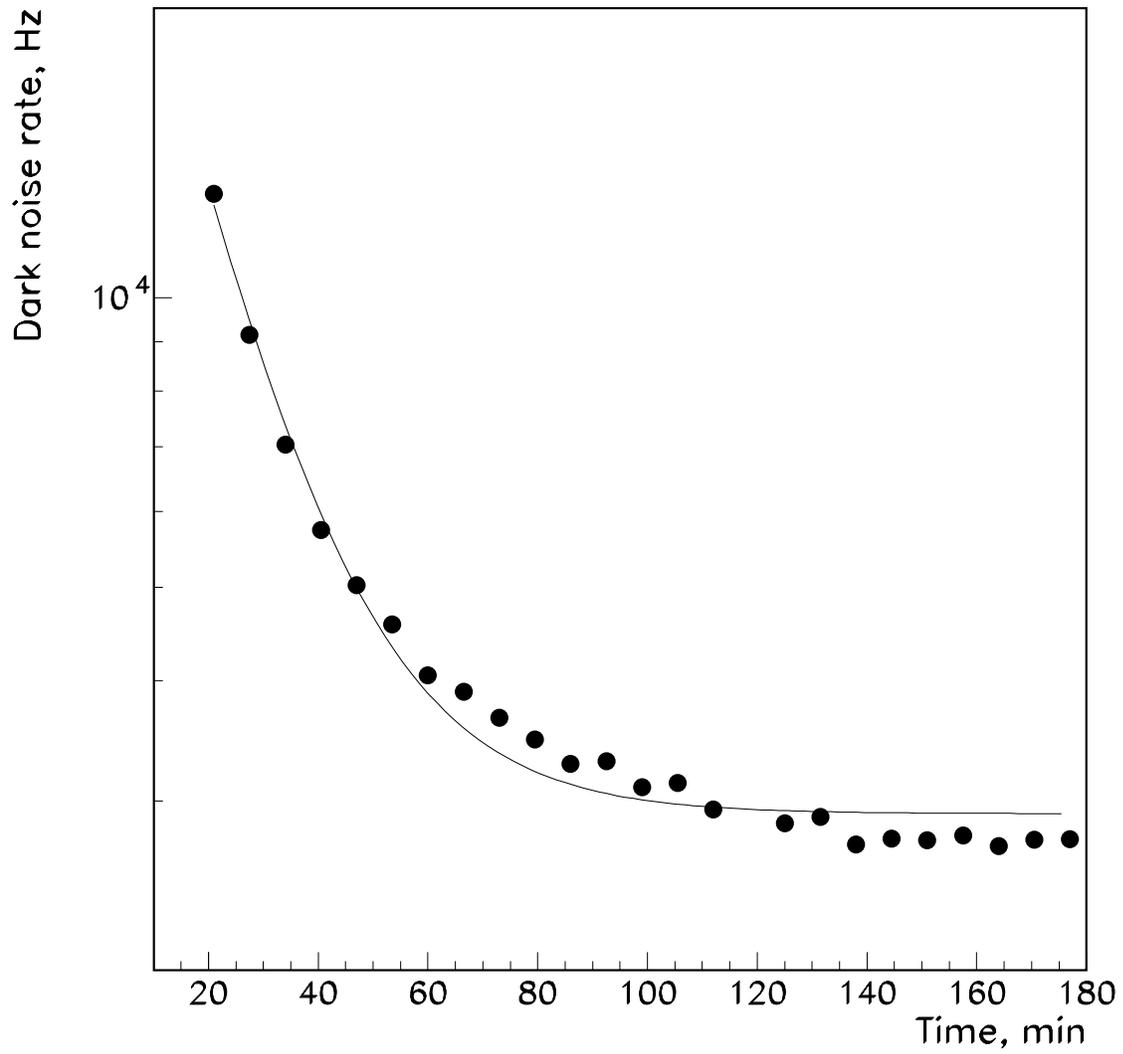
Figure 14 shows a dark noise measurement for a single phototube. It is often asserted that dark noise decreases after a phototube is kept in darkness for some period of time. Shown is the dark noise rate measured for a phototube after exposure to fluorescent light as a function of time since the exposure. The data is fitted to a function of the form

Figure 14: Dark noise rate as a function of the length of time the tube was under voltage and in the dark. A decay constant of ≈ 17 minutes is obtained from a fit to the data.
