Polishing Tests

06/28/14

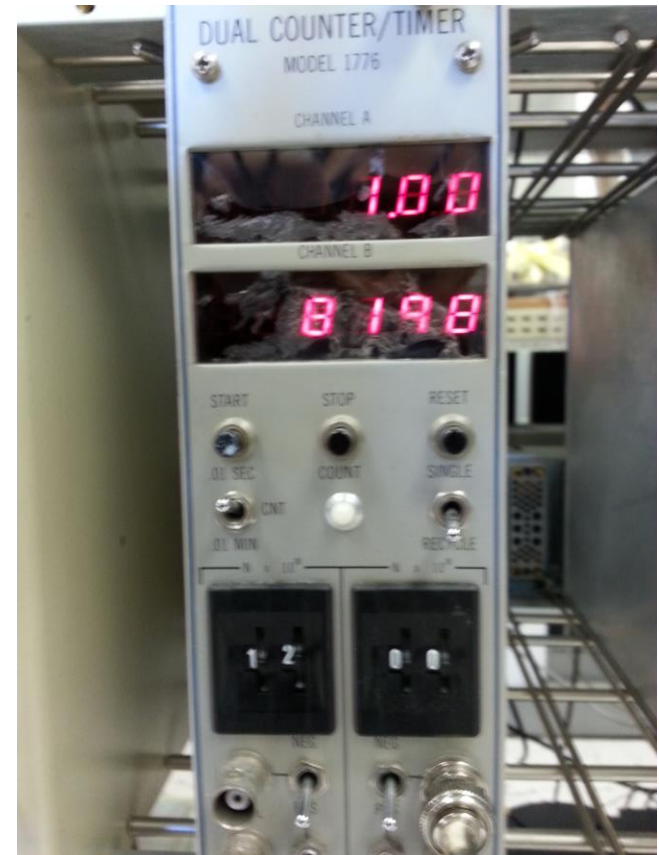
Polishing Trials (Speed Monitoring)

- Utilizing Tape Drive motor to drive the flannel buffing wheel
- Measured the number of pulses per rotation from the encoder
- Use NIM counter to measure number of pulses per second and convert to RPM for speed monitoring
 - $8000 * 0.12 \approx 1000$ rpm
- Ensures consistent buffing speed for each user & scintillator
