# Large MWPC Electronics Testing

- Received all boards from manufacturer
- Tested boards for functionality
- Removed excess material below connector
- Sanded down to proper size

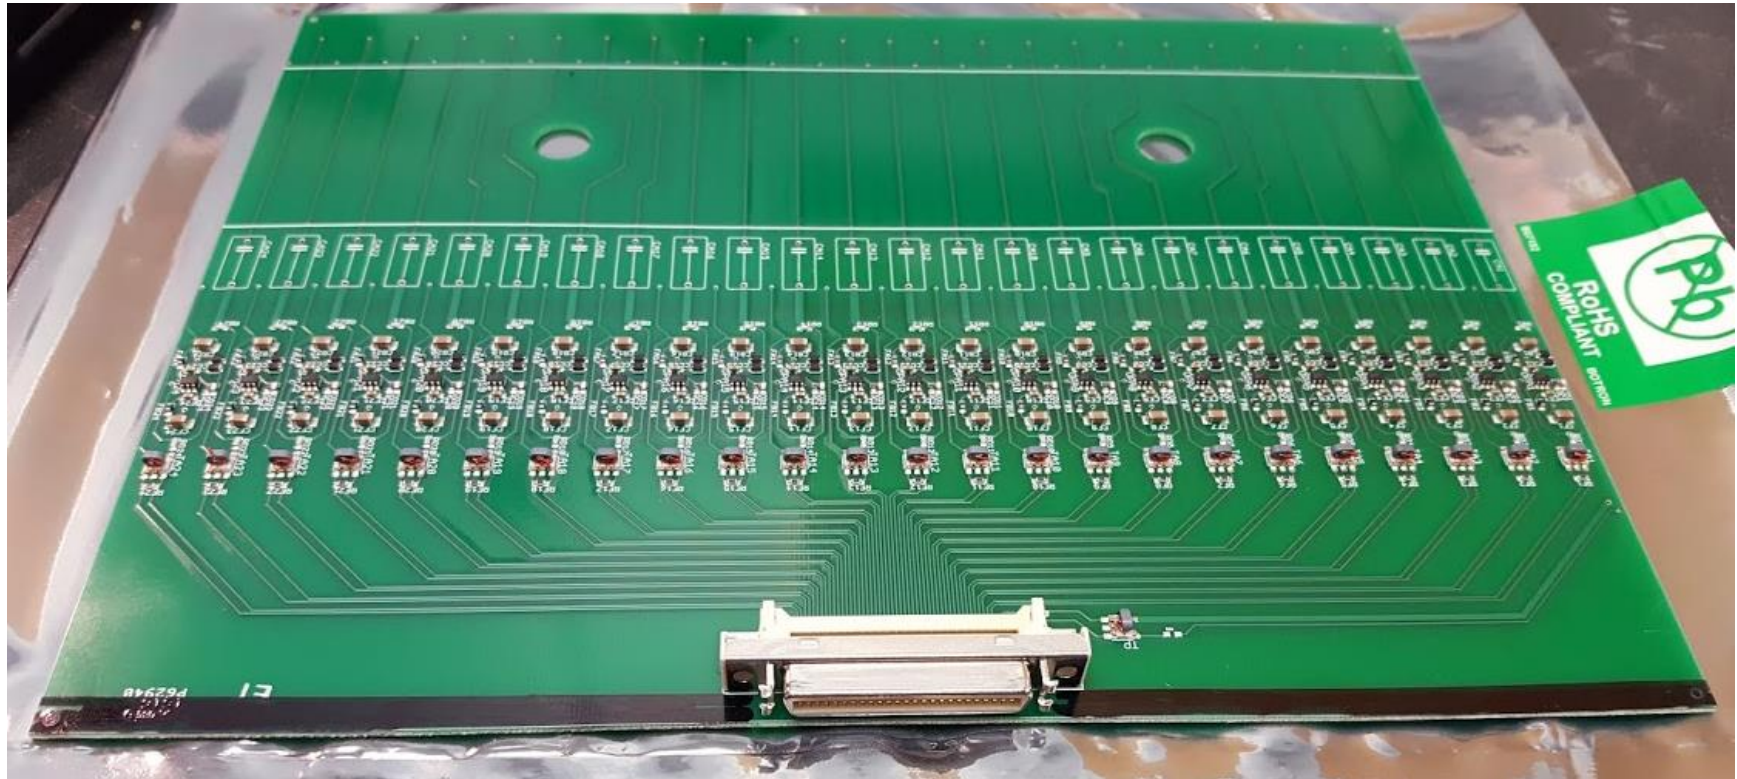
# Removing excess material from boards

The issue that the breakaway rails being present on the board causes is that the connector cannot attach to the board as the lower portion of the cable hits the board material before a connection is made

Solution: Remove material with Dremel cutting tool
