TRIG1 measurements on FCAL North
Problem TI in one crate?

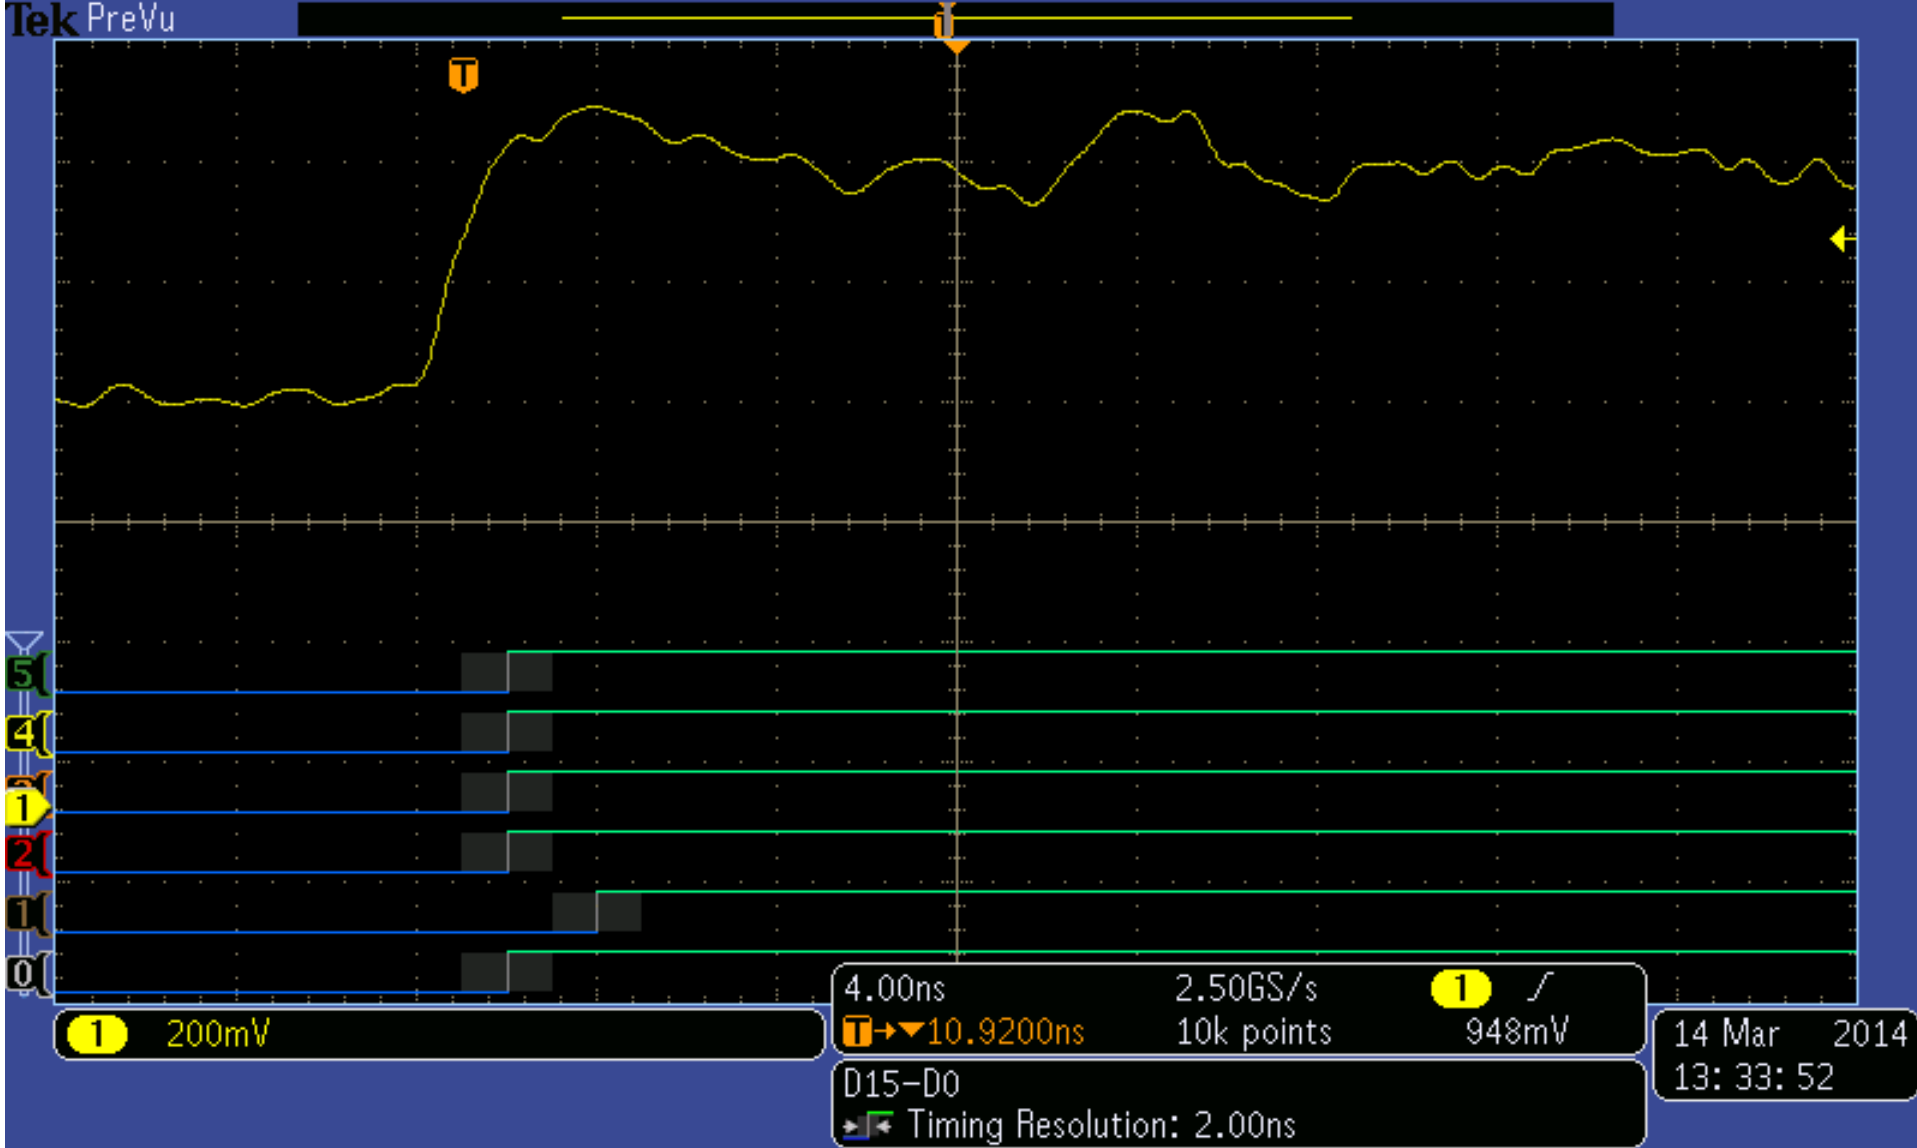
Zoom in of TRIG1 alignment

Replaced TI and all Trig1 signals are in alignment

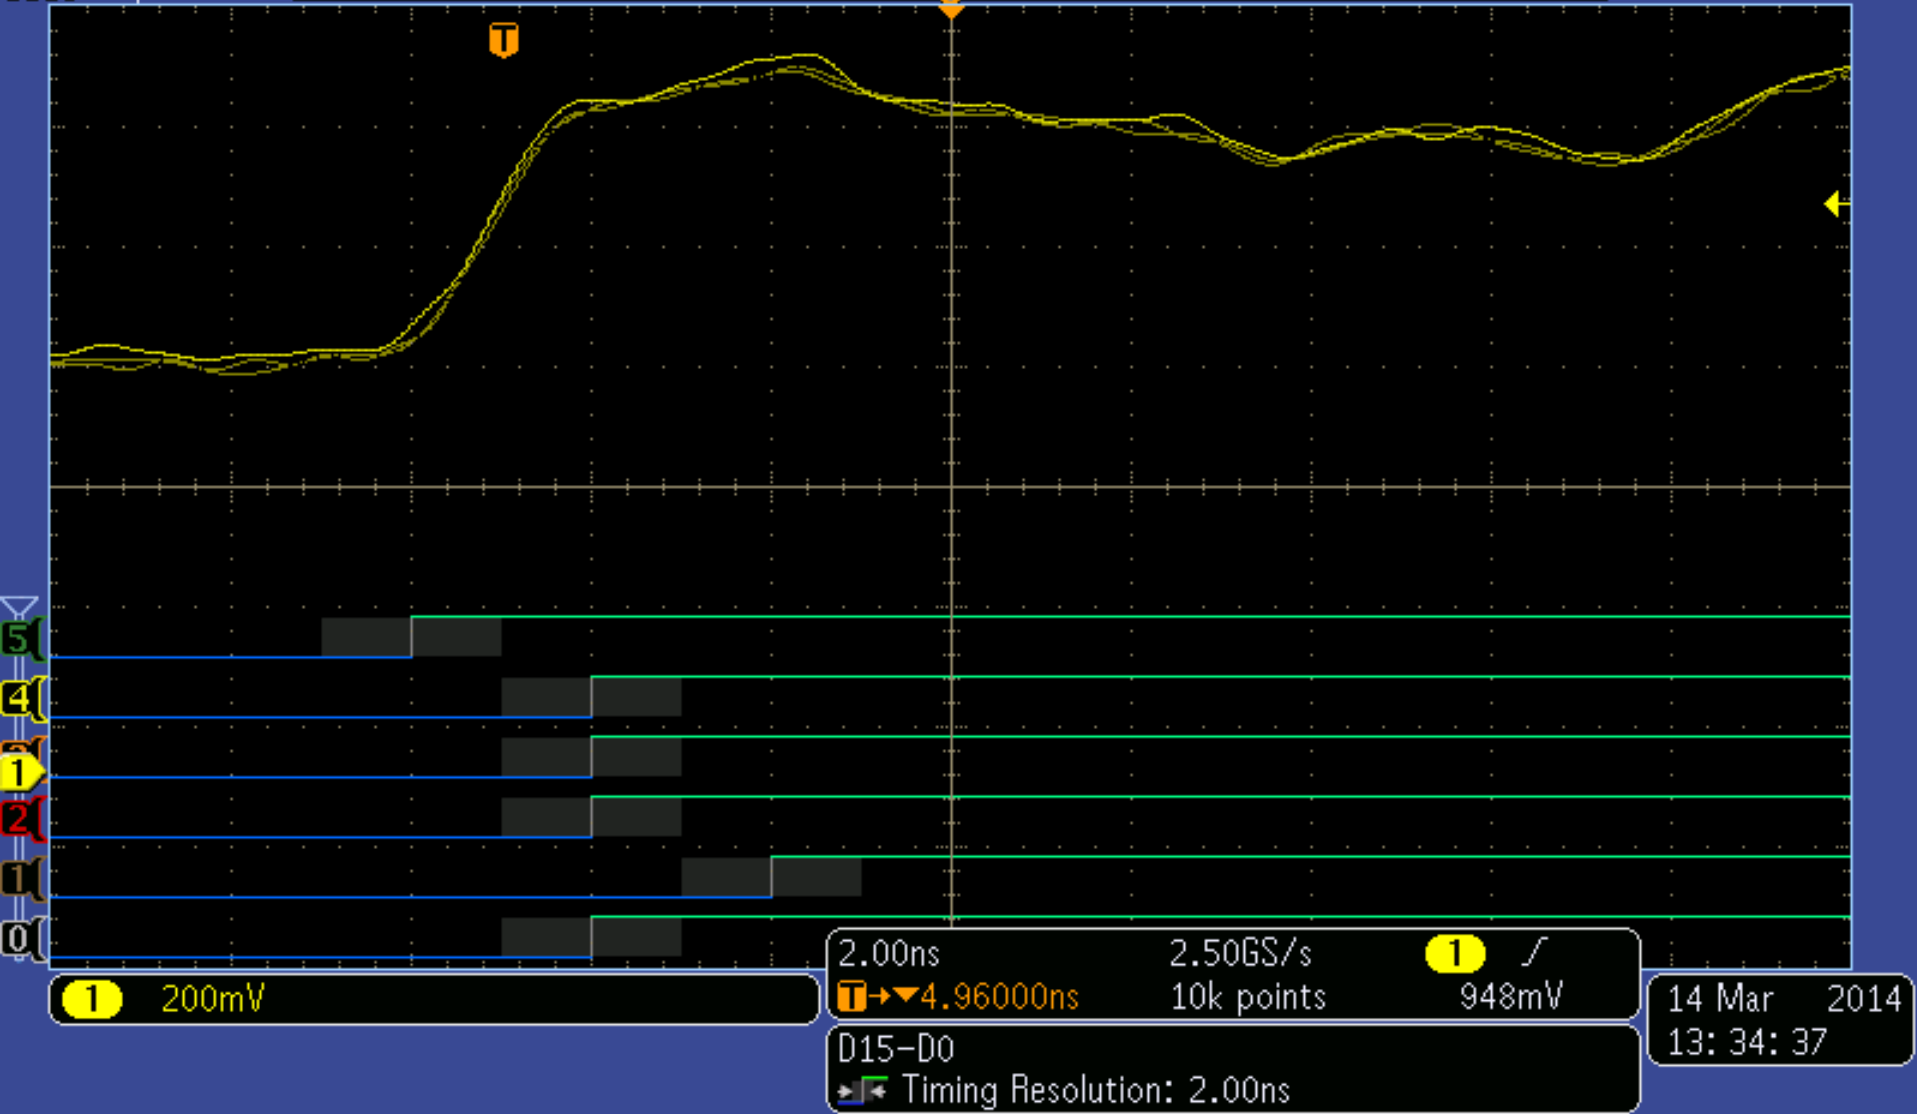
Zoom in of TRIG1 alignment

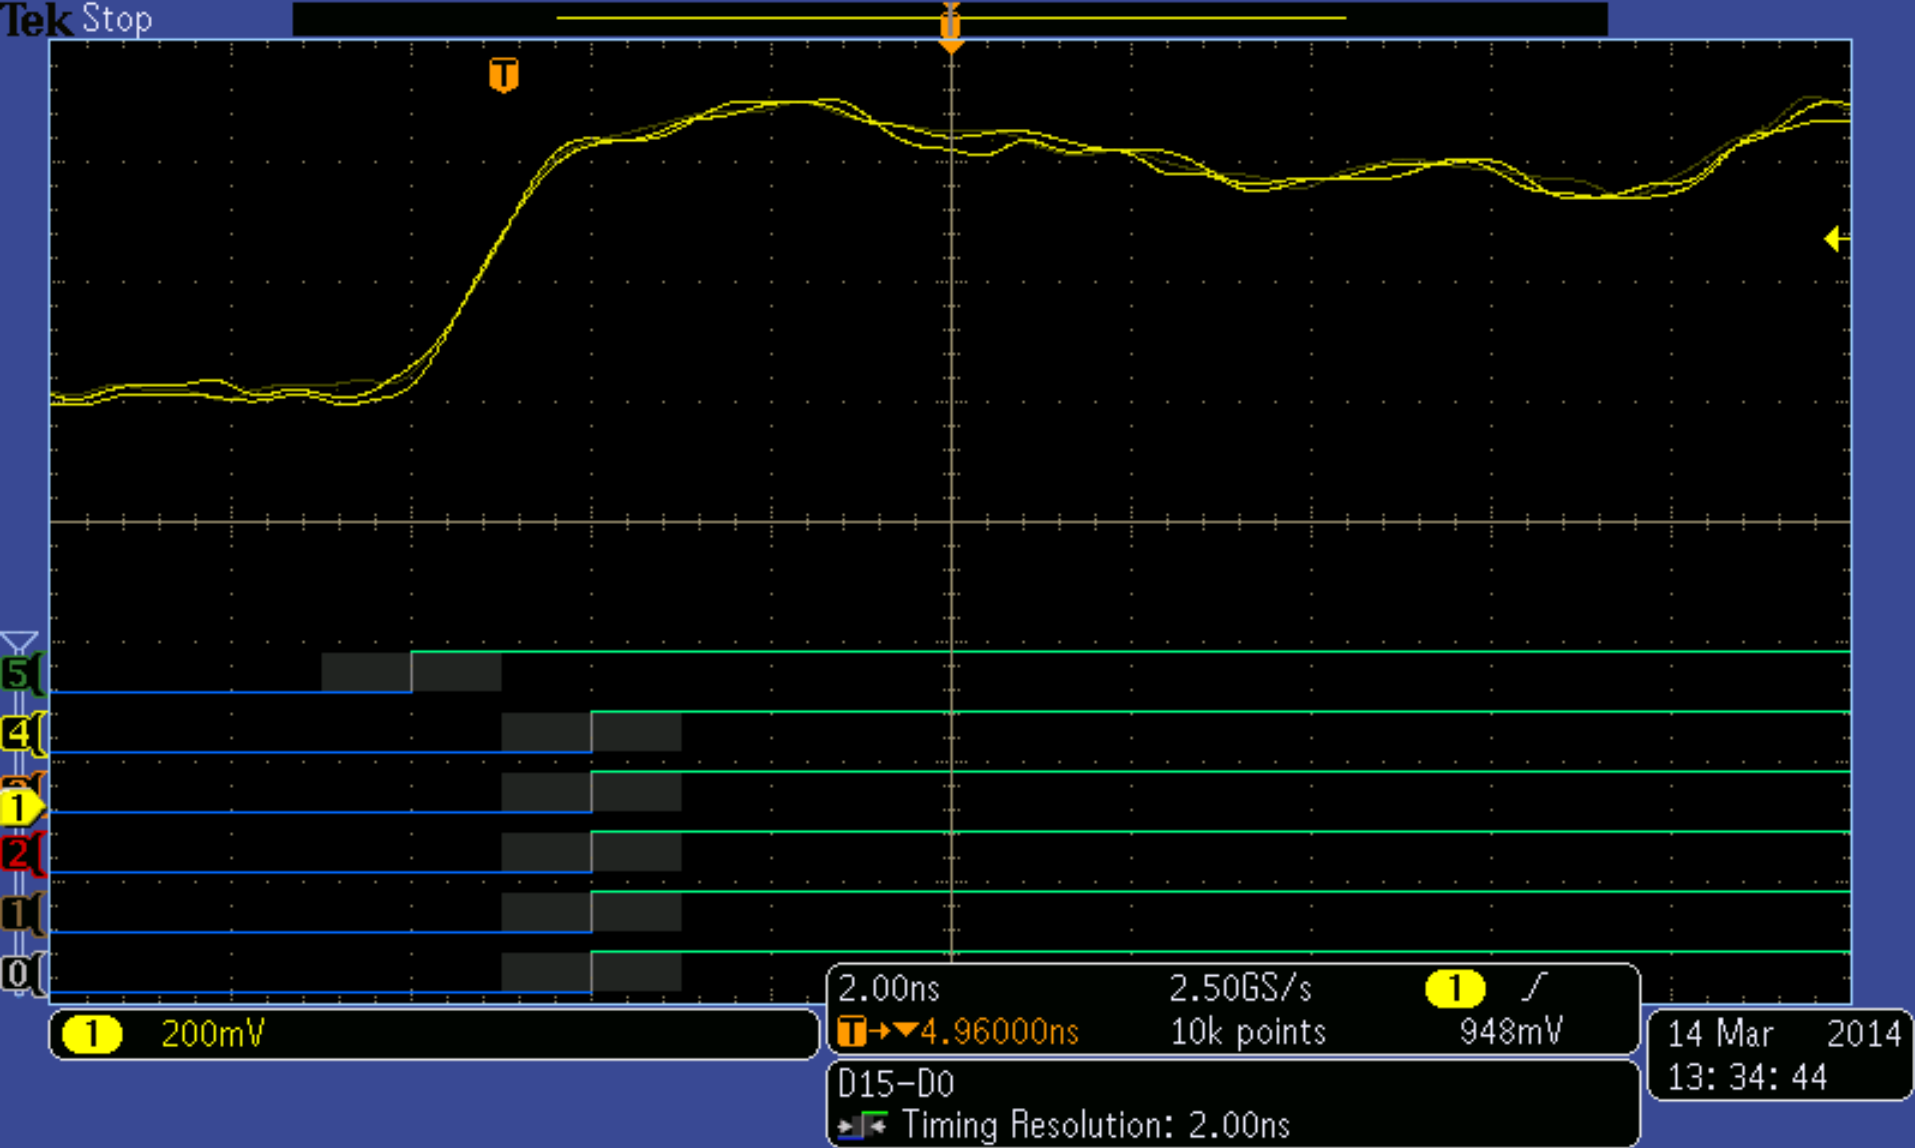
Zoom in of TRIG1 alignment

O'scope digital logic probe used for up to 8 signals

Note jitter uncertainty is shown with grey area

O'scope is triggered with probe on 1st crate's TRIG1 signal

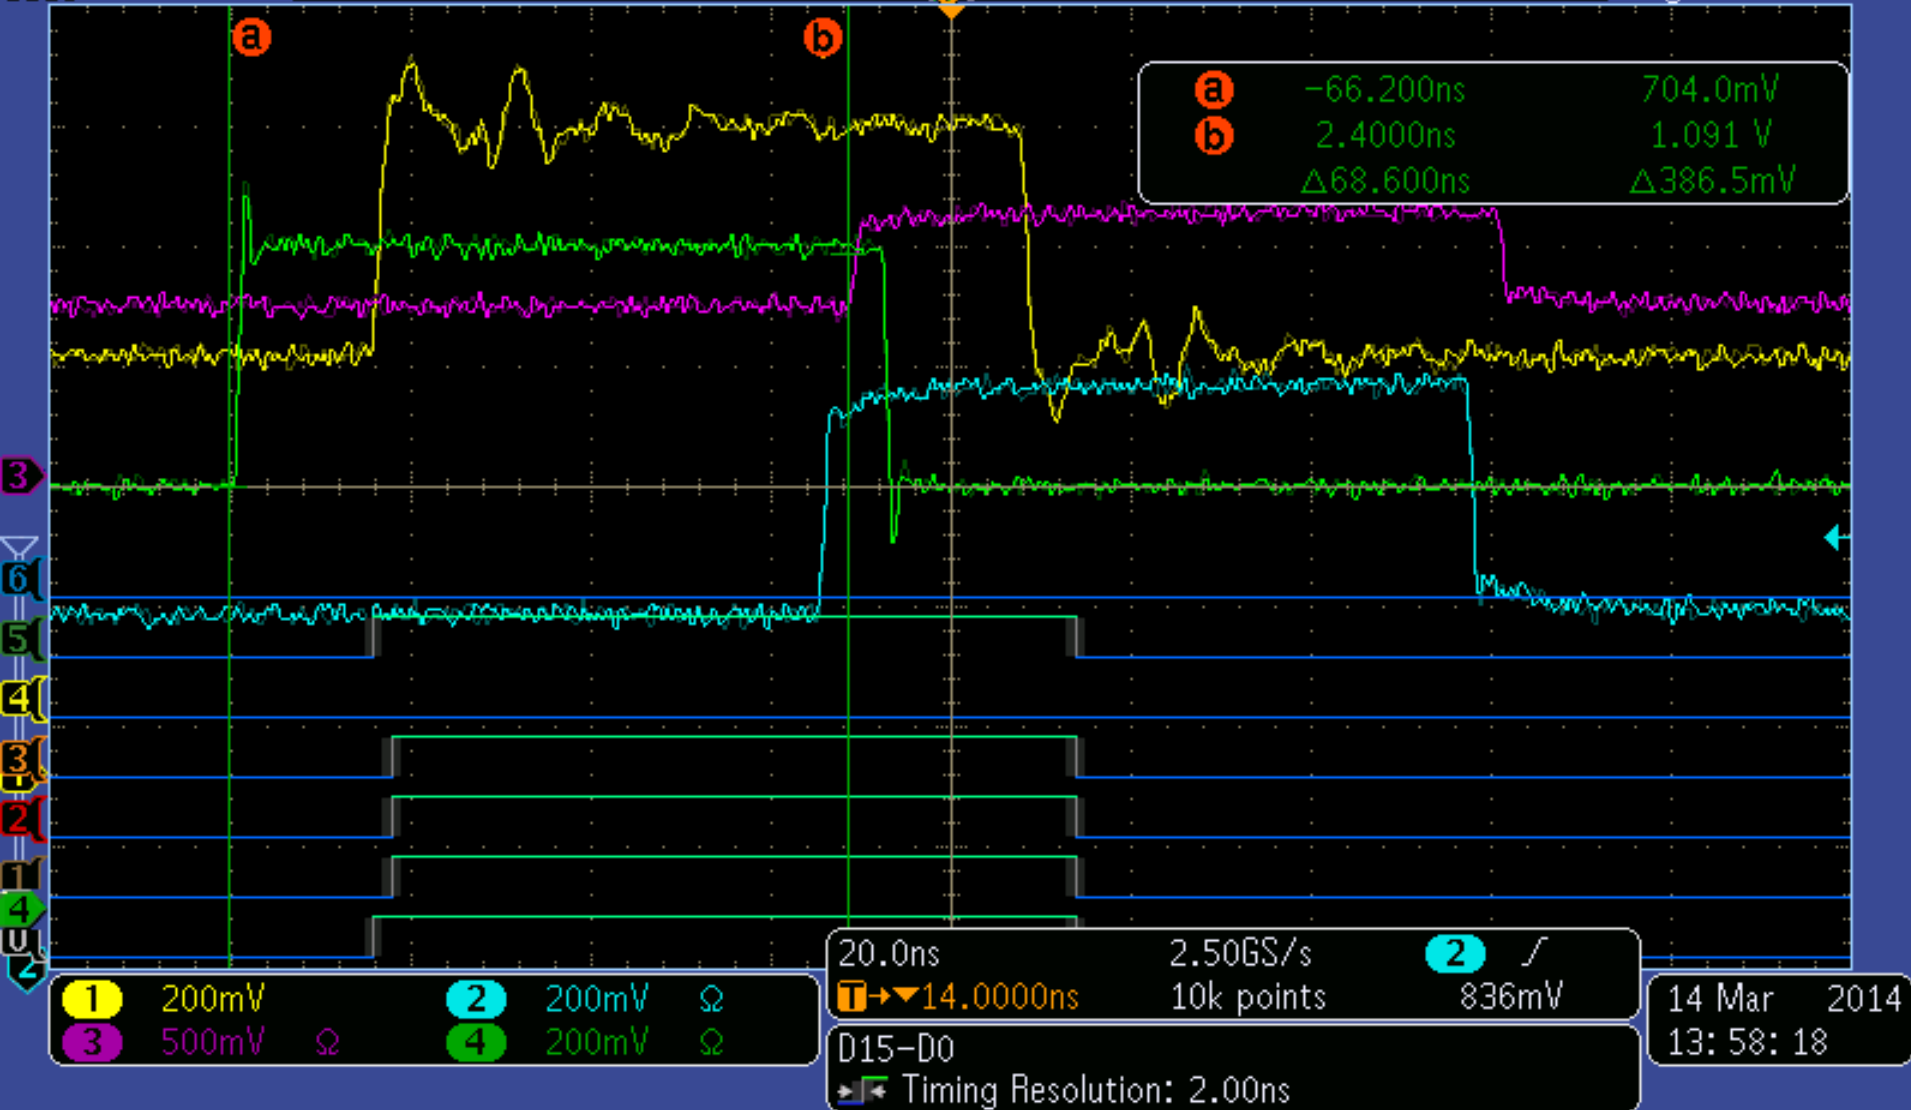
- 2: BCAL south-1
- 3: BCAL south-2
- 4: FCAL north-2(short cable)
- 1: FCAL north-1(Probe)

TRIG1 signals from SD front panel
