Start Counter Update

W. U. Boeglin

Collaboration Meeting September
2010 Start Counter

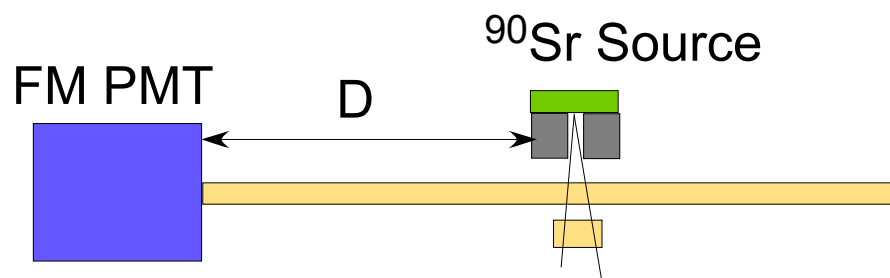
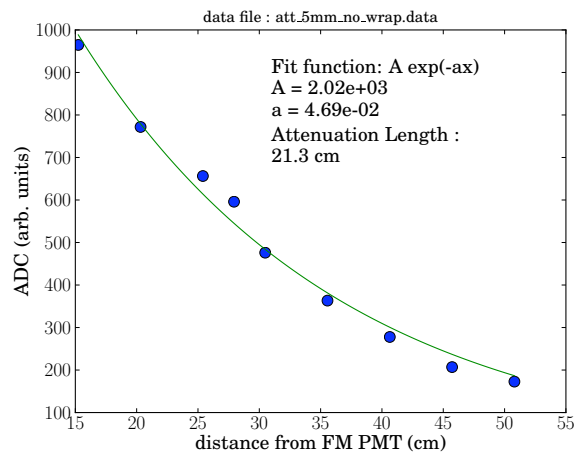
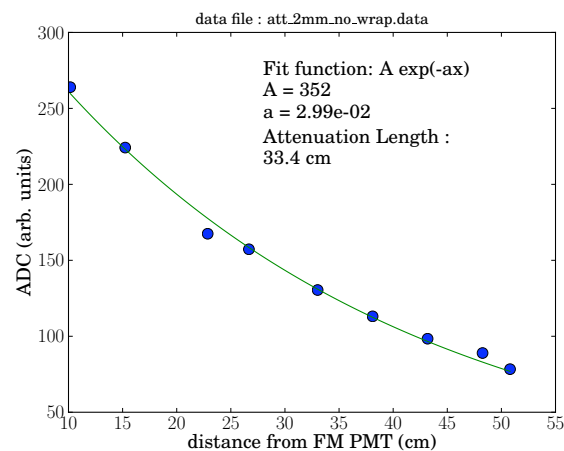
EJ-200 Scintillator Bar Studies

Light output measurements:

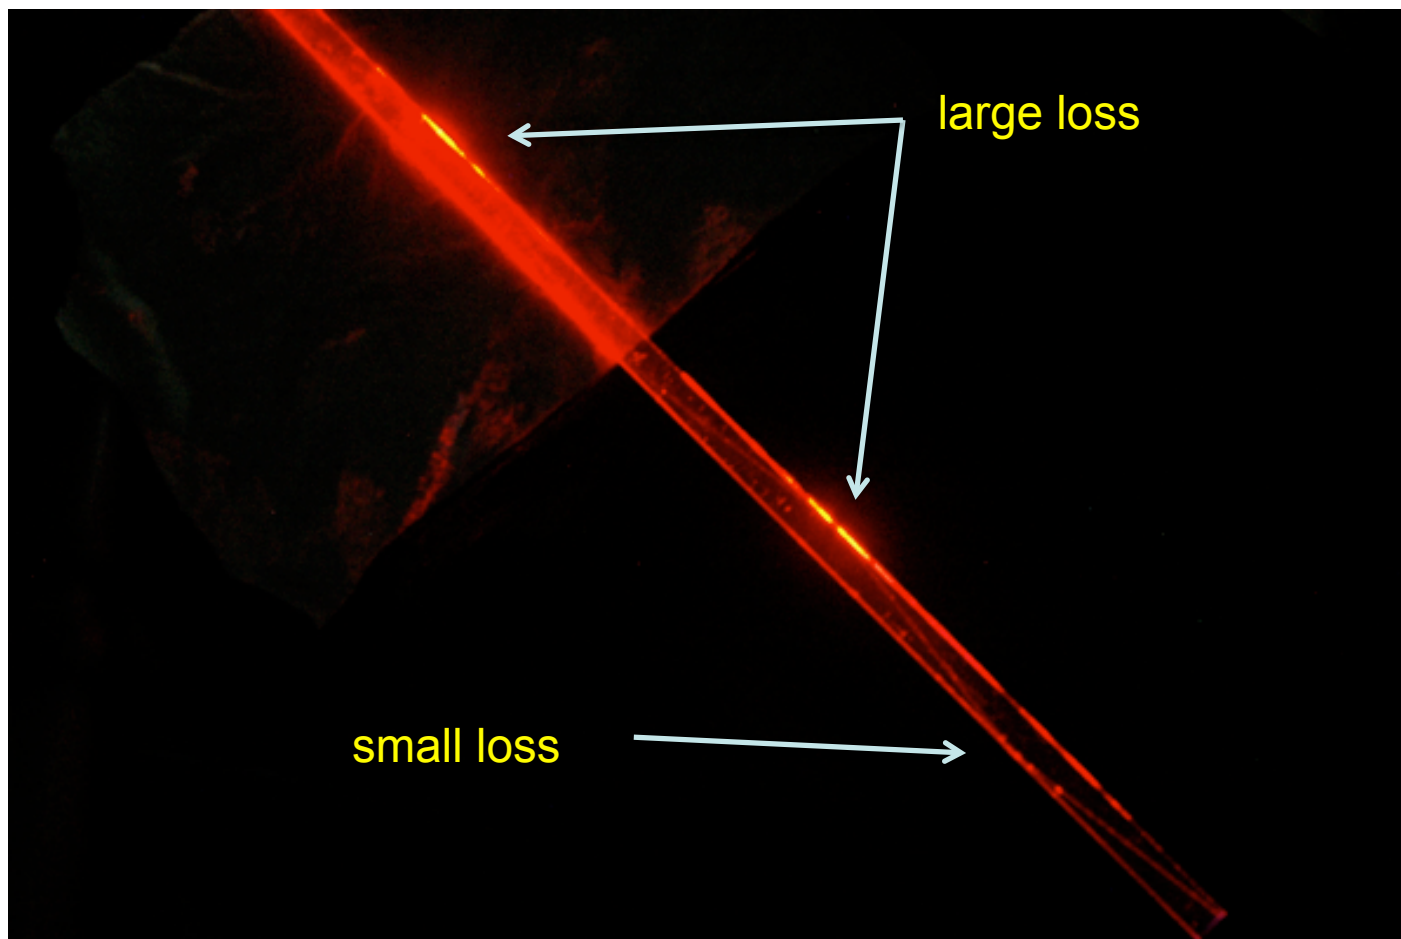
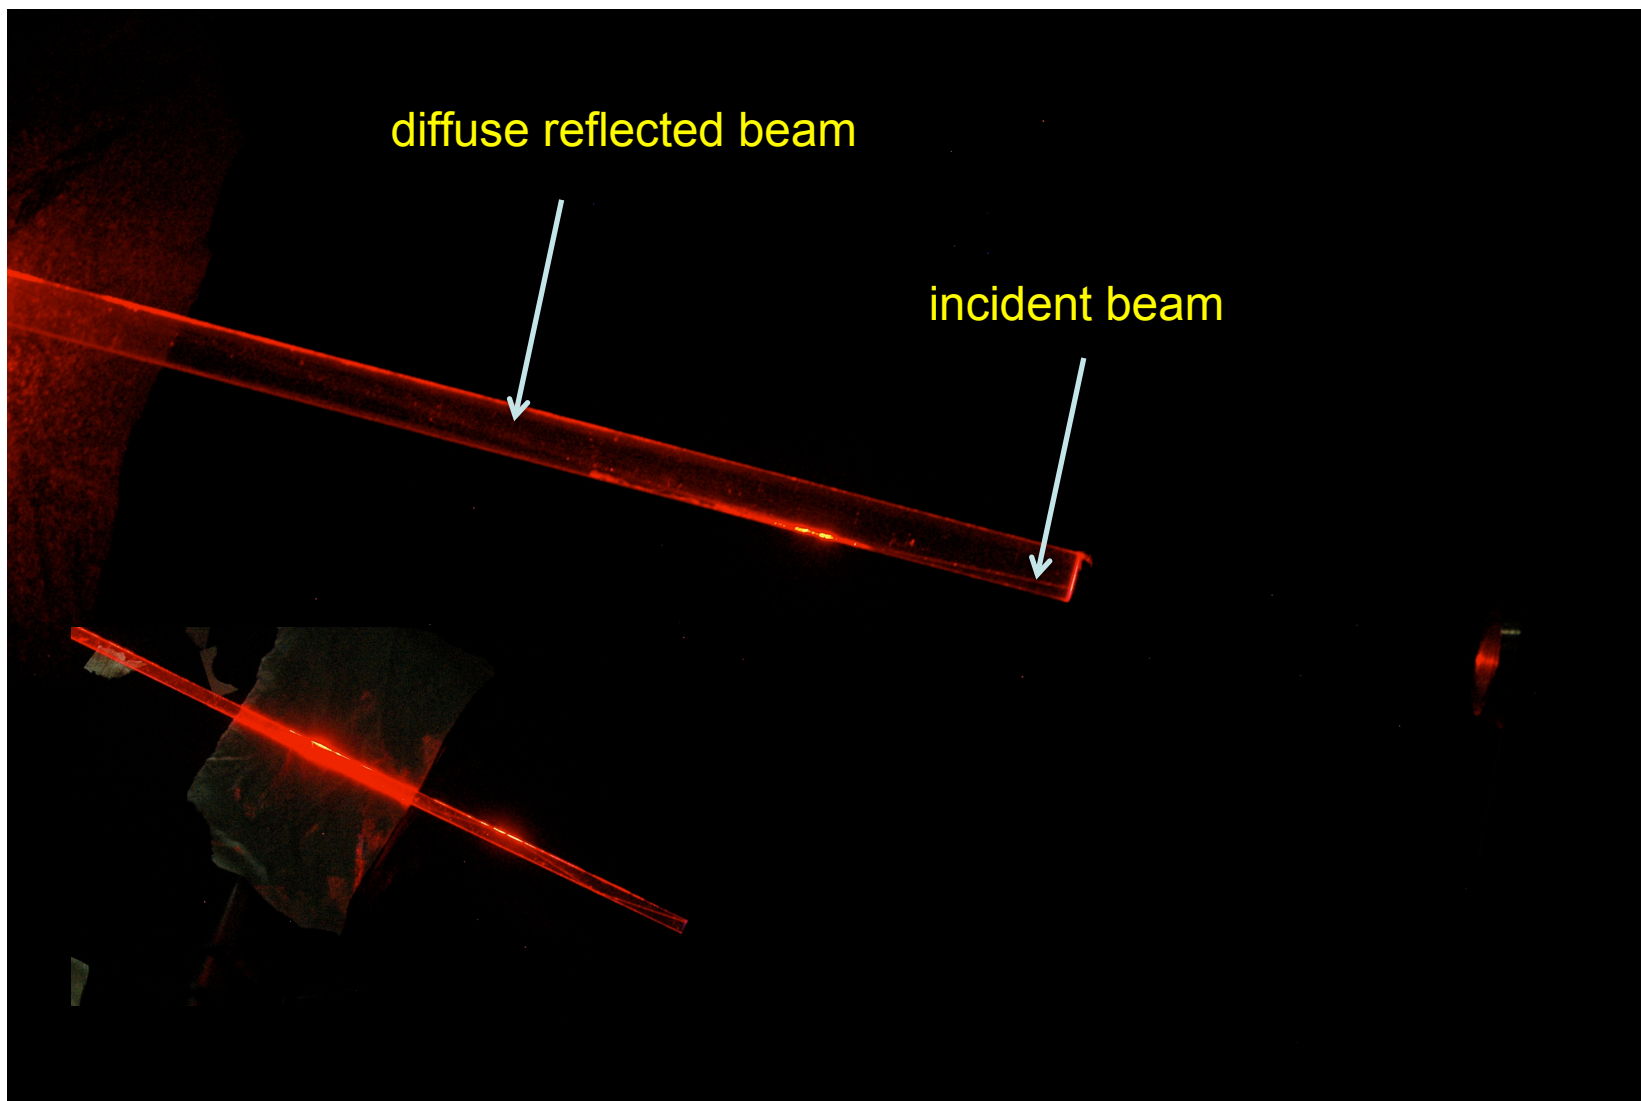
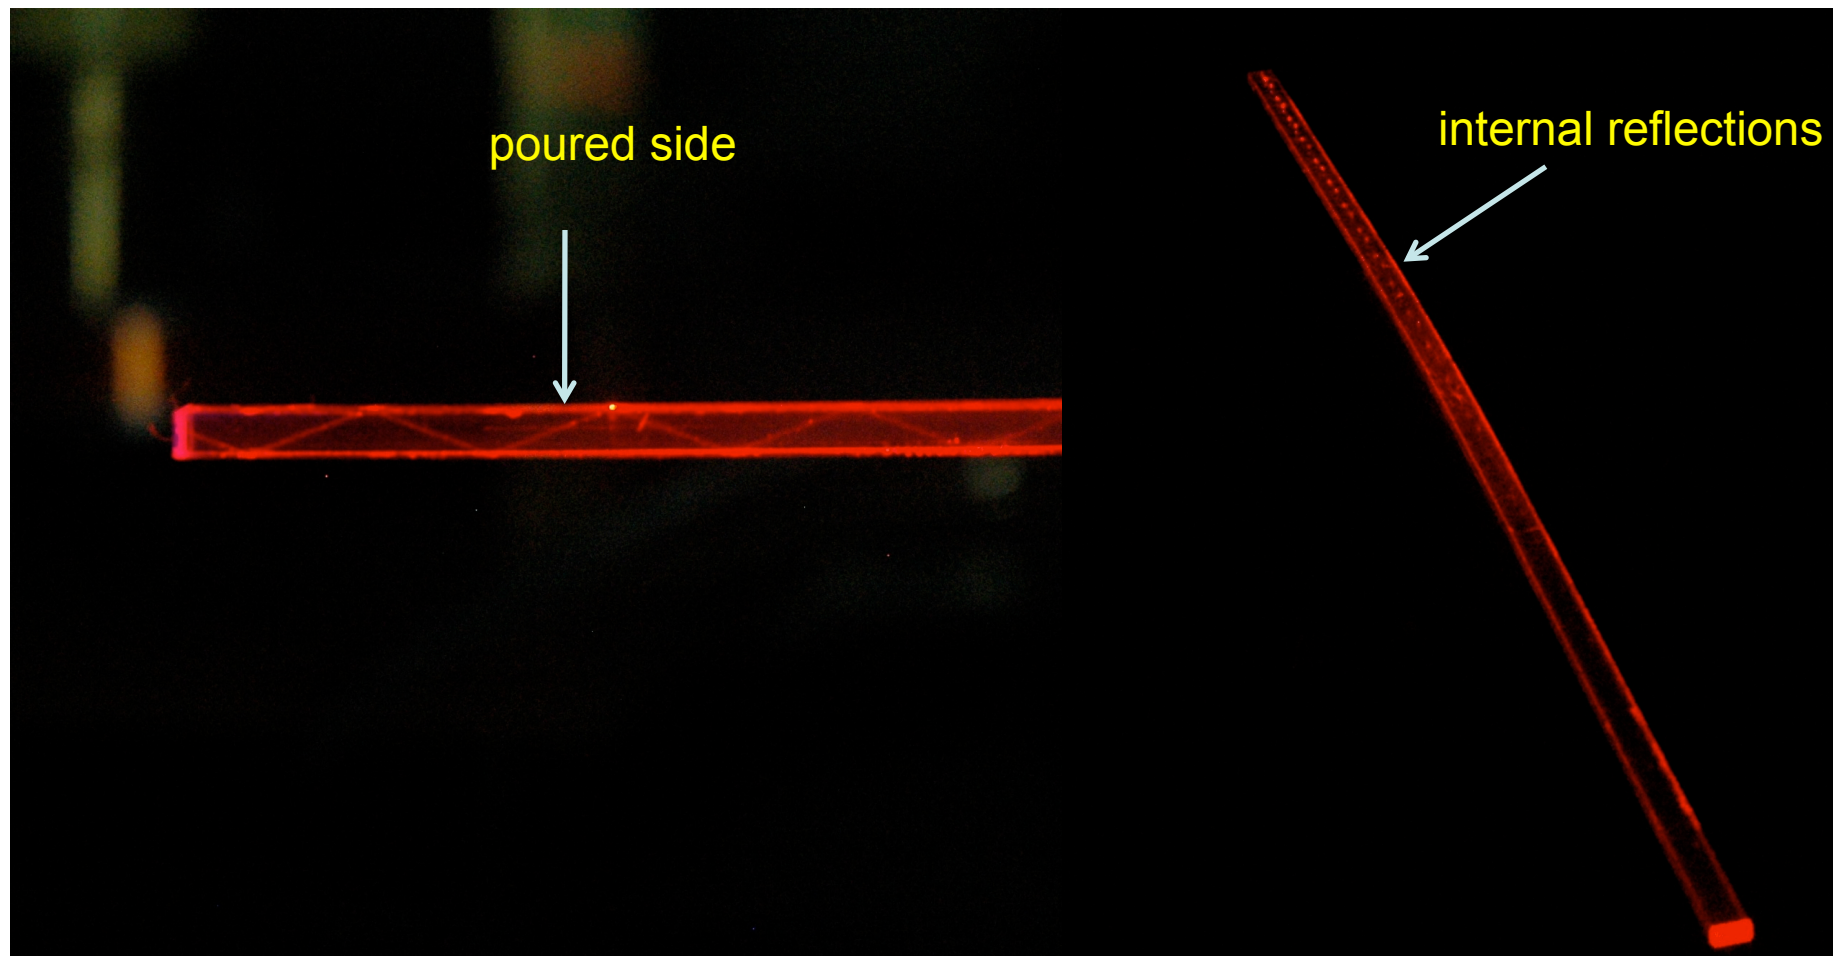
Laser Studies

- poured side (wide side) good quality
- diamond machined side problematic, confirmed by Eljen
- thin scintillator edge smaller fraction of total internal surface
- thick scintillator wide edge leads to large light loss

- injecting laser light into scintillators showed poor edge quality
- ordered new scintillators for further testing
- scintillator bending setup, ready next week
- hand polishing inadequate for reproducible work
- construction of polishing equipment started
- equipment for SiPM testing ready

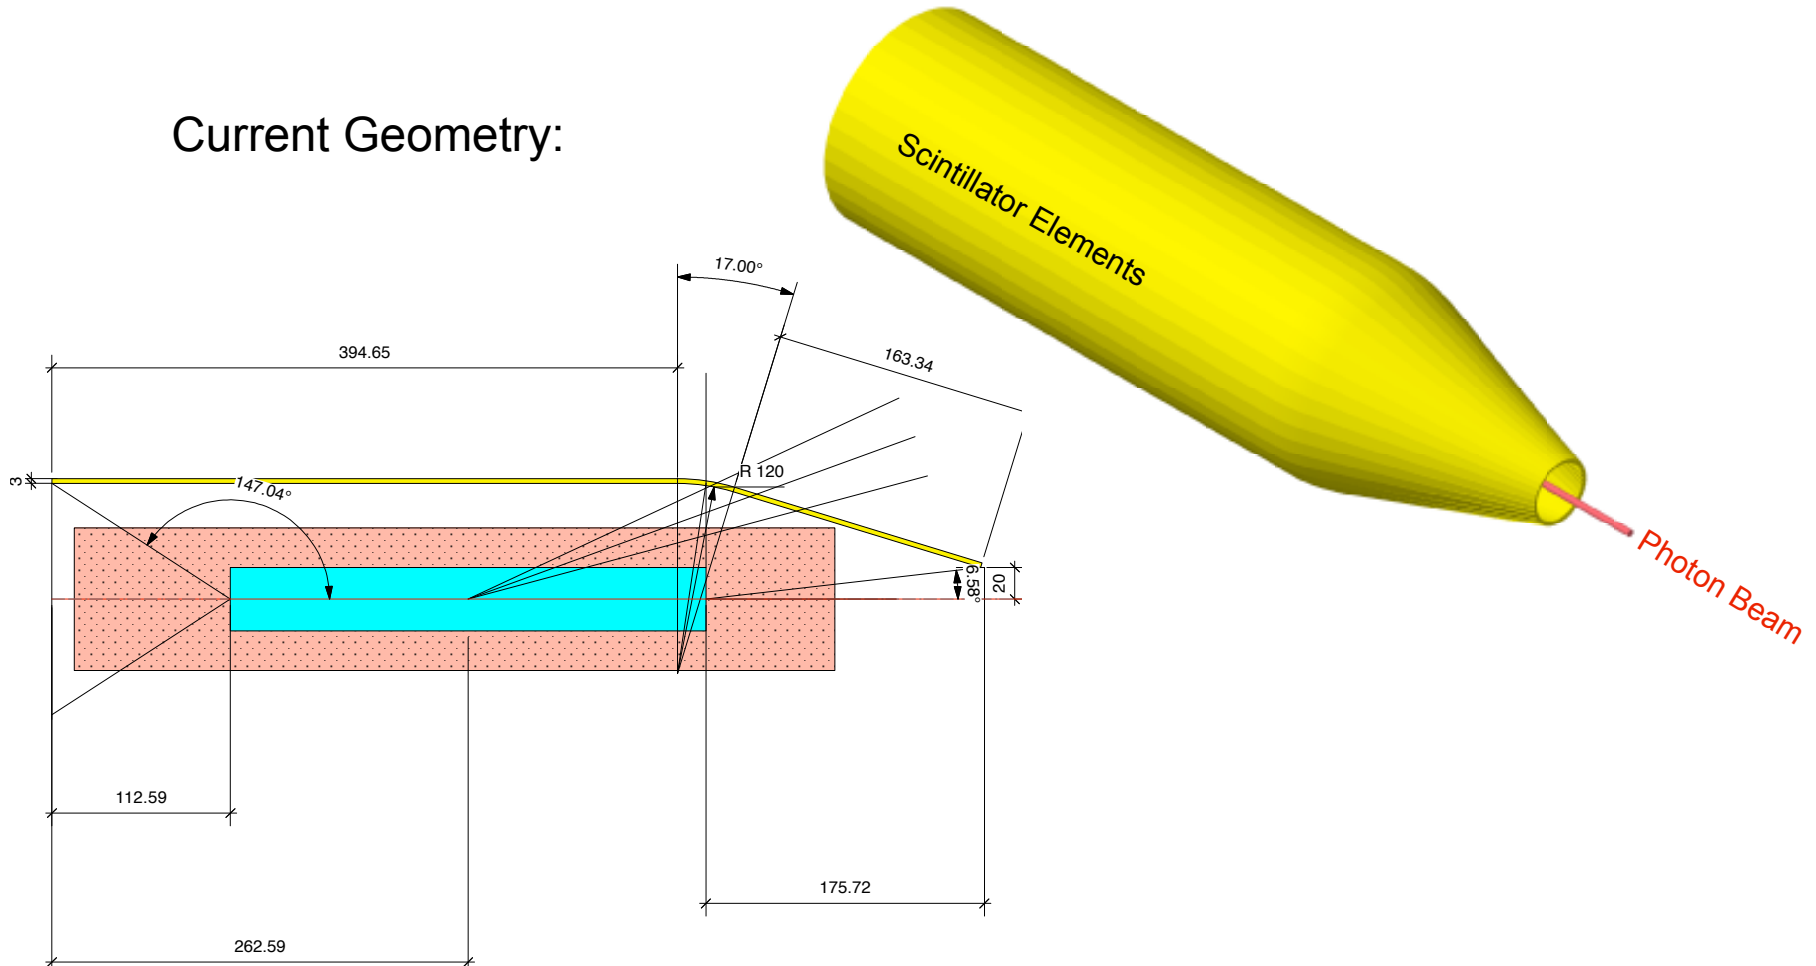
Geometry Changes

Current Geometry:

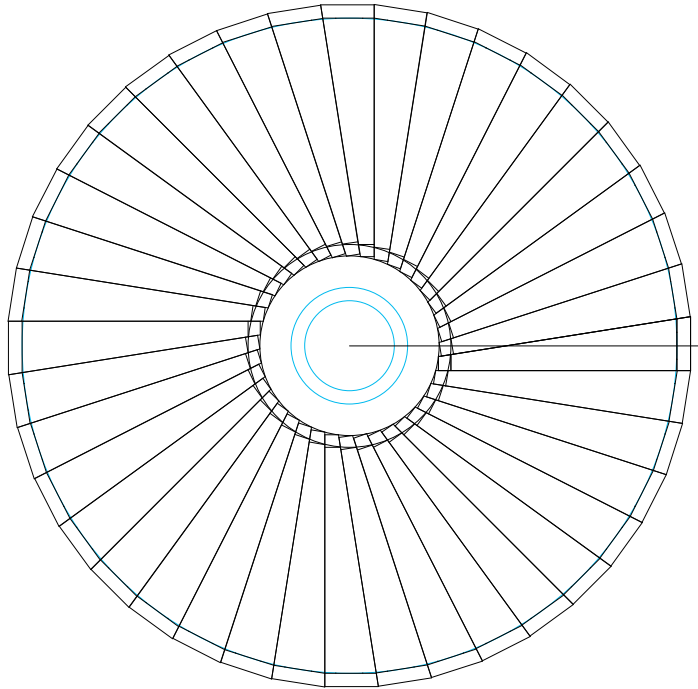
Current asymmetric

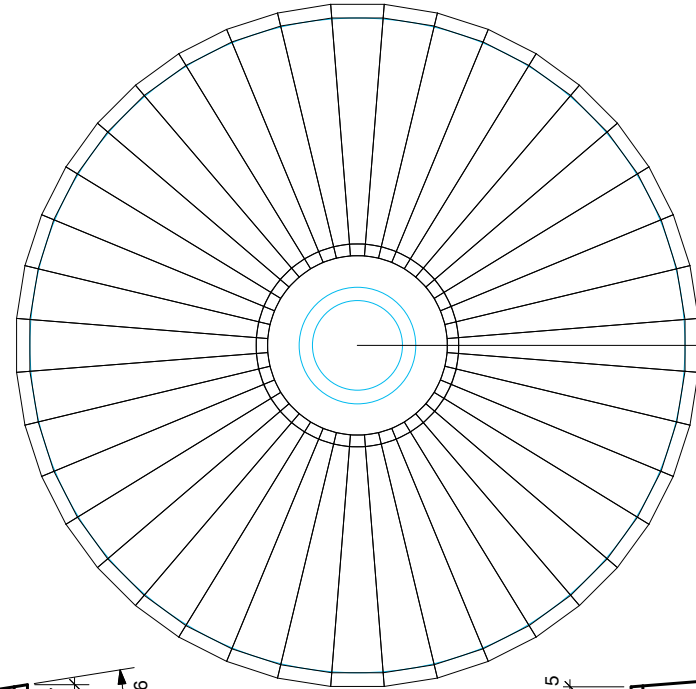
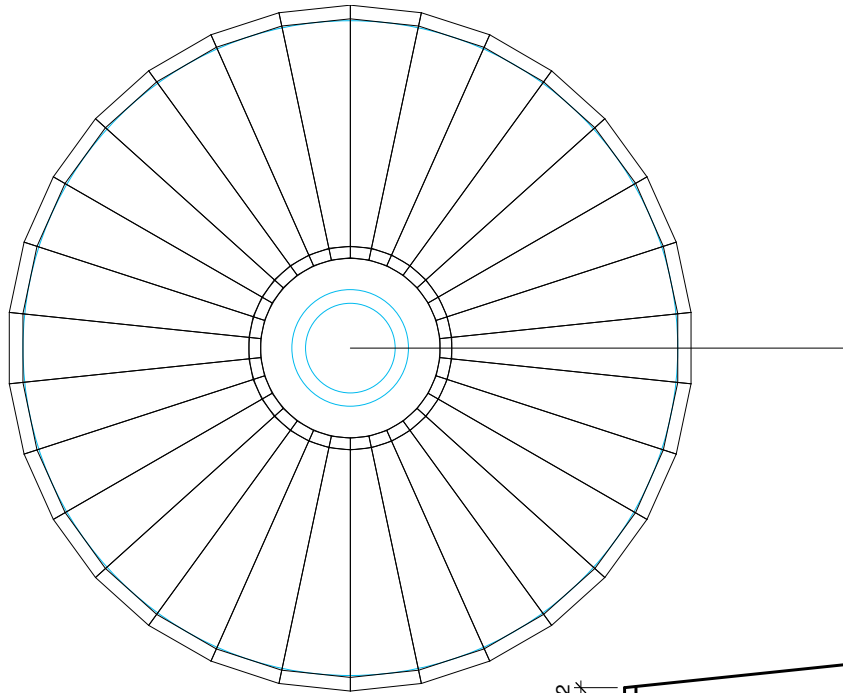
New symmetric

- easier to fabricate
- improved light output

- smaller segmentation
- higher rates/element
